YEAR11NR01

Historic and Restoration site tour in Italy

Quaderni di Assorestauro

YEARS 11 NUMBER 01
JUNE 2022

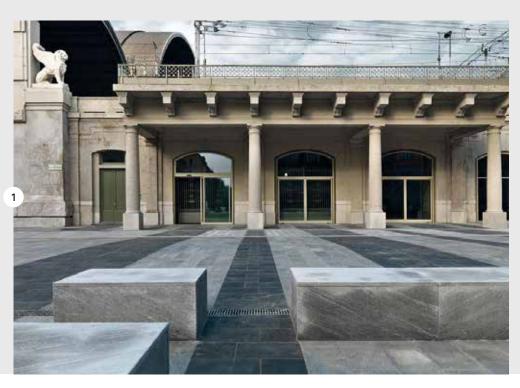
Fig 1. Piazza Edmond Jacob Safra and the entrance to the Shoah Memorial (ph. Andrea Martiradonna)

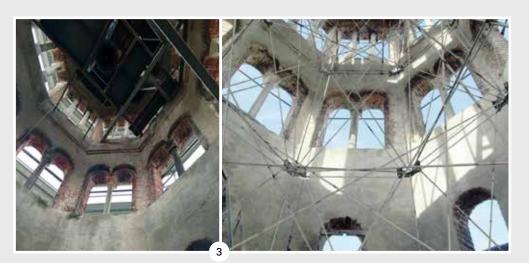
Fig 4. Section of the Tower divided into levels to identify the intervention areas

The bell tower of Chiaravalle has been remodeled several times over time. Between the end of the 15th and the beginning of the 16th century a consolidation intervention was carried out on the arches of the transept, probably due to the inadequacy of the supports which had not been designed and sized in view of the load of such a high tower. The 17th century saw not only the implementation of additions or reforms but also replacements. From the end of the 19th century to the present days, we can mention the restoration and consolidation of the tower in 1905 by Gaetano Moretti together with Raineri Arcaini. The sphere and the terminal cross placed on the upper end of the tower were also removed, repaired, and gilded with bite. This intervention had an aspect of considerable historical-methodological interest, which concerns the theme of the proposed removal of the additions from the 17th century.

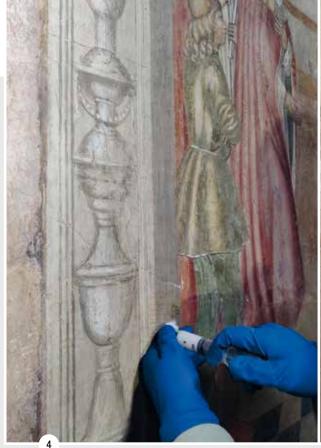
Fig 4. Plaster consolidation of the Pio's Chapel by Cooperativa Archeologia's team of experts

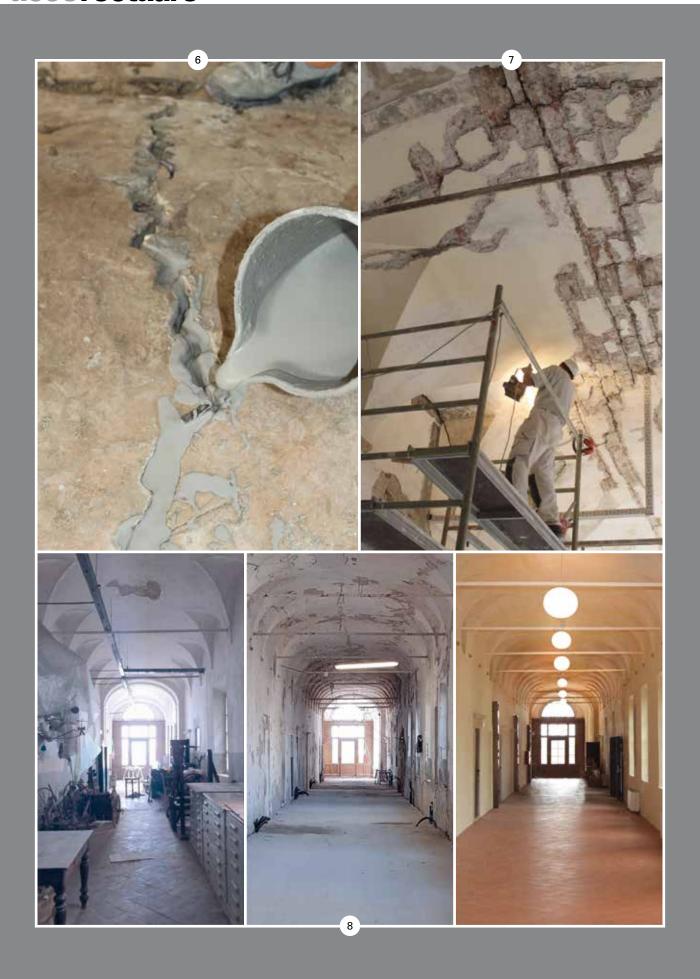
Fig O6. Detail of the procedure for closing a crack on a vault of the cloister

Fig O7. Post-earthquake condition of the vaults

They consolidated the masonry vaults through the injection of the cracks (Fig 6-7) and the construction of low thickness floors in lightweight structural concrete. A double-crossed wooden planking help stiffen the floors, while the steel angles guarantee a better connection to the walls through the grouting with threaded rods.

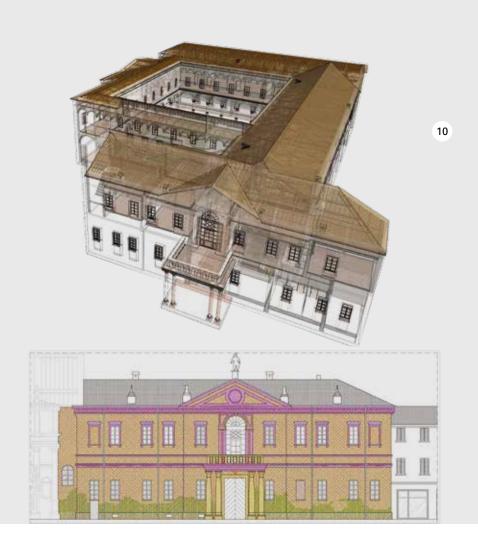
Fig 11. BIM model implemented with the earthquake damage survey

Parametric modeling assigned different materials to the different elements (Fig 9-10). In this way, it was possible to quantify and manage the detected crack patterns through automatic schedules, reporting the specific characteristics of each rupture (Fig 11).

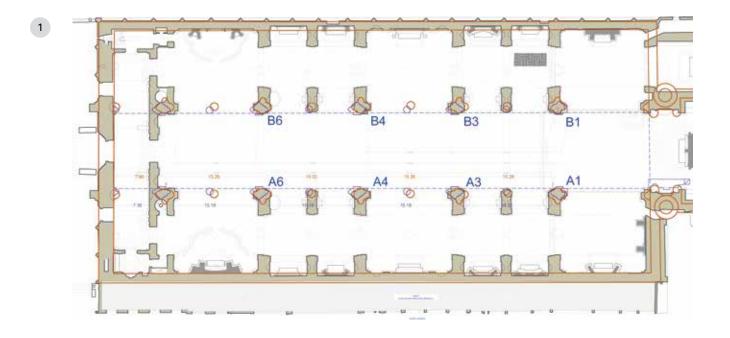
Fig 2. Overlapping of the modern cathedral and the inner prospect drawn by Leon Battista Aleotti (XVI century)

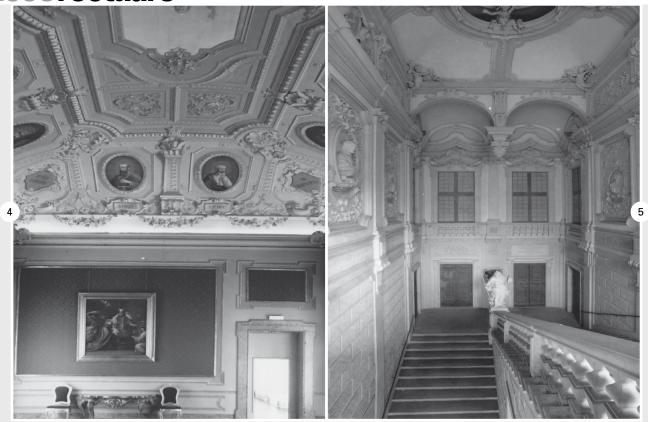
Fig 4. Interior, Archbishop's Palace

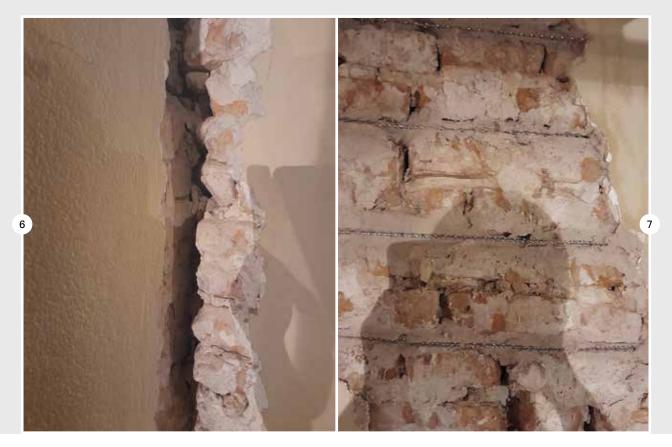
Fig 6. Damages on masonry after the 2012 earthquake

Fig 7. Stitching with stainless steel elements inserted in the restyling of flat lesions

In plan and in elevation the building is characterized by a considerable geometric and constructive complexity. After the earthquakes the crack pattern that appeared was quite widespread, especially as regards the masonry's vaults on the noble floor of the Archbishop's Palace main part. In general, diagonal passages and not cracks had occurred in the masonry; almost on each floor all the brick's platbands had suffered injuries on their key and/or extremity; some columns had shown vertical crushing cracks along their development. The structural cracks of the masonry's walls had caused the plaster's rising and in some cases the detachment of portions of it; on the other hand there were deficiencies and fractures as regards the stone elements. There was also a sliding of the roof covering and the displacement of some elements of the roof's wooden framework (Fig 6).

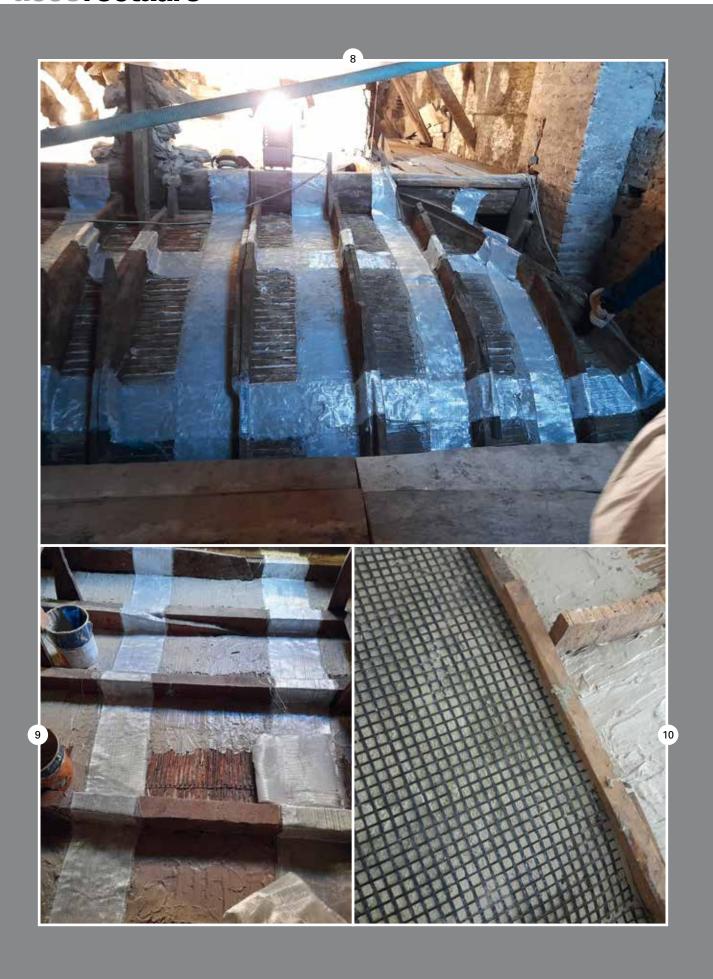
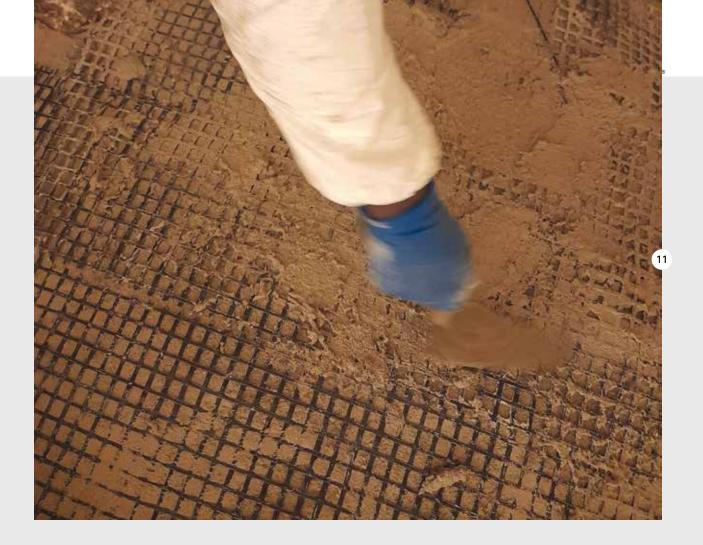
Fig 8. Reinforcement of arched vaults with GFRP

Fig 9. Reinforcement of camorcanna vaults with GFRP

The typology of the vault itself determined the choice of which composite system to use for their reinforcement. The following types were found: wattle (that is "cannicciato") and camorcanna vaults and in masonry. In general, the construction manager opted for interventions characterized by low invasiveness, low weight and mechanical compatibility. Then the vaults in wattle (Fig 8) and in camorcanna (Fig 9) were consolidated with the application of bands in FPR (fiber-reinforced polymeric matrix composites) of glass fiber, positioned to form a mesh, thus improving the overall behavior of the area and re-

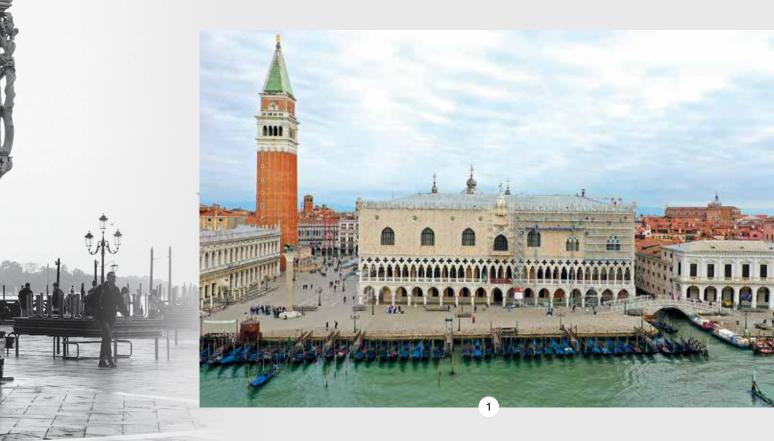
Fig 2. Product sampling processes currently in progress

The Ducal Palace is a heterogeneous and complex system in terms of type of materials and the state of preservation. The restoration project, which started in 2019 (Fig. 1-2), involves a series of consolidation, restoration and securing of the elements that make up the building. The first part of the project concerns the analysis phase with the aim of defining the state of conservation, the stability of the surfaces and some stone elements. The following analyses were conducted by means of: archival research, site surveys, photographic and Laser Scanner surveys, in order to obtain precise information on the current layout of the building. They led to the definition of a project of investigations that was divided into three phases: phase zero, which allowed for preliminary information on a portion of the facade; phase one related to radar investigations on the entire surface of the cladding and the summit edge; and phase two by means of which disassembly and reassembly operations were carried out on some of the elements constituting the cladding and the summit frame in order to know their construction characteristics. As a result of the investigations, it was possible to define the interventions to be carried out, which concern the consolidation of the material and the structural principals.

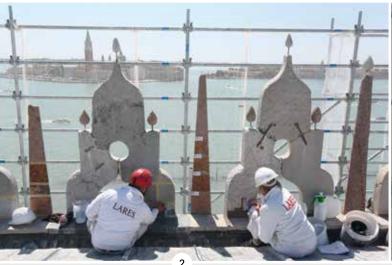
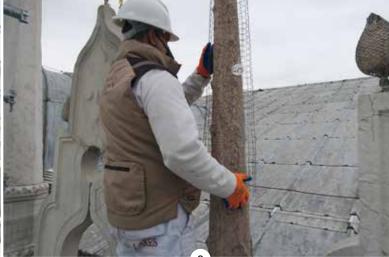
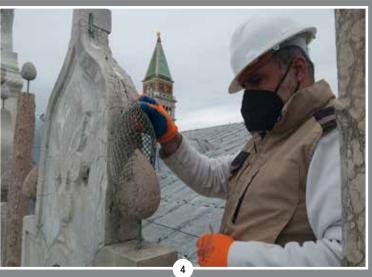
Fig 3-4-5. Removal of protection nets The Consolidation of the material aims to improve the cohesion and adhesion characteristics between the constituents of the stone material. In the specific case of the Doge's Palace, consolidation is extended to all stone elements, particularly concerning:
