quaderni di assorestauro

# GRAND TOUR RESTAURO 2022

YEARS 11 | NUMBER 02  
SEPTEMBER 2022

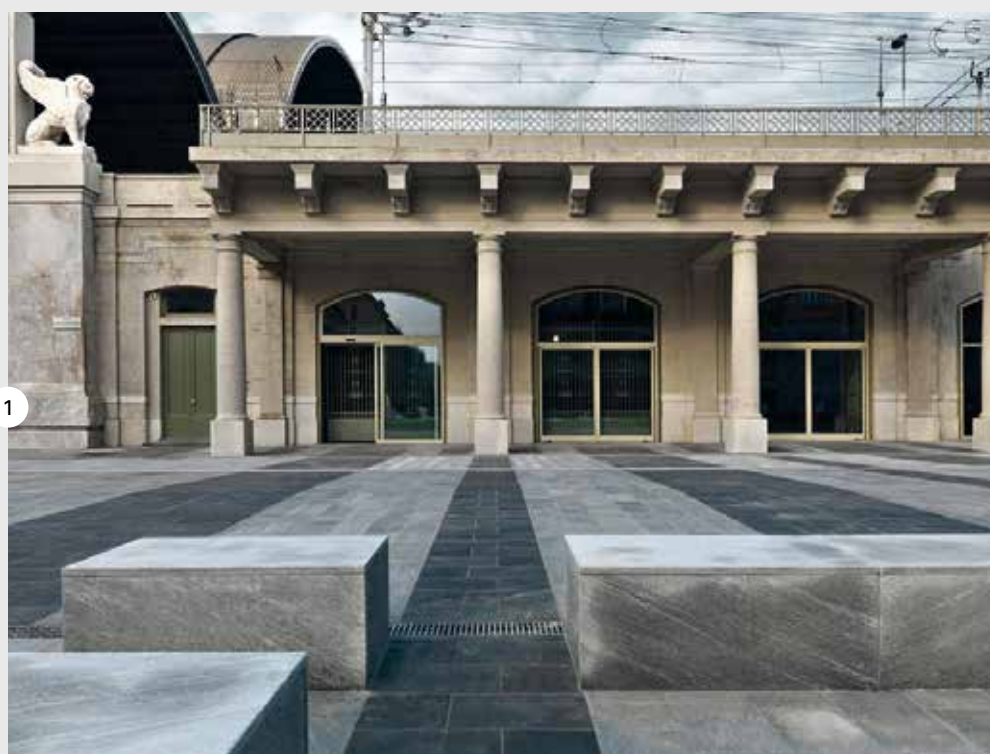
Fig 1. Piazza Edmond Jacob Safra and the entrance to the Shoah Memorial (ph. Andrea Martiradonna)

The main objective of the project, by Morpurgo de Curtis Architetti Associati, is to convert the place, disused and then abandoned towards the end of the 90s, into a space for reflection and re-elaboration placed in close dialogue with the city. The Shoah Memorial is conceived as a large “lantern” visible from the outside; walking along Piazza Edmond Jacob Safra (Fig 1) and looking through the windows in front of the original open gates, it is possible to observe the belly of the building which consists of an exposed reinforced concrete frame. Once enclosed and hidden, today the space openly shows itself for what it was while offering a place for research and re-elaboration. During its first phase, the project

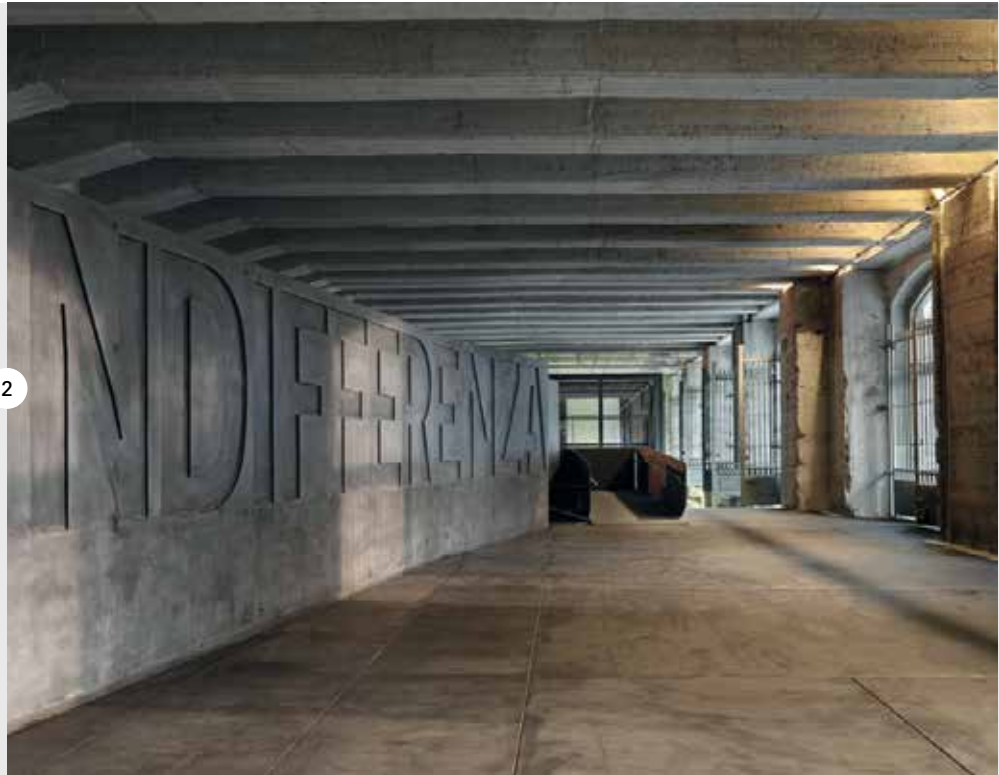
2

Fig 2. Entrance Hall with the Wall of Indifference, first installation of the Memorial path (ph. Andrea Martiradonna)

focused on the respect of the internal spatiality and materiality: non-original partitions were demolished and the structure was stripped of a thick layer of plaster that covered all the internal surfaces. Over the years, the spaces had changed in order to satisfy the new uses of the premises. The concept of memory serves to set new foundations for the present, and also build the future: this is why it is not a simple museum but a memorial and a venue for dialogue. On one hand, we have the recollection of this tragedy, with a path that connects the places of the events; on the other hand, it is a space in which citizens can participate in workshops. The place of knowledge is conceptually kept separate from the one aimed at active re-elaboration, but there is visual continuity between the two environments thanks to the demolition of part of the slab and the relative pillars outside the path of the actual memorial. This operation allowed to restore new foundations towards the square and made it possible for the memorial to dialogue with the space of the city. The project consists of permanent installations, including the library and the auditorium, which communicate with the existing structure. The old is deliberately separated from the new, with the aim of preserving the original structure and making it eloquent, thanks to forms and materials that establish a relationship between history and those who cross and will cross it. All the interventions aim at making the history of the station legible. What the architects wanted to maintain is a correspondence between form and content, only possible through the addition of clear architectural elements. The latter were made with materials contextual to the place, but recognizable from the originals thanks to the different treatment methods: the rooms are made of iron, concrete, wood and train ballast but also glass that highlight the distance from the original materials of the station. These transparent slabs, in addition to acting as a security and delimitation system, have a strong symbolic meaning: it is an invitation to visitors not to take their eyes off them but to carefully observe the places of memory.

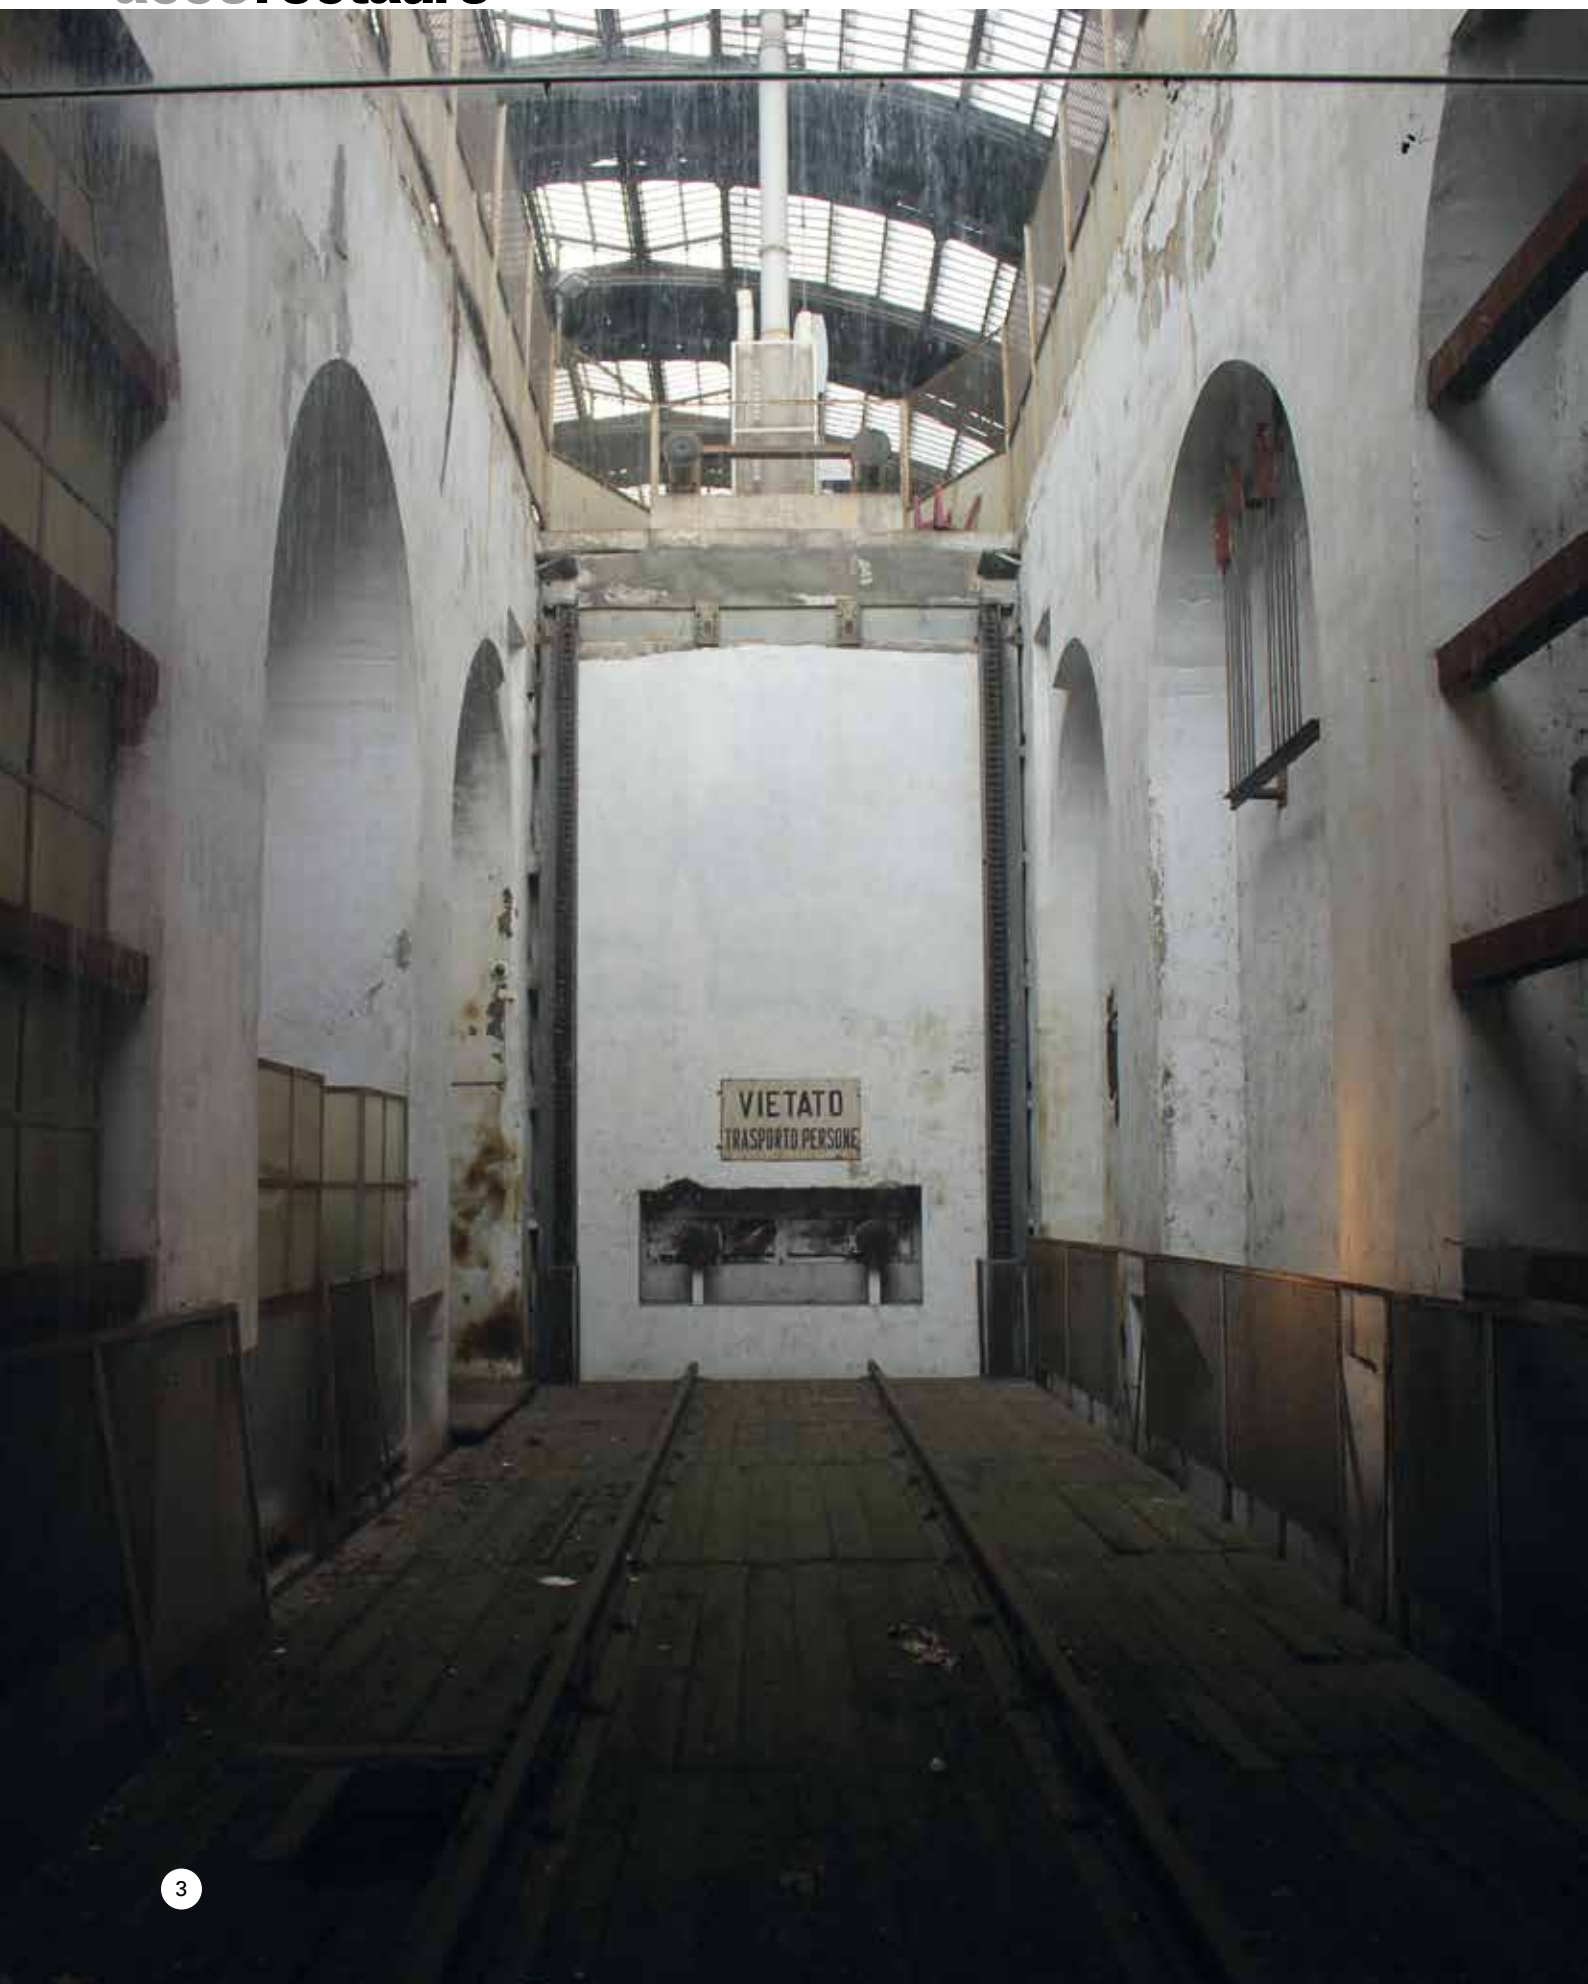
Fig 3. Connection between the two levels of the Central Station: space used for the lifting of the wagons (ph. Tania Ghensi)

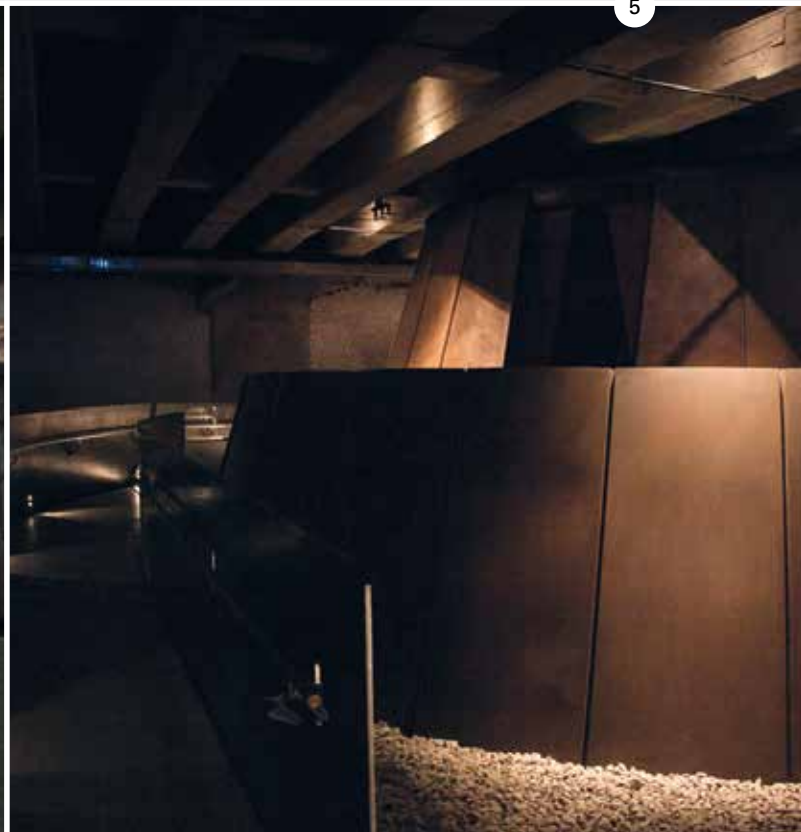
5

Fig 5. Place of reflection (ph. Lorenzo Taccioli)

The Memorial, intended as a place of commemoration and awareness, involves people on multiple sensory fronts. The sound plays a fundamental role as the structure was conceived as a large chest capable of emphasizing and propagating the noise of trains departing and arriving at the upper level. It develops between the second and fourth spans of the ground and raised floors, which are connected to each other by a ramp that runs along the Wall of Indifference (Fig 2). From here starts a journey that touches the pivotal points of the complex spatial system in an effort to make the story of the events clear. The observatory was designed to explain the functioning of the machinery that allowed the movement of the wagons; this installation allows people to watch videos by Istituto Luce, which show the manoeuvres performed by both the moving wagons and the lift. From a gap in the attic between platforms 18 and 19 (Fig 3) in the raised floor of the Memorial, it is possible to see the upper floor of the Central Station. Once lifted, all the wagons were hooked together and then connected to a motor vehicle to leave for Auschwitz-Birkenau, Mauthausen and other annihilation and concentration camps, both abroad or in Italy, such as those in Fossoli and Bolzano. Along the first of the two platforms (Fig 4), which still have the original floor, visitors reach the so-called “track towards an unspecified destination”, where they will find the original stock wagons now restored and donated by the State Railways. At the end of the itinerary, it was also created a place of reflection (Fig 5) where people can think about what they saw along the way.

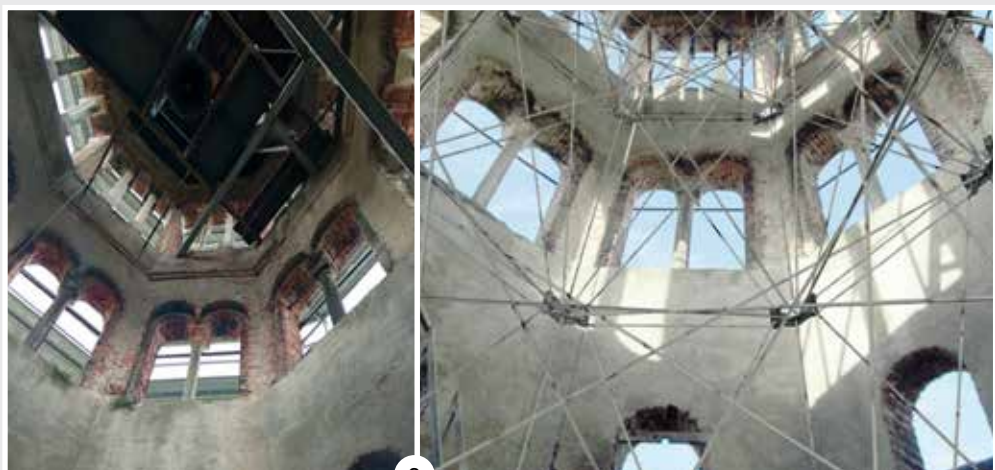
Fig 3. Final configuration of the structural reinforcement

Thanks to a structural numerical modeling, it was possible to recognize the weaknesses and the main fragilities of the monument under normal conditions and, in case of seismic actions, to design the structural intervention. The walls of the Tower appear uneven, due to the many alterations that the structure has undergone over the centuries, as demonstrated by the results of the sonic investigations. The bell tower suffers from structural deficiencies from a seismic point of view, due to its high slenderness and rather empty geometry, which make it vulnerable to horizontal loads. Locally, at different levels, it has been identified the presence of masonry elements close to detachment, along with significantly eroded stone columns, with very low residual strength, and oxidized iron elements that do not provide the necessary structural security. To reconcile the structural needs with the criteria of non-invasiveness, lightness, and reversibility of the intervention, (essential to preserve the historical-architectural authenticity of such an important monument) it was decided to insert a light structure in steel cables inside the tower. This system offers a confinement action and works as a three-dimensional bracing structure, collaborating with the masonry walls of the tower. It consists of a parabolic hyperboloid post tensioned structure, a sort of “hourglass”, made of inclined cables. In case of a seismic event, the masonry structure will be compressed, on one side, and a tensile action will be exerted in the cables, on the opposite side. The choice of cables was made because of their resistance, effectiveness, and their ability to provide an adequate ductility to the structure, but also for the reduced perceptual impact for the visitor.

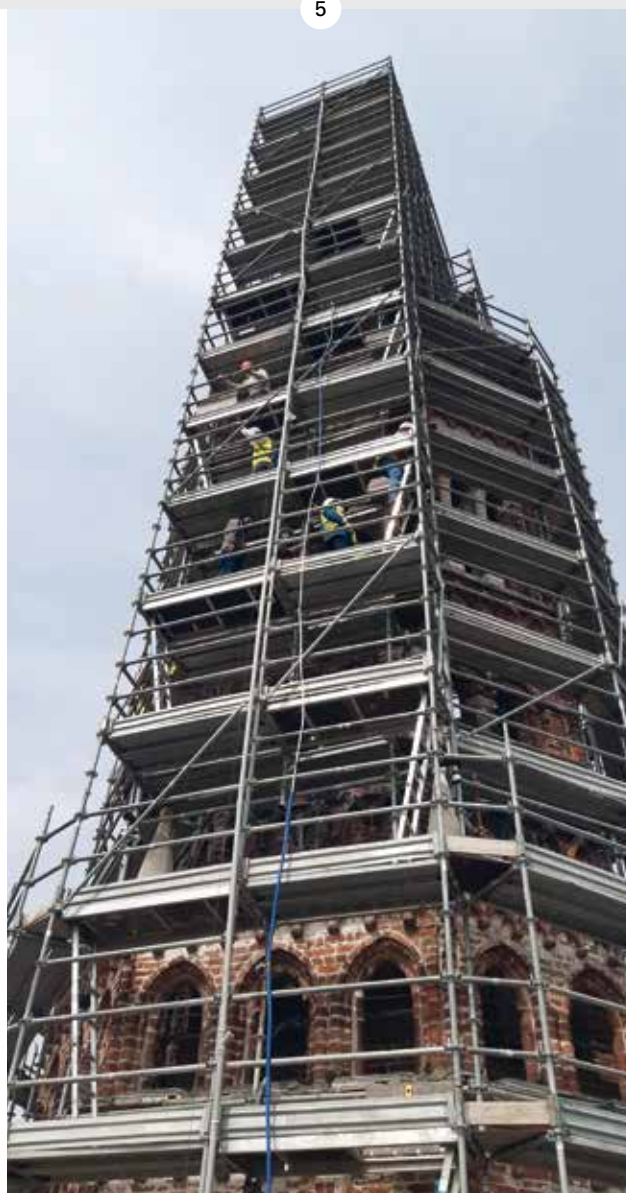
5

Fig 5. The scaffolding of the bell tower

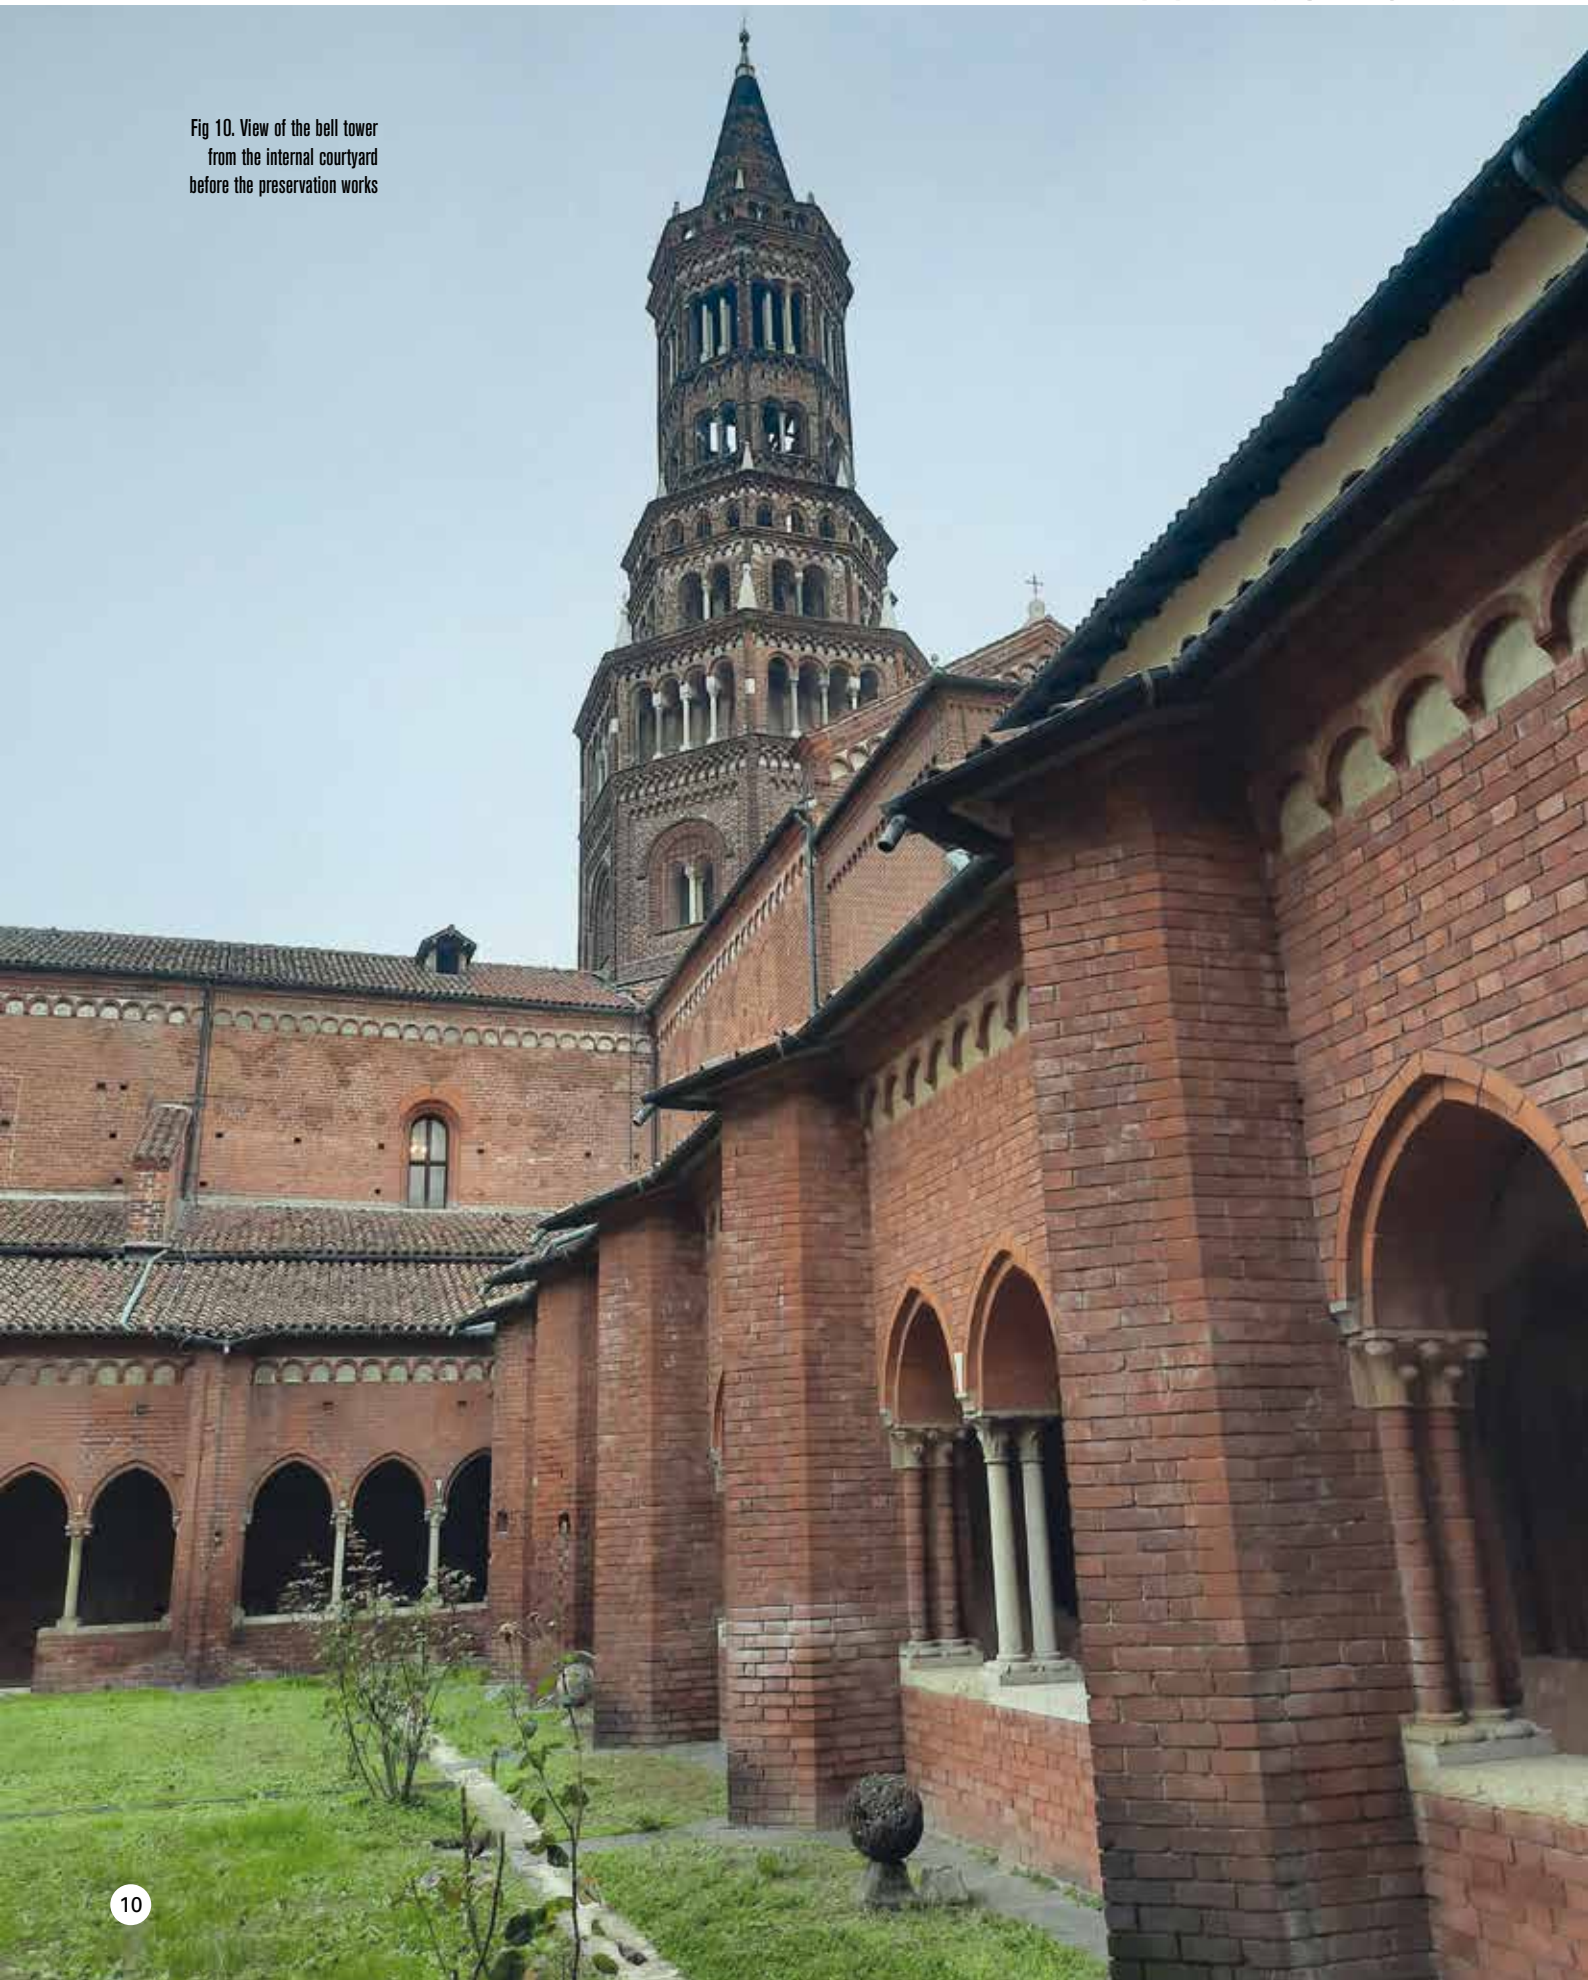
Fig 10. View of the bell tower from the internal courtyard before the preservation works

The inspection analysis performed on the surfaces revealed several issues regarding the conservation of materials and the degradation of the architectural surfaces, due to the stratification of thick black crusts, salt efflorescences and bird droppings; in addition, the analysis pointed out the localized detachment of terracotta and stone decorations.

ings. Both the original and the reconstructed stone elements showed signs of detachment: the stone surfaces were severely damaged and eroded, to the point that in some cases it is not possible to recognize the original shape/form. From a structural point of view this was related to the large quantity of openings and the slender structure of the tower.

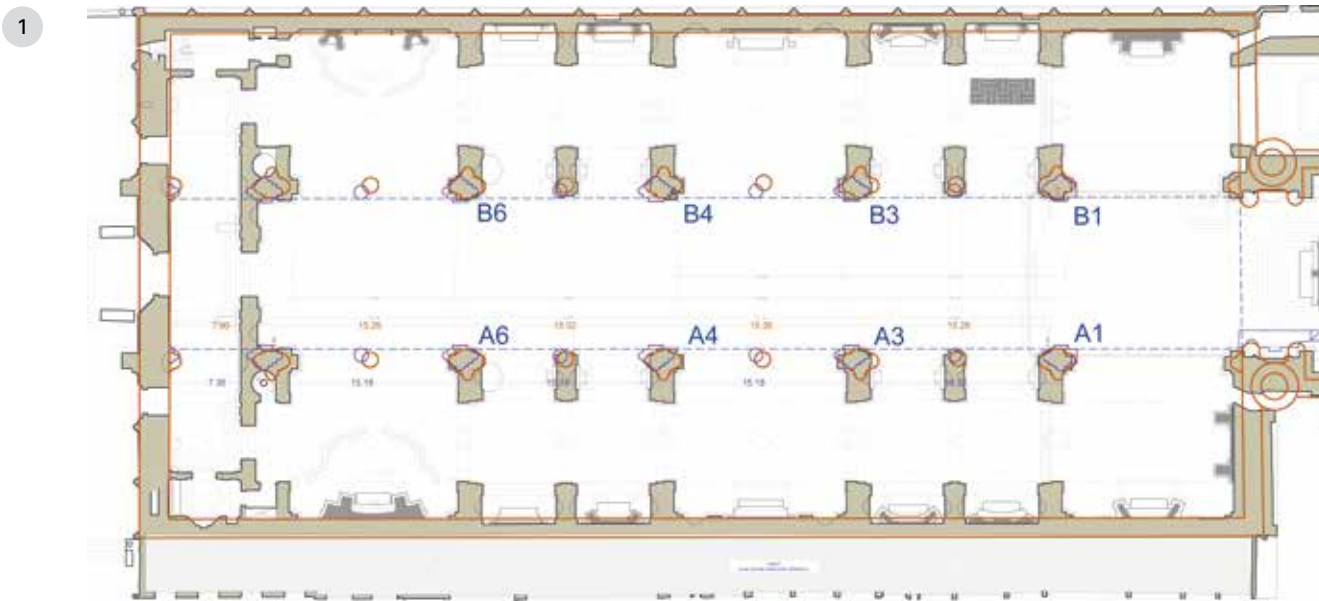
Fig 2. Overlapping of the modern cathedral and the inner prospect drawn by Leon Battista Aleotti (XVI century)

Fig 3. Relief of two different pillars: the different position of the original polylobate (orange) is one of the most crucial elements to consider for the intervention

This significant data comes from both historical sources and diagnostic investigations. The latter show that all the pillars investigated consist of a portion of a polylobed medieval pillar, off centered from the final configuration of the pillars built in the eighteenth century. This decentralization, caused by the differences in plan between the original three-nave basilica and Mazzarelli's design, led builders to shear the oldest pillars when they were placed in the perimeter of the new shape (Fig 1-2). However, no interventions were made to clamp the old and new masonry, forming a discontinuous interface sometimes recognizable by the presence of medieval plaster.

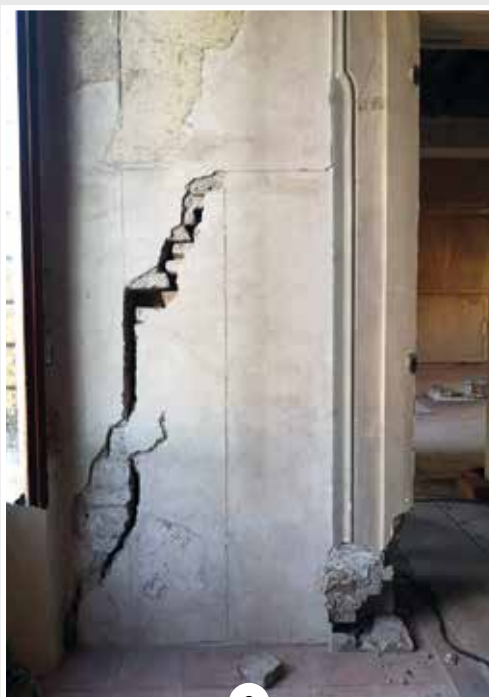
2

The knowledge process started to assess the current condition of the building, by means of geometrical surveys, structural and chemical/physical analysis and mapping of the cracks and structural damages.. This first process showed clearly the inner vulnerability of the entire building, emphasized by the earthquake (Fig 2).

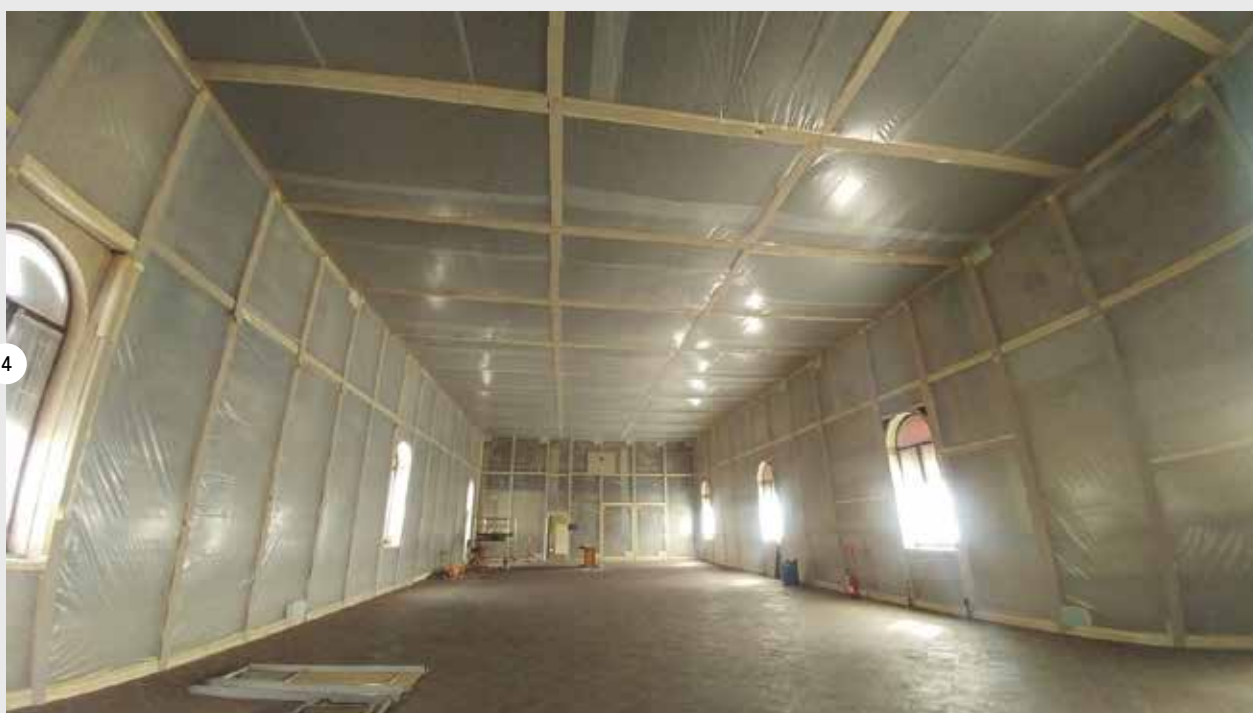
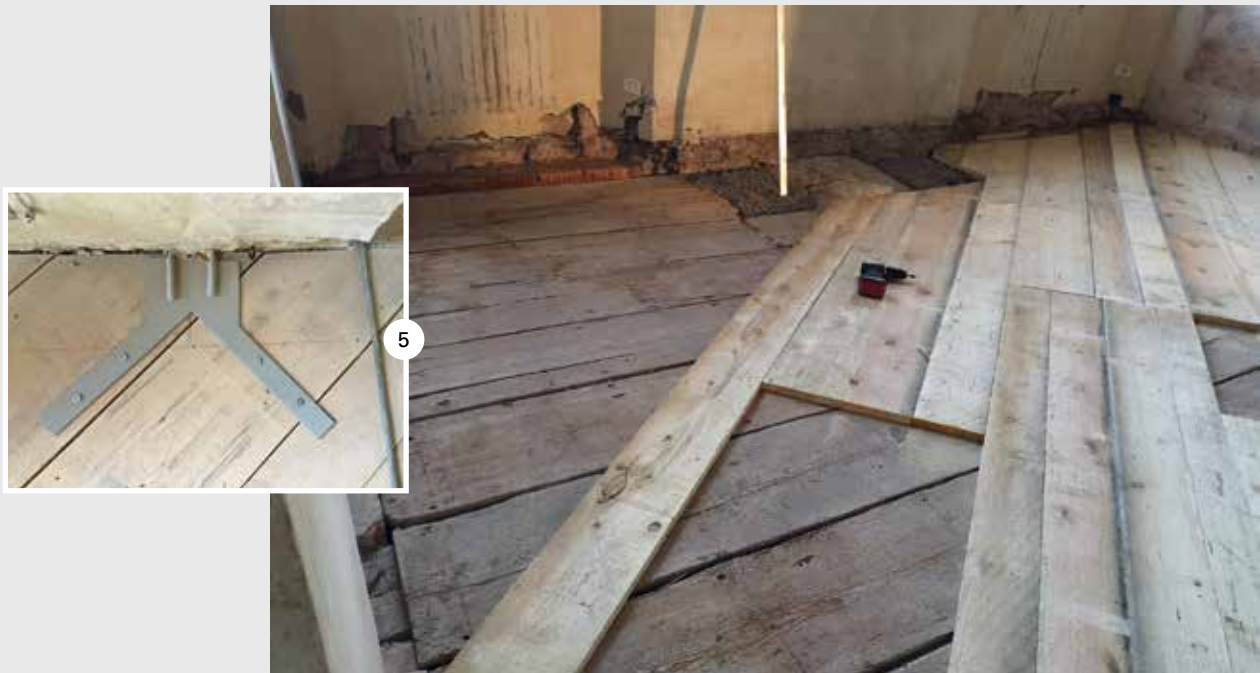
In the 14th century wing, the poor or lack of clamping of the perimeter walls to the spine walls has generated a repeated series of damages in the corners; cracks on the walls in the vicinity of the floors of the attic are also visible, showing the start of the rotation of the façade walls.

The 15th century wing is the most damaged part due to its geometry and the higher height, along with the of any important restoration or recovery works in the recent years. Numerous cracks, easily visible on the walls, the arch covers, and on the areas weakened by the passage of flues, together with detachments of the non-anchored vertical walls, are visible all along the structure. The floors show widespread separations from the masonry and cracks in the sand ceilings. On the noble floor: systematic lesions of a diagonal type can

be seen on the top corners of the spine walls, which show the start of the rotation of the front wall linked to the considerable height and increased by the trusses of the roof. The delamination between the masonry and the ceilings are mainly due to the total absence of horizontal anchoring systems and to the fact that the ceilings themselves do not provide rigidity, hence the masonry walls have no intermediate supports and very high vertical floor spans.

The analysis of the cracking issued, led to design the structural interventions aimed at restoring the damage incurred and the creation of a diffused combination of reinforcement interventions that will ensure an improvement of the local and overall seismic response of the entire building (Fig.5).

The structural measures, in addition to the repair and restoration works such as the injection in the cracks, nip-tuck, reinforced seaming, retipping of the mortar couplings, also include the widespread stiffening of the wooden flooring on the various floor and the attic, the consolidation of the composed beams, the insertion of structural chains and the sub foundation in masonry work which highlighted the absence of a wider section at the foot. The structural buffering of existing apertures has also been foreseen, in particular on the north façade, to integrate the existing walls and obtain an improvement of the static and seismic behaviour of the treated walls.

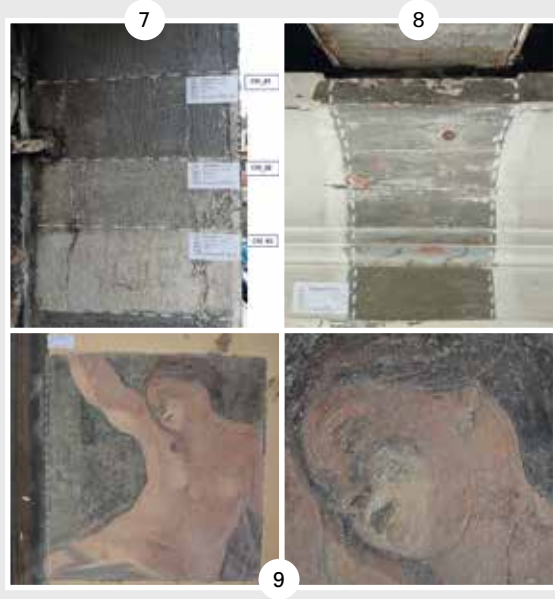
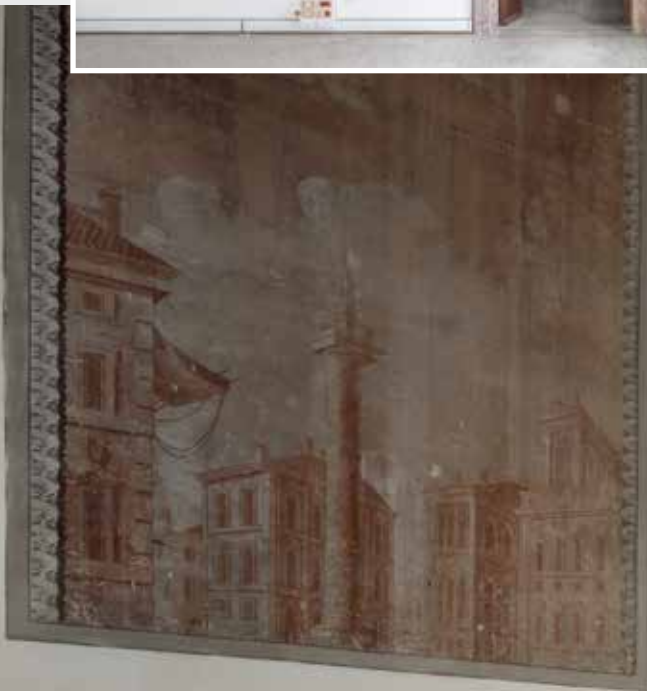
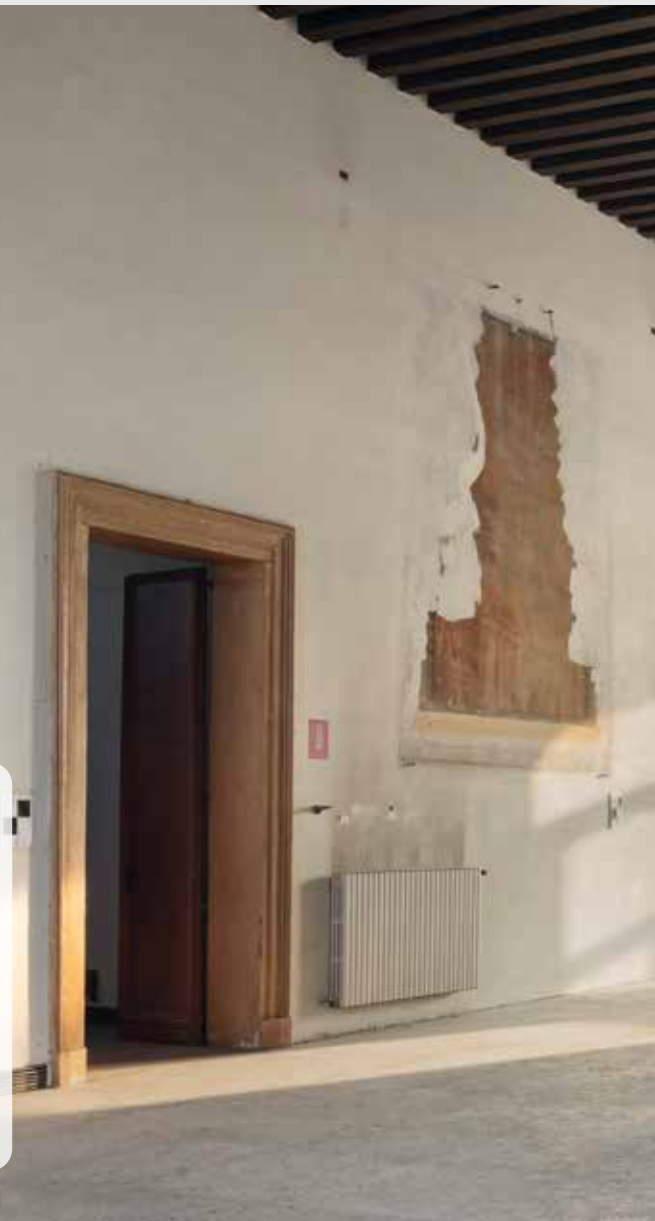
Fig 8. Detail of the sample on the wooden frame where the original paint layer is observed (ph. Lithos)

The wooden beams, the overlapping layers of paint of the perimeter frames of the halls, the several-times-repainted doors and the external portals will be cleaned of surface deposits, the decorations will be brought to light, the cracks will be healed, the gaps will be integrated and finally treated with a protective (Fig 8).

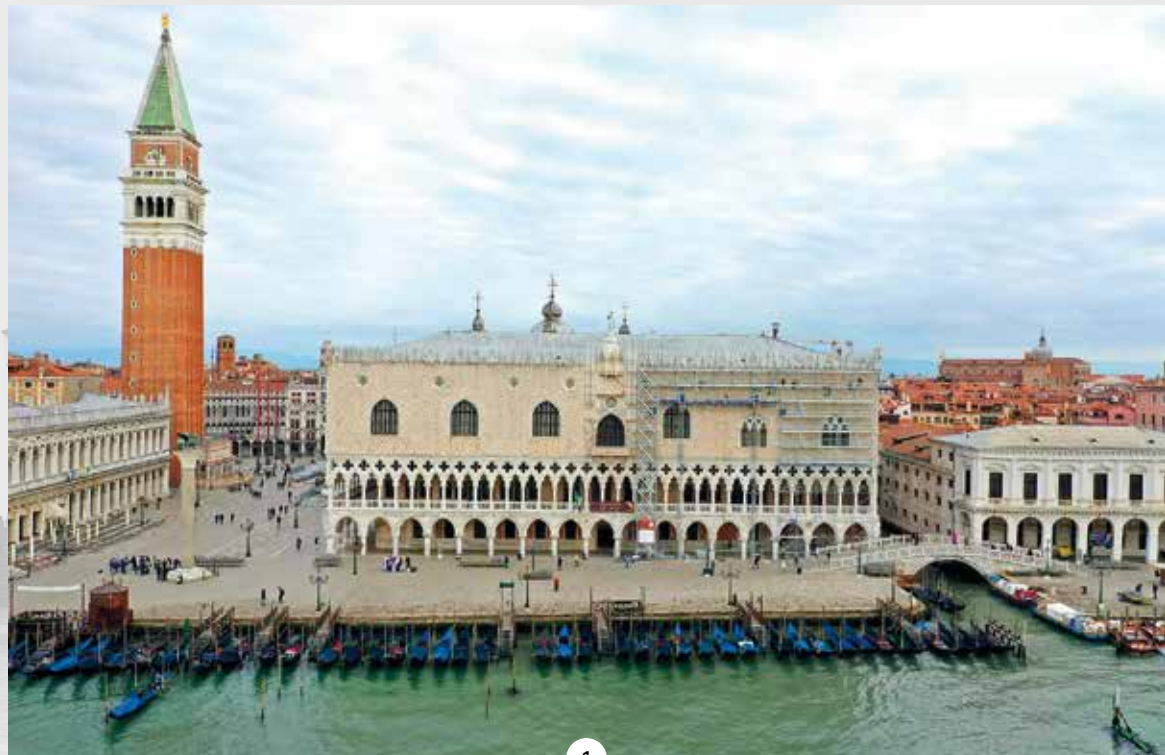
1

Fig 2. Product sampling processes currently in progress

The Ducal Palace is a heterogeneous and complex system in terms of type of materials and the state of preservation. The restoration project, which started in 2019 (Fig. 1-2), involves a series of consolidation, restoration and securing of the elements that make up the building. The first part of the project concerns the analysis phase with the aim of defining the state of conservation, the stability of the surfaces and some stone elements. The following analyses were conducted by means of: archival research, site surveys, photographic and Laser Scanner surveys, in order to obtain precise information on the current layout of the building. They led to the definition of a project of investigations that was divided into three phases: phase zero, which allowed for preliminary information on a portion of the facade; phase one related to radar investigations on the entire surface of the cladding and the summit edge; and phase two by means of which disassembly and reassembly operations were carried out on some of the elements constituting the cladding and the summit frame in order to know their construction characteristics. As a result of the investigations, it was possible to define the interventions to be carried out, which concern the consolidation of the material and the structural principals.
