ANNO02NR02
DICEMBRE2013

ACTA OF THE INTERNATIONAL WORKSHOP

**MED ART FOLLOW-UP
RESTORATION OF
THE SHEIKH SÜLEYMAN MOSQUE
TRAINING IN ITALY - SECTION 1-2**

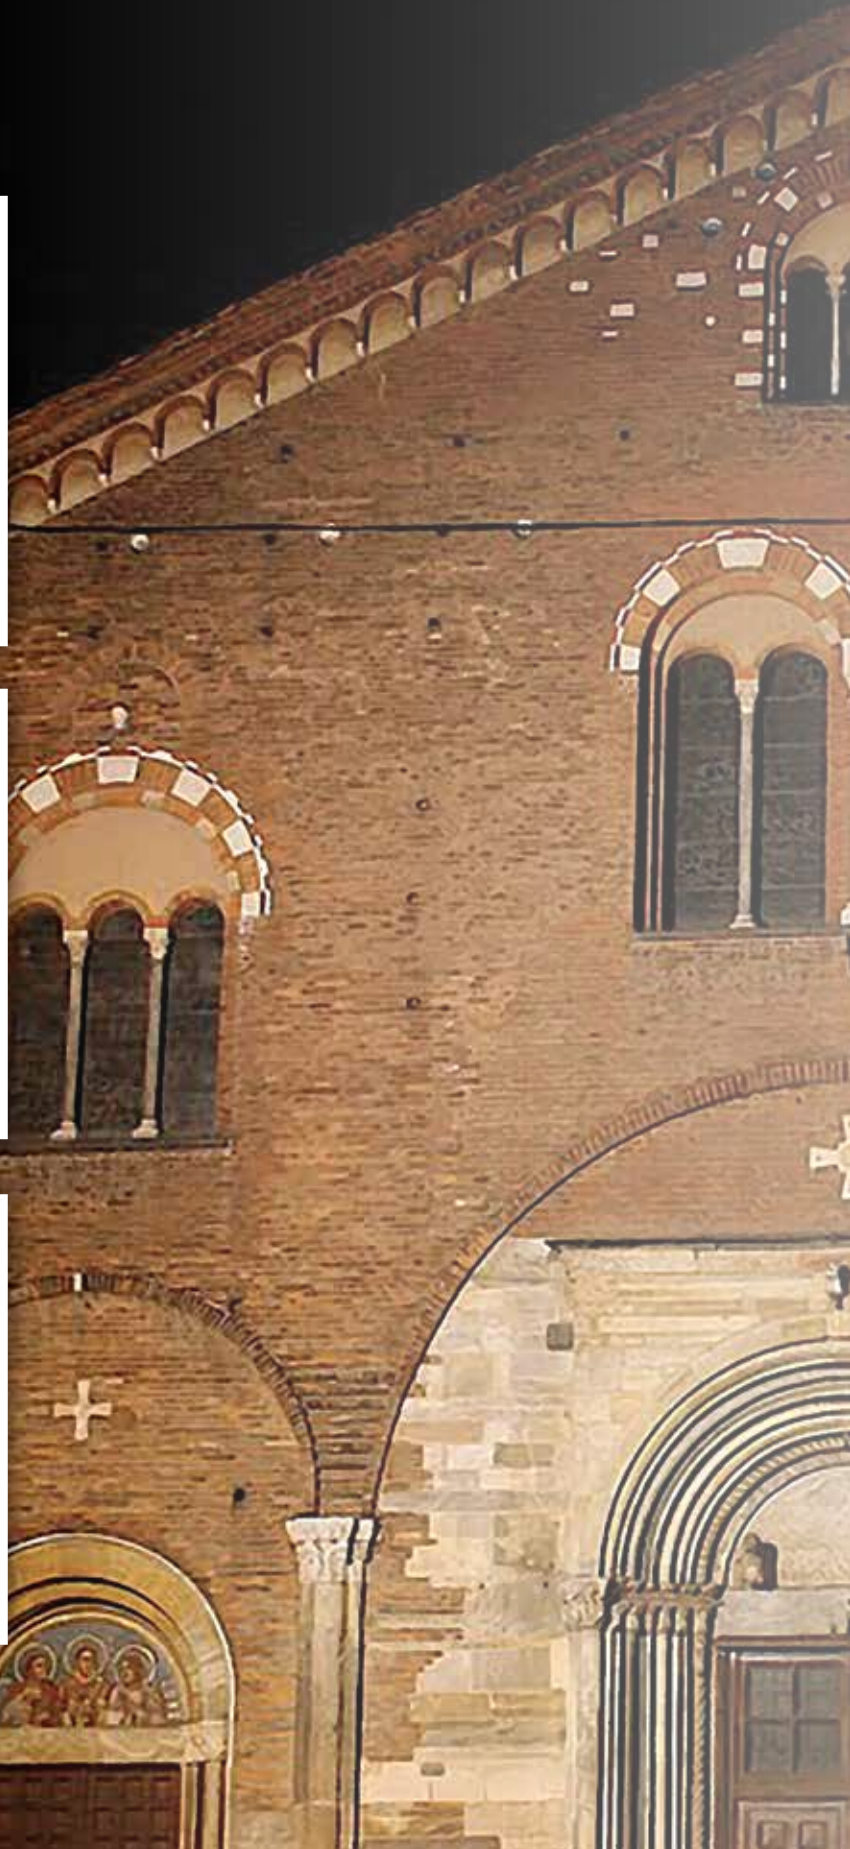
Location of the measurement areas and indication of the range of action of the electro-physical system

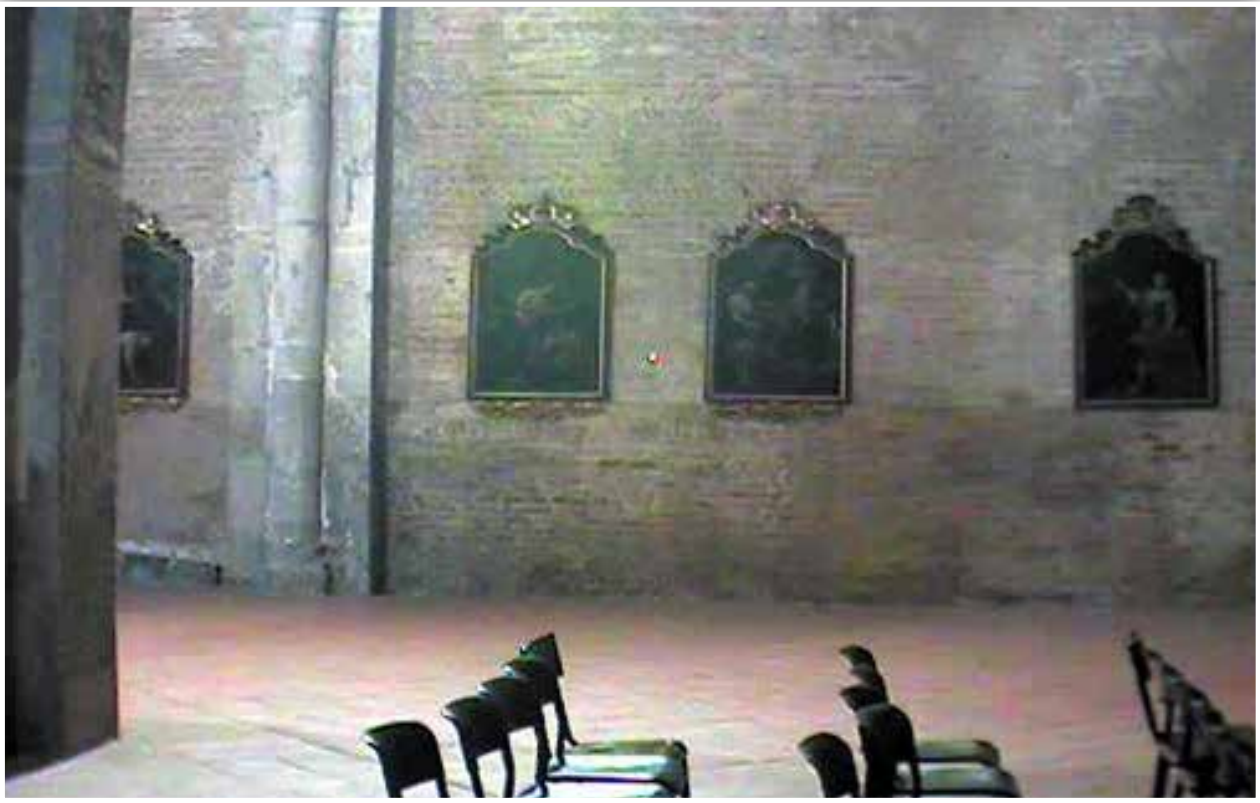
"Visible Image" in the area of the measuring point S3 (a) and infrared images and graphics surface temperatures along the vertical recorded in May 2009 (b) and April 2012 (c)

The study, which was carried out over the period of three years, objectively demonstrated the positive dehumidification action performed by the system on the masonry. The high level of detail of the investigations carried out, as well as the quality and quantity of the data collected, seem to support the reliability of the results obtained.

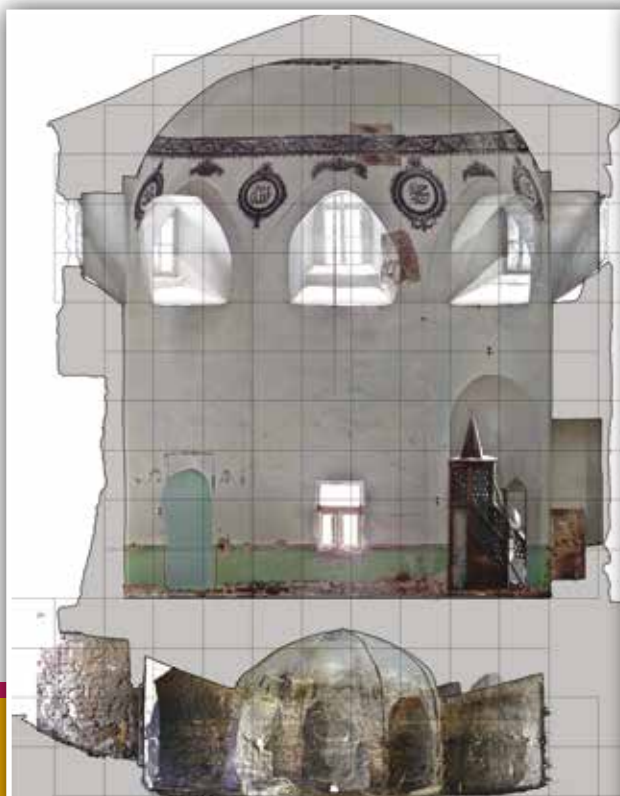
2D drawing table with CAD section and planar point cloud image

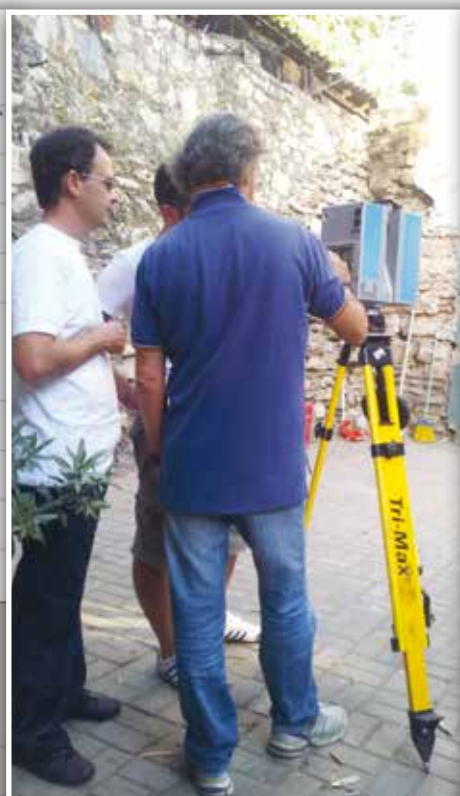
First external station of 3D laser scanner survey

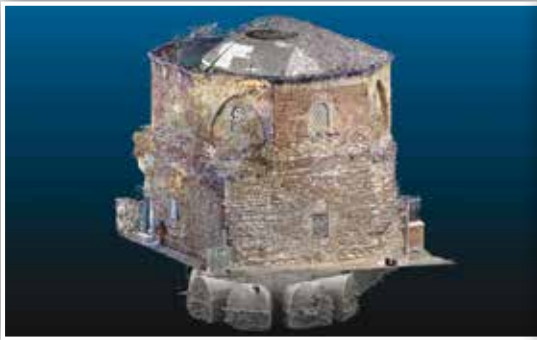
Isometric view of colour point cloud

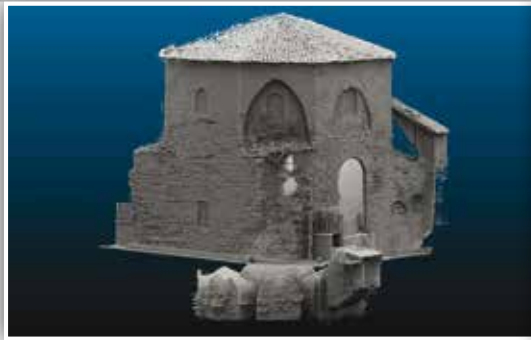
Isometric view of point cloud complete model

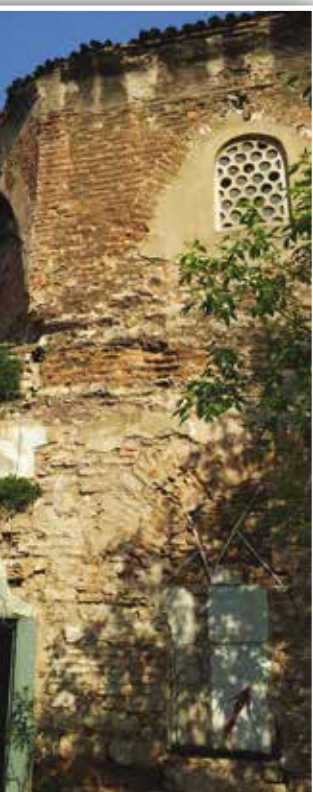
Sheik Suleyman Mosque view of the entrance

A Z+F IMAGER® 5010C scanner was used and a total of 35 scans were carried out. At the same time of the laser-scans, photographs were also taken for the composition of an equal number of spherical images. From scanner in HDR mode and from professional camera a total of 1,500 photograms were made. A coloured 3D-point cloud model was made from the survey data from which graphic restitutions of plans elevations and sections were developed.

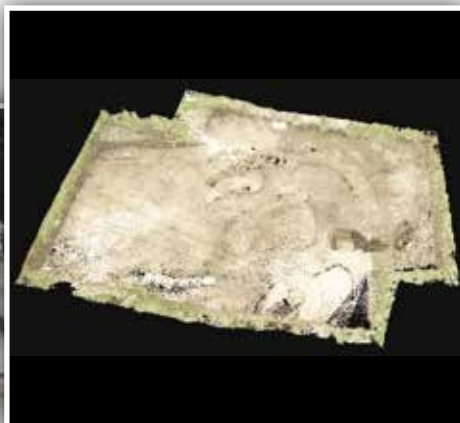
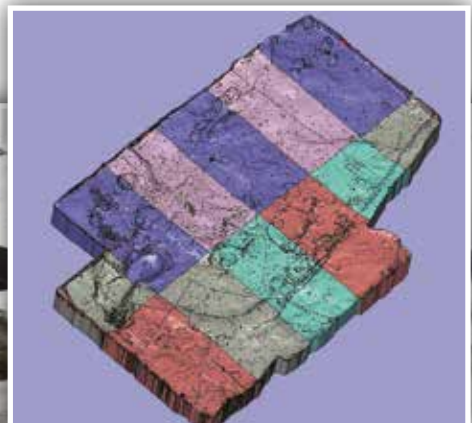
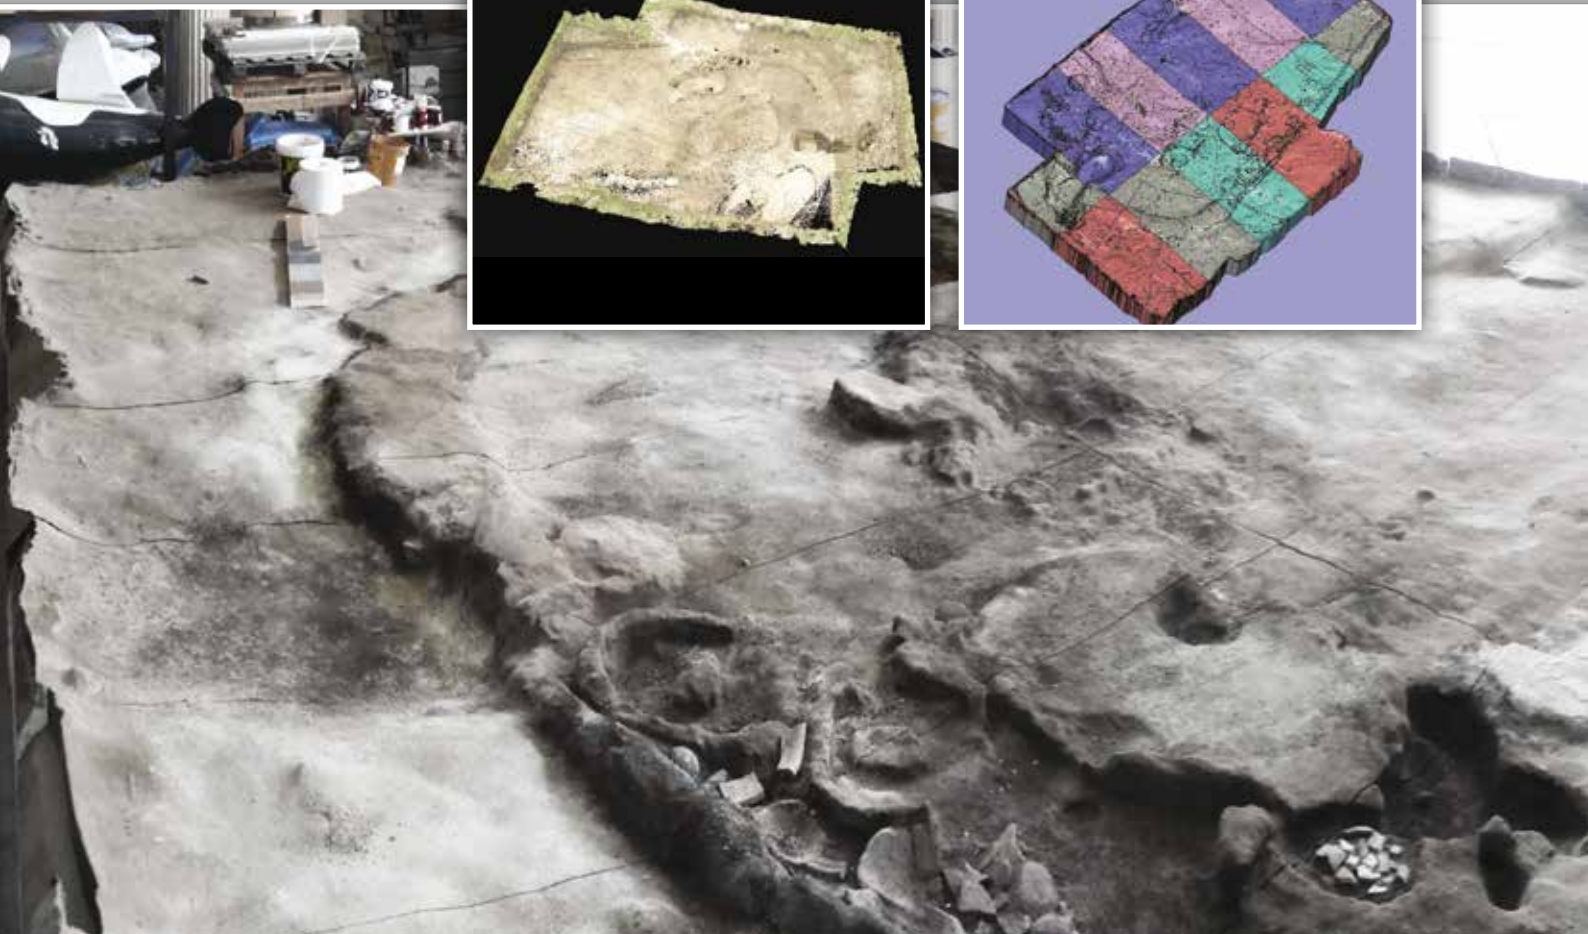
3D mesh model of archeological site divided for CNC engraving

A digital model was elaborated to make it ready for realization. This prototype occupies an area of 90 sq.m and it has been divided in 18 base “blocks” (4x1 m) and 6 border “blocks” with same width, but variable length. Site’s morphology was recreated with CNC engraving system from blocks full of polystyrene, then covered with fibreglass coating. Fibreglass is model’s supporting structure. Its union with polystyrene ensures that maintenance can step on the copy. It also protects it from weather conditions effects and it does not affect blocks weight, which can be easily transported. Thanks to a series of simulations realized on digital model, we detected disposition and number of drainings for meteoric water. Prototype for factual rendering was created in a shed, where we colored model’s surface using photograph documentation previously collected. We used acrylic water colors and various sands of different kind of grain and shade to perfectly reproduce soil we collected “in loco”. The whole surface was then covered with transparent matt polyurethane protection. This innovative representing and valorization system of an archaeological site opens the way for other similar sites safeguard with held down costs both for realization and maintenance, considering that for this kind of models a low level of maintenance is required.

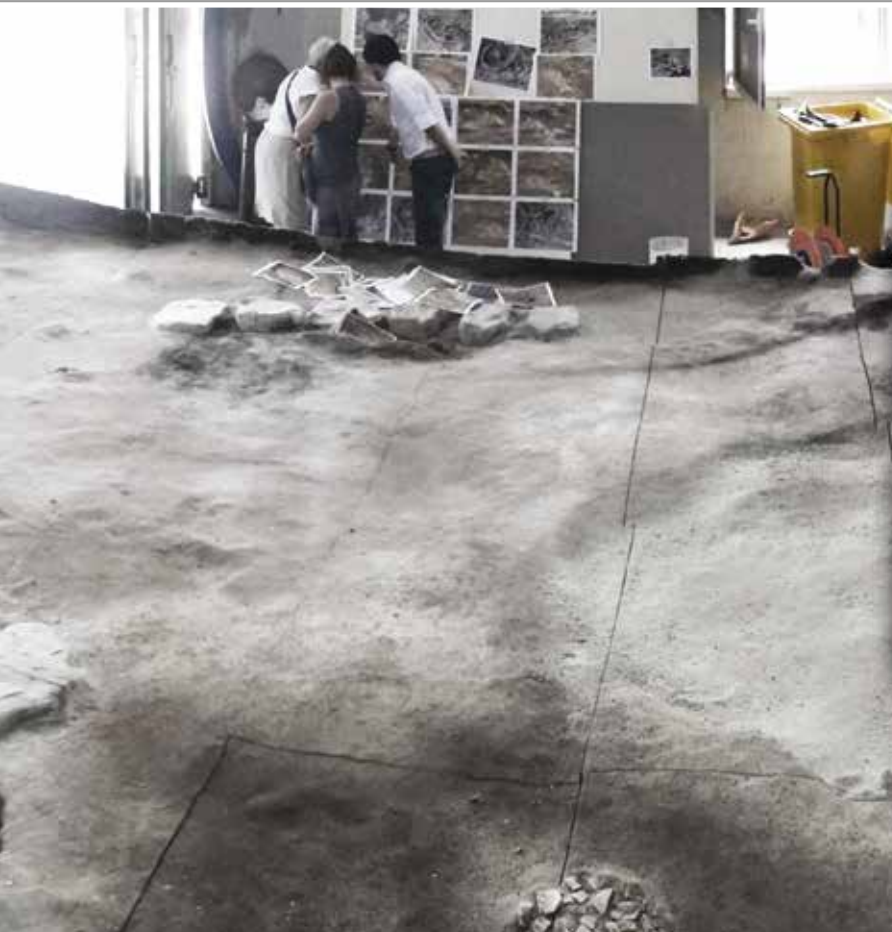
Archeological site copy under construction

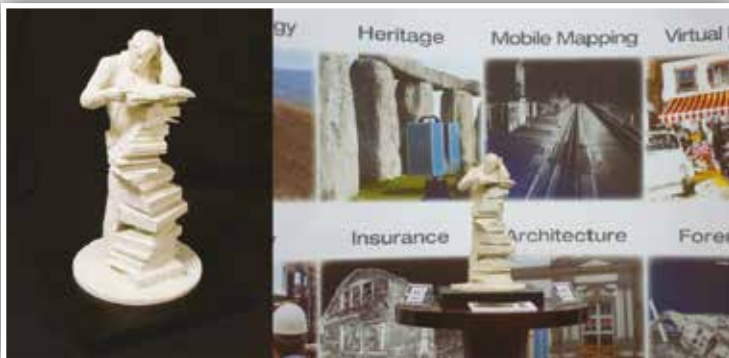
The 3D printout in full color during processing. Right one single layer of the model profile

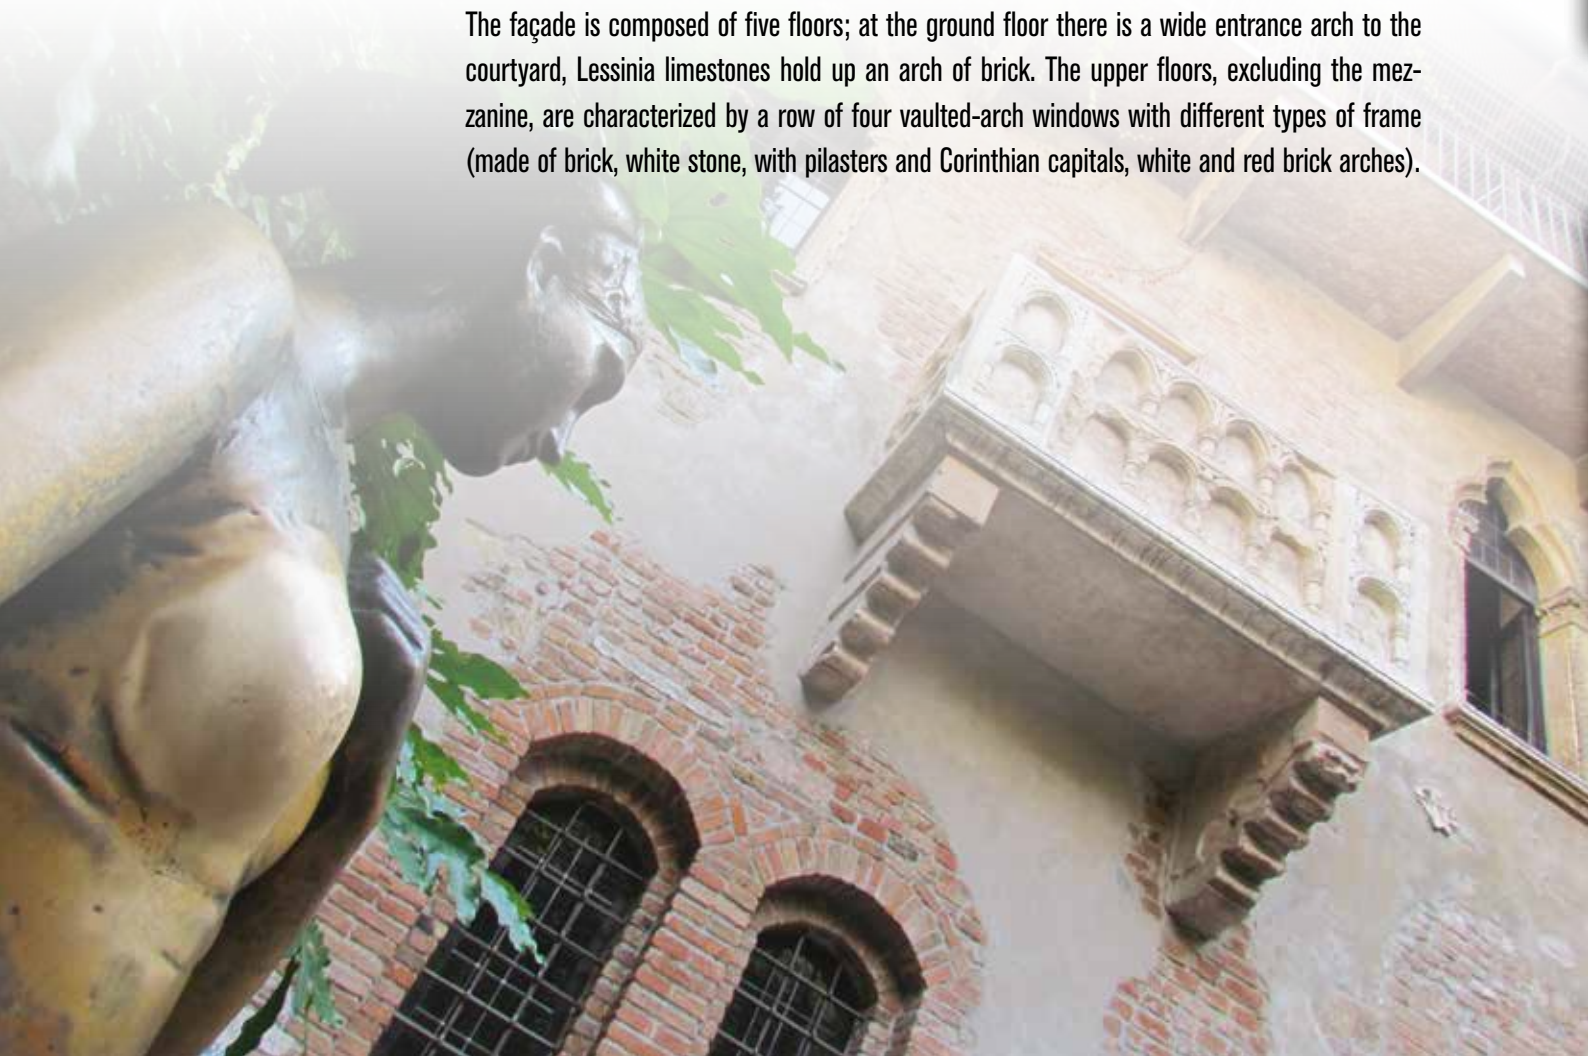
Figure 1. Verona, Via Cappello, 23, Juliet's house, facade

The façade is composed of five floors; at the ground floor there is a wide entrance arch to the courtyard, Lessinia limestones hold up an arch of brick. The upper floors, excluding the mezzanine, are characterized by a row of four vaulted-arch windows with different types of frame (made of brick, white stone, with pilasters and Corinthian capitals, white and red brick arches).

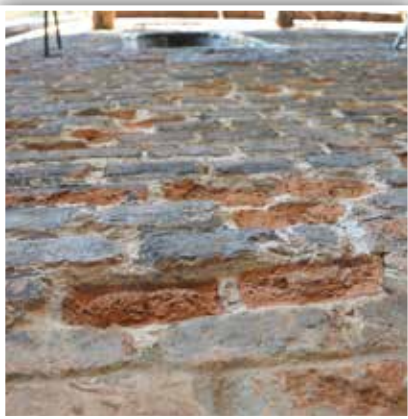
Figure 2. Juliet's house, decay of brick facade

The façade bricks were interested by dark patinas and pollutant deposits even in the form of black crusts; phenomena of erosion and flaking were also present and the problem of soluble salts was limited. The lime mortar joints were superficially chalked or without any binder. In general, several cracks, especially in the central portion of the façade, were evident (figure 2).

The wide and deep cracks were treated as follow: after practicing holes in the walls, the bars were inserted and the epoxy resin was injected. The rotten bricks were instead replaced with similar ones (figure 7).

The grouting of micro and macro cracks was made with two different mixtures: with lime, powder of terra-cotta brick powder and pigments, for brick cracking, and with lime and sand for joint mortar.

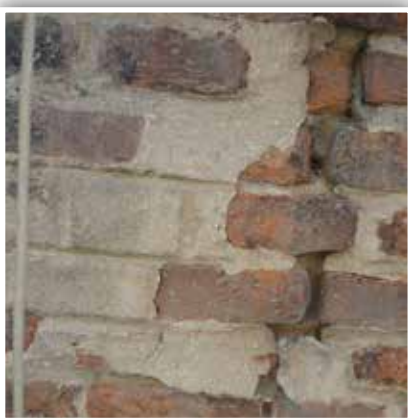
Figure 3. Juliet's house, facade, fragments of ancient plaster, made of a grout of lime and sand

At the first and third floor, the fragments of ancient plaster, made of a grout of lime and sand, were in poor condition (figure 3). The compact limestone of the architectural elements was in an advanced state of decay with the exception of the entrance arch, better conserved. The main stone degradation was black crusts in areas without runoff of the rain such (figure 4) as flaking, cracking and little lacune. Finally, the lower part of the façade was heavily smeared by graffiti paint and chewing gum (figure 5).

After a delicate dry cleaning, the ancient plaster fragments were consolidated with a water-based acrylic in micro-emulsion (Calchera San Giorgio), the re-adhesion of plaster layers were performed with grout based of natural limes at low specific weight, free from salts (Ledan C30 - AN.T.A.RES), injected through existing cracks. The cleaning of surfaces plastered was carried

out with nonionic detergent in aqueous solution (Tween 20 at 2%) and in some areas poultices of ammonium carbonate at 5% were used. The cracks and micro-cracks were grouted with a mortar of seasoned lime with inert fillers physically and chemically similar to the plaster to ensure homogeneous elasticity between the old and new mortars.

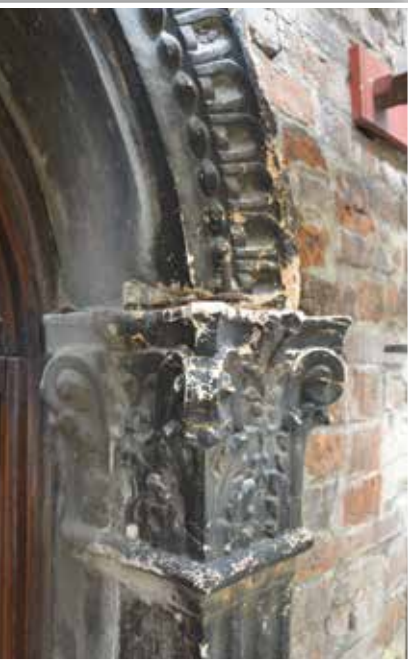
Figure 4. Juliet's house, particular of the decay of the stone frame: black crust

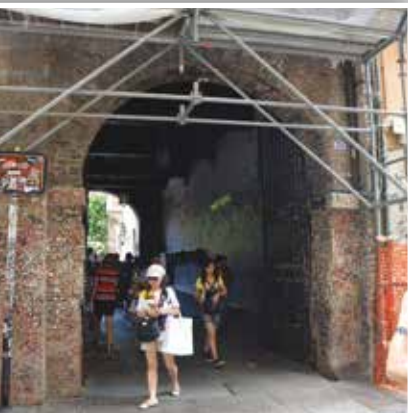
Figure 5 Juliet's house, particular of the entrance arch to the courtyard before restoration

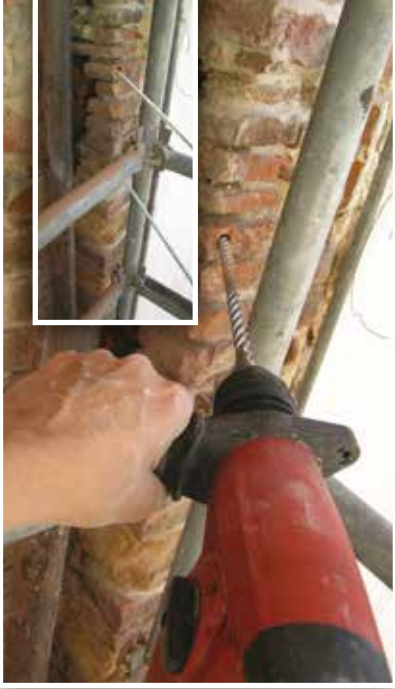
Figure 6. Juliet's house, block phase of bricks

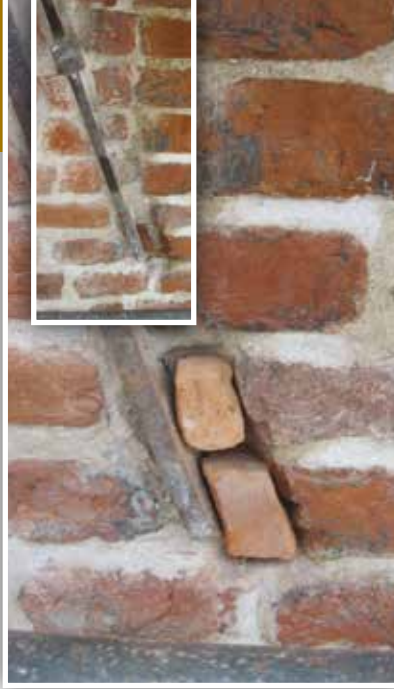
Figure 7. Juliet's house, "cuci-scuci" phase

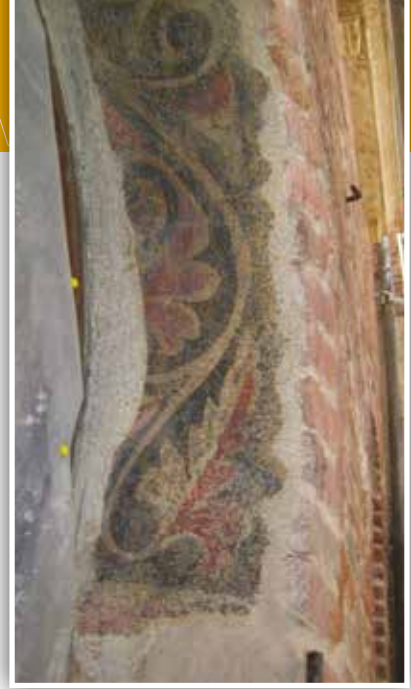
Figure 8. Juliet's house, the consolidation of medieval frescoes

During the cleaning of the plaster, medieval frescoes were discovered under the window frames of the first floor: drawings made with red, green and ochre spirals on a black background. The removal of all later overlays and the cleaning by poultices of deionized water and ammonium carbonate were then performed and the adhesion of detached layers were done with injections of natural hydraulic mortar free from salts (Lafarge, AN.T.A.RES) (figure 8). The gap of plaster, micro and macro cracks were filled with a mortar of seasoned lime with similar inert filler to the original plaster. The lacune of the paint layer were layered with watercolors using the "lowering the tone" technique without false reconstructions. Siloxanes-based protective (Water repellent H224 at 7% in white spirit - AN.T.A.RES) was finally applied to the painted surfaces.

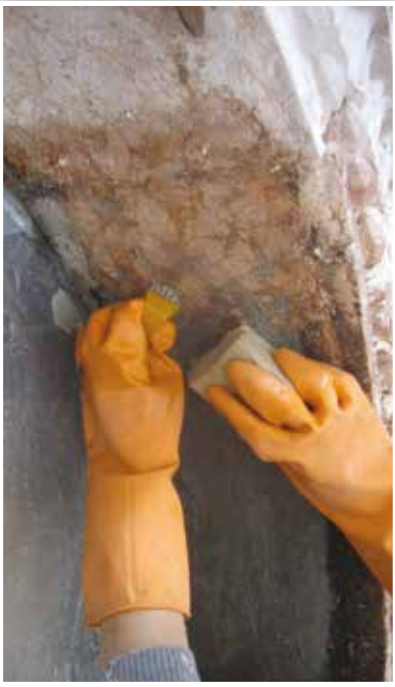
Figure 9. Juliet's house, the cleaning of the stones of the window frames

The flakes of stone material were firstly fixed with mixtures of stone powder and natural hydraulic lime NHL 5 in order to avoid detachment in the subsequent cleaning, performed by using brush, water at low pressure, poultice of ammonium carbonate (figure 9). The disaggregated elements were consolidated with ethyl silicate (AN.T.A.RES) by brush, injection or by percolation. The block of stones was performed as above described for the bricks and the grouting was made with natural hydraulic lime-free salts with different color mixture depending on the color of the stone in different parts of the façade. The final protection was performed with water-repellent siloxane (Water repellent H224 at 7% in white spirit - AN.T.A.RES) spraying the surfaces in a uniform manner from the top downwards.

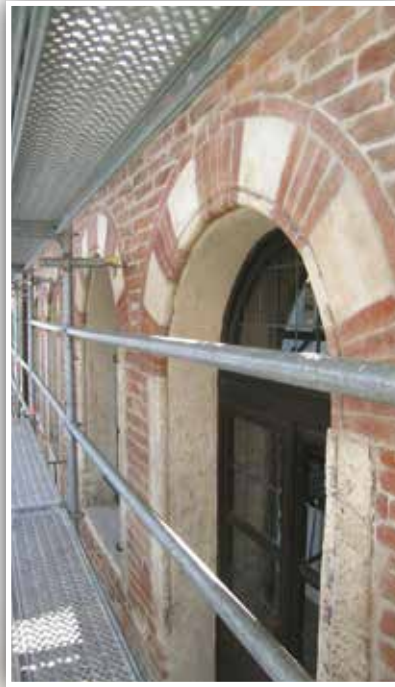
Figure 10. Juliet's house, facade after the cleaning and consolidation

The present work, through the use of appropriate products and methodologies, has allowed to slow down and stop the decay of different substrates such as bricks, ancient and modern plasters and natural stones of the front of Juliet's house in order to preserve them in the future (figure 10). At the same time it has been possible to improve the reading of the many traces of the past that have marked this building. Last but not least in importance, the restoration has uncovered medieval frescoes under ancient plasters.

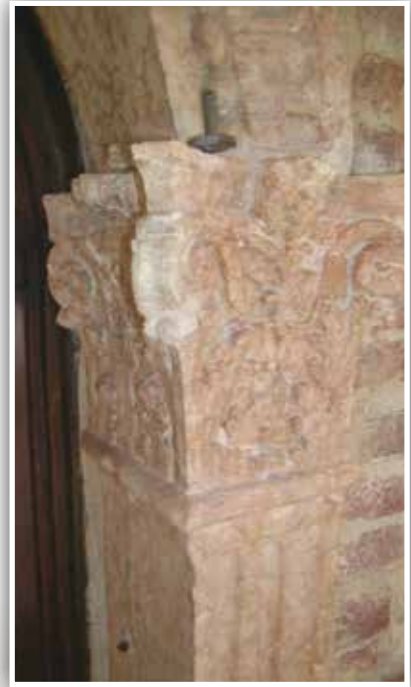
Juliet's house, frame with Corinthian capitals after the restoration
