quaderni di assorestauro

YEAR05NR05
DECEMBER 2016

SEMINAR
ICE-ASSORESTAURO
IN COOPERATION
WITH ISFAHAN
UNIVERSITY OF ART

**RESTORATION
& CONSERVATION
OF DECORATIVE
SURFACES
(ORNAMENTS)**

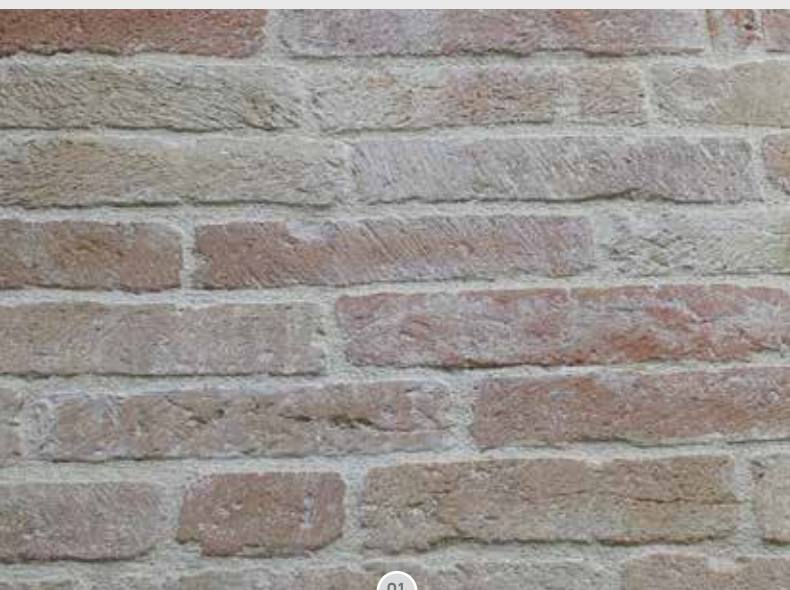
01

tant information can be gathered about traditional working tools, how and why some techniques were used to finish stone (straight chiselling, claw chiselling, anathyrosis, etc.), bricks (surface grinding, scratching, etc.) (figure 1), plaster (smoothing, claw chiselling, graffiti, painting, etc.), mortar joints (smoothing, pointing, etc.), clay soil. As a consequence, a historic construction has been gradually endowed with new important connotations. Such information helped restorers reproduce in some cases, or conserve in some other cases.

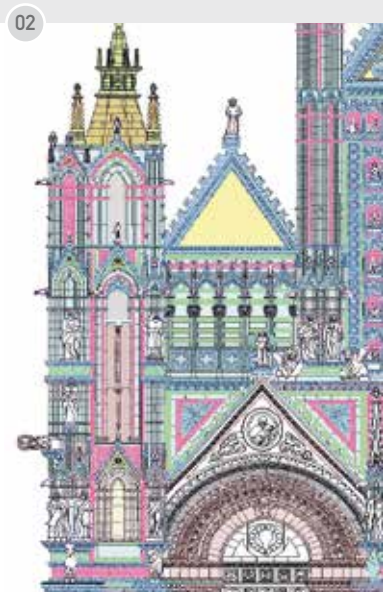
Fig 1. Detailed project for restoration of Divanhane palace in Baku (Azerbaijan): mapping of interventions on the basis of existing decay.

Fig 2. Detailed project for restoration of Siena's Cathedral façade: mapping of single materials, different degradation states of conservation and different percentage of incidence of degradation for surface unit.

a_Through mapping of interventions on the base of the different alterations (figure 1). By this term I mean a project that relies heavily on previous mapping of surface alterations, identifying interventions based replacing almost automatically, whenever possible, the list of decays with a new list of interventions. For example you can think of replacing with "extraction of soluble salts" the voice of alteration "efflorescence" to visualize the area and the quantities of surfaces to be treated with this work.

b_Through mapping of interventions on the base of materials and their conservation status (figure 2). A second approach may be to define the restoration works upon the mapping of all materials and their state of conservation; this method has the advantage of covering all surfaces of the monument and not to be tied to the preliminary assessment of the degradation, however, requires a careful description of all operational phases of restoration provided on each single material (phases which may differ depending on the materials and on the forms of degradation) and requires a considerable experience in the assessment of the unit costs of interventions for each material.

In the reported example of Siena's Cathedral façade restoration design to each color corresponds a different marble or, within the same marble, a different degree of protrusion or complexity of decoration or incidence of degradation.

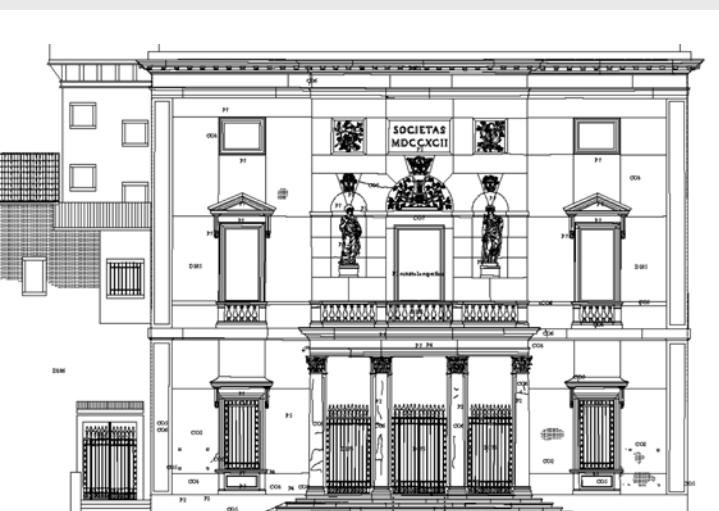
03

c_Using drawings with abbreviations or codes (figure 3). A third method of representation of the restoration project can be considered to draw up design tables based on the geometric survey inserting symbols or codes that refer to the single decay or work specifications.

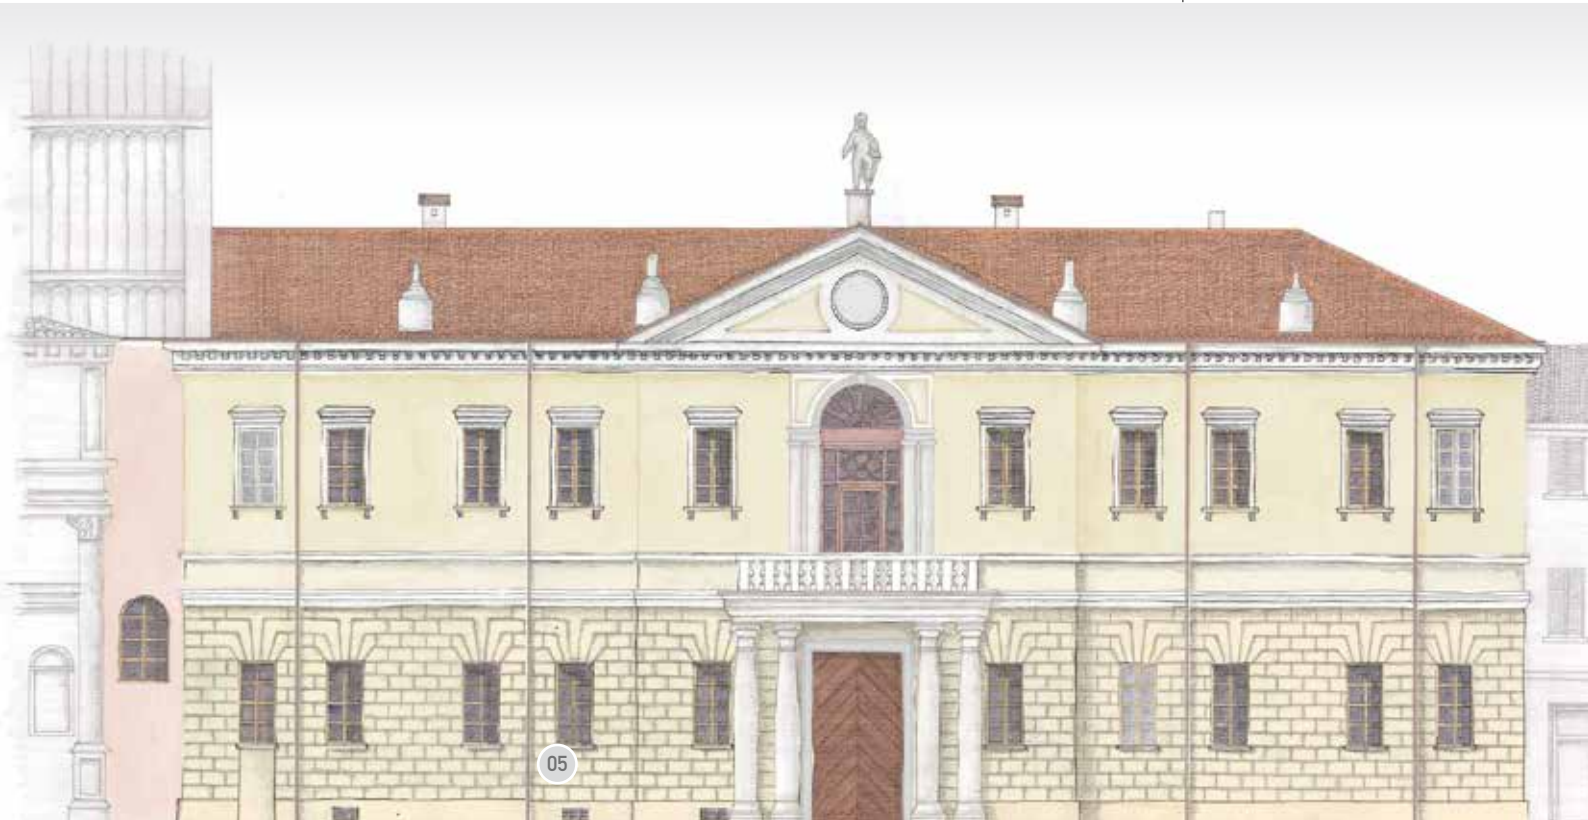
Water colors painting to visualize the final result for restoration and coloring of a 18th century façade of S Benedetto Po Monastery

In case of plaster façades it is recommended to visualize the final result of the restoration and of the final coloring with some computer renders (figure 5) or, even better because more realistic, with water color paintings. This phase will allow to make decision about different coloring of architectural elements and possible lighting results depending of the chosen light systems.

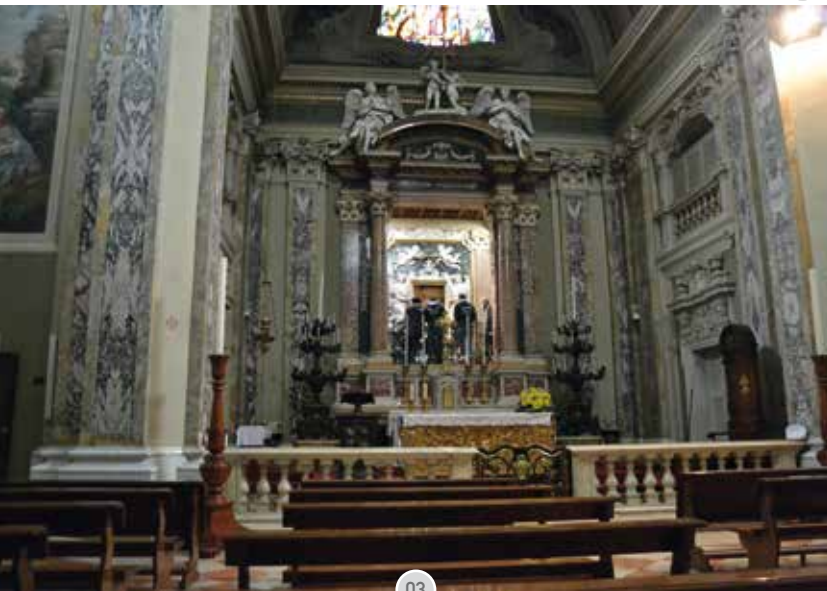
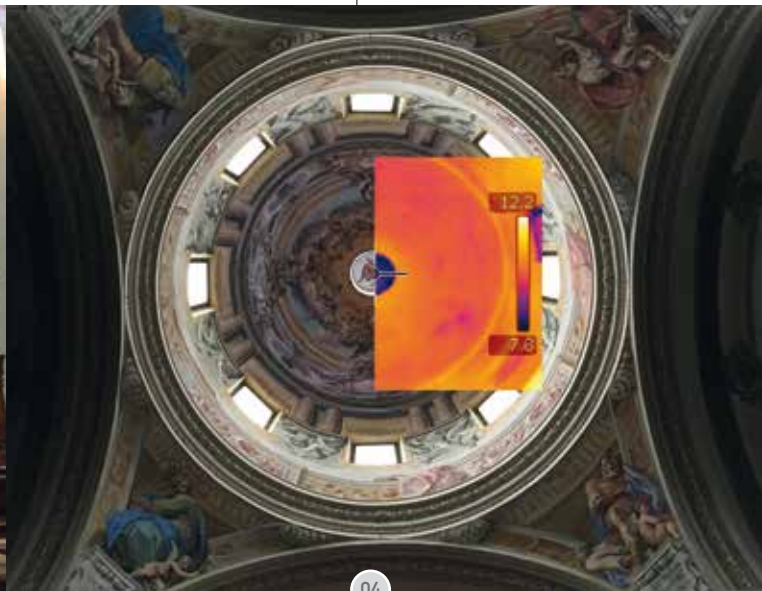
03

In the first place was carried a general Thermographic survey of the environments (figures 3-4), for an overall estimate of the conservation situation of structural and non-structural elements present inside. Second analysis was performed directly on the painting (figure 5) using non-invasive instruments, aimed at identifying the detached plaster, bulges, cracks and the presence of moisture and infiltration with the aim of identifying the most needy restoration areas of the element according to protect their conservation. The results obtained from this experimental investigation are recorded and processed to be delivered to the restorer, who will - if necessary - conduct further chemical / laboratory checks on pigments and plan material restoration. With the same purpose it was also conducted a ultrasonic survey on the stone Cross dated to 1276 a.C.

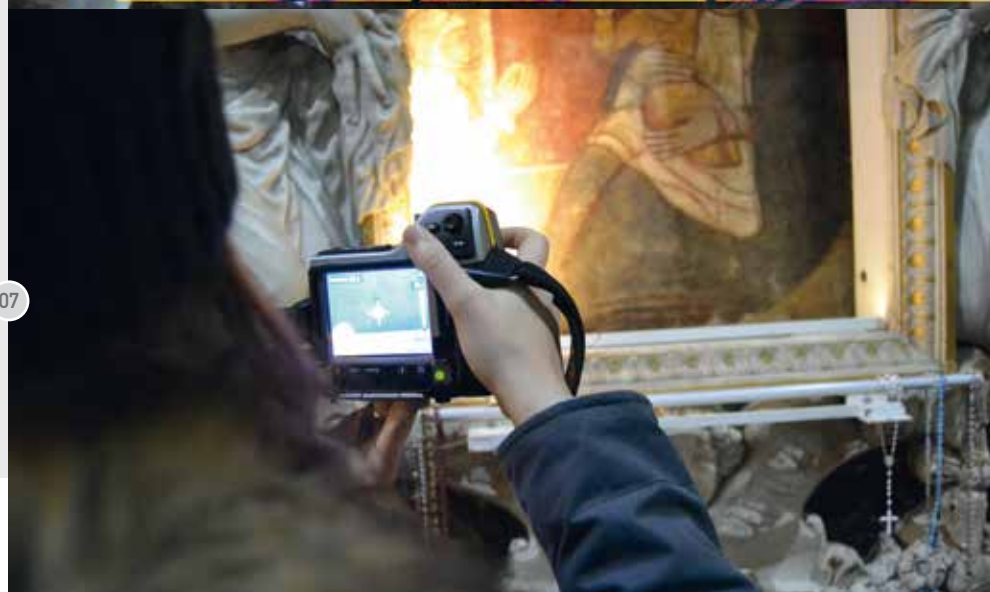
Fig 8-9.
Such control
was then further
expanded
and enriched
with sonic
and ultrasonic
investigation.

Subsequently a thermographic/thermohygrometer analysis on general environment for defining the general climatic conditions of the Sanctuary, (figure 6) the infrared technology has been applied on the fresco of B.V. the Castle (figure 7). Passive Thermographic refunds have detected, as shown by infrared images, areas with surface degradation (humidity, plaster peeling). Subsequently, with the aim of determining with more precision the source and severity of such difettologie encountered in it was applied the active Thermography (by resorting to the use of artificial sources of heat) and related image processing through specific analysis software. Such control was then further expanded and enriched with sonic and ultrasonic investigation (figure 8) by comparing the reading frequencies that give back a tomographic mapping. The last step has been implemented the thermohygrometric survey to detect the presence of water and moisture in the fresco. Relativity to the stone Cross, the application of direct ultrasonic survey reveal internal inhomogeneity of sandstone: a minimal degradation that testifies excellent storage condition considering his date of accomplishment (figure 9).

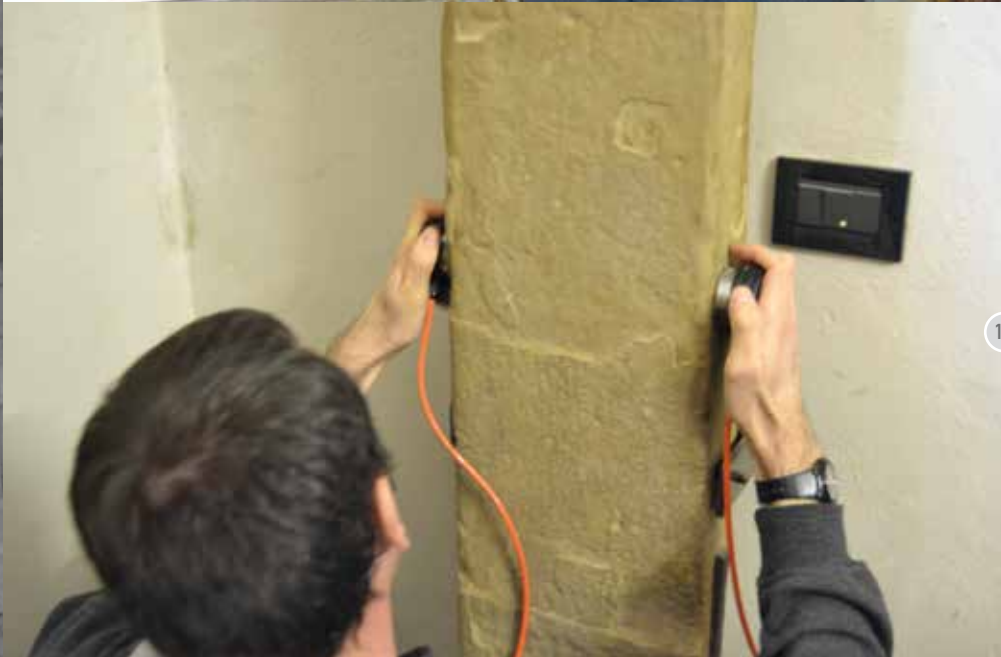
Fig 10.
Relativity to the
stone Cross, the
application of direct
ultrasonic survey
reveal internal
inhomogeneity
of sandstone:
a minimal
degradation that
testifies excellent
storage condition
considering his date
of accomplishment

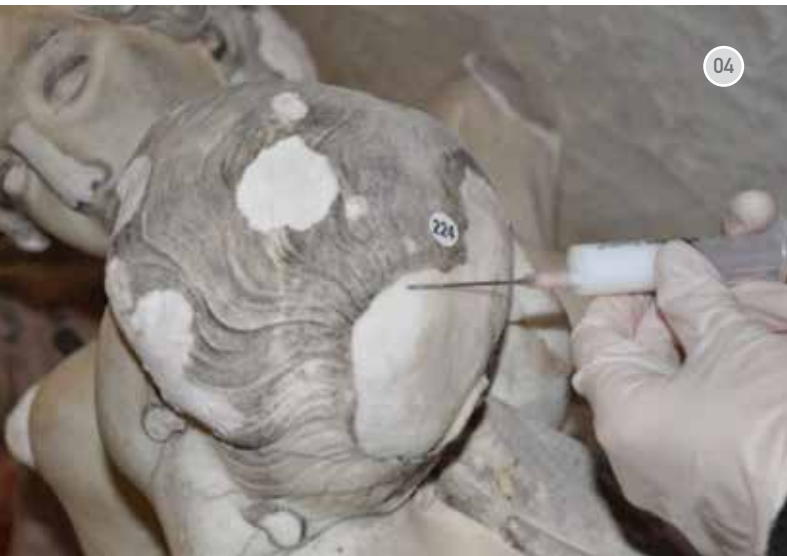
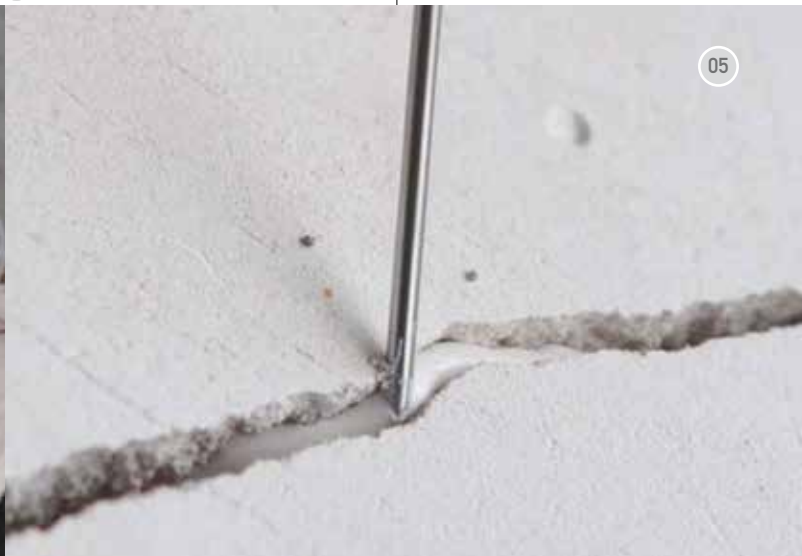
Fig 4. Microinjection.

Fig 5. Microinjection grout calcium carbonate fillers and nanoline.

With them it is also possible to produce grouting mortar to seal micro-cracks. (figures 4-5)

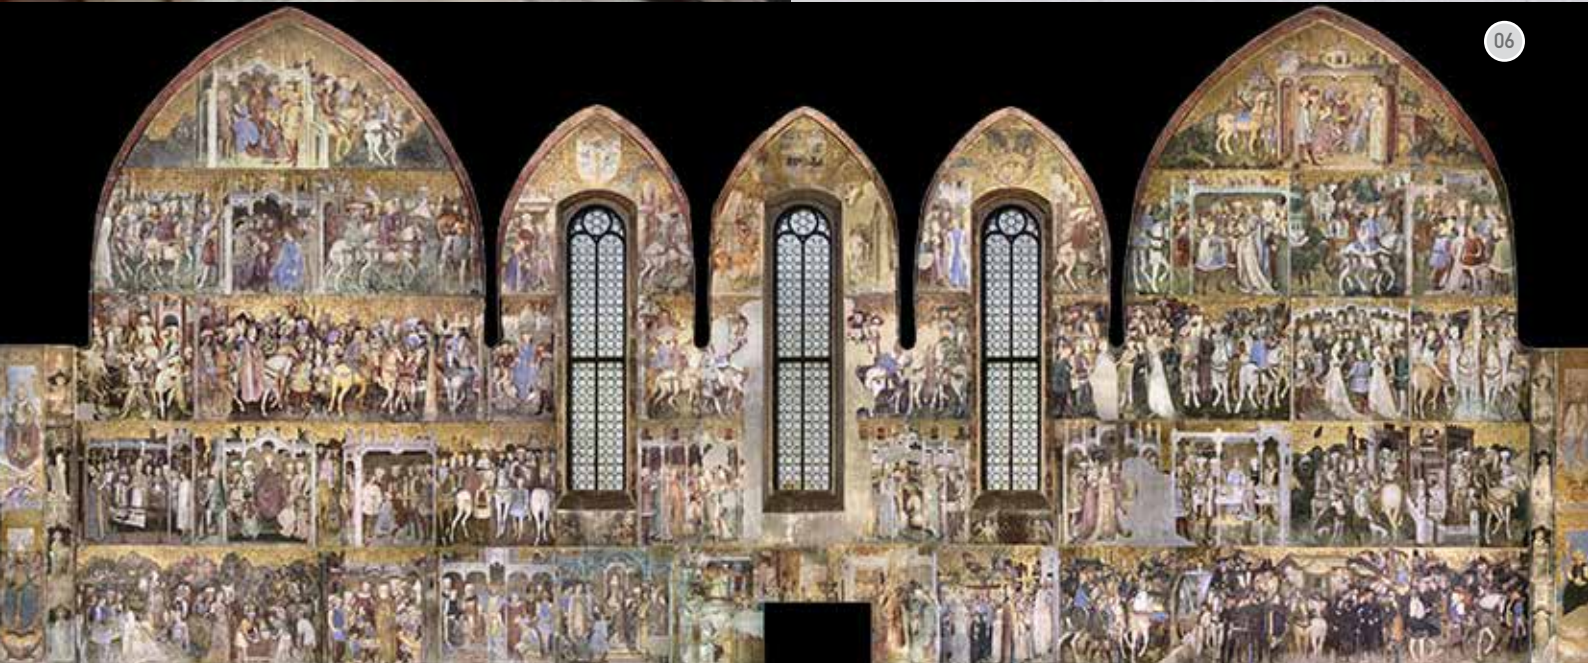
Fig 6. Pictorial cycle of the Chapel of the Queen Teodolinda, Cathedral of Monza, Italy. Restored by Anna Lucchini.

They are especially used for the decorated surfaces with a superficial disintegration. (figure 6)

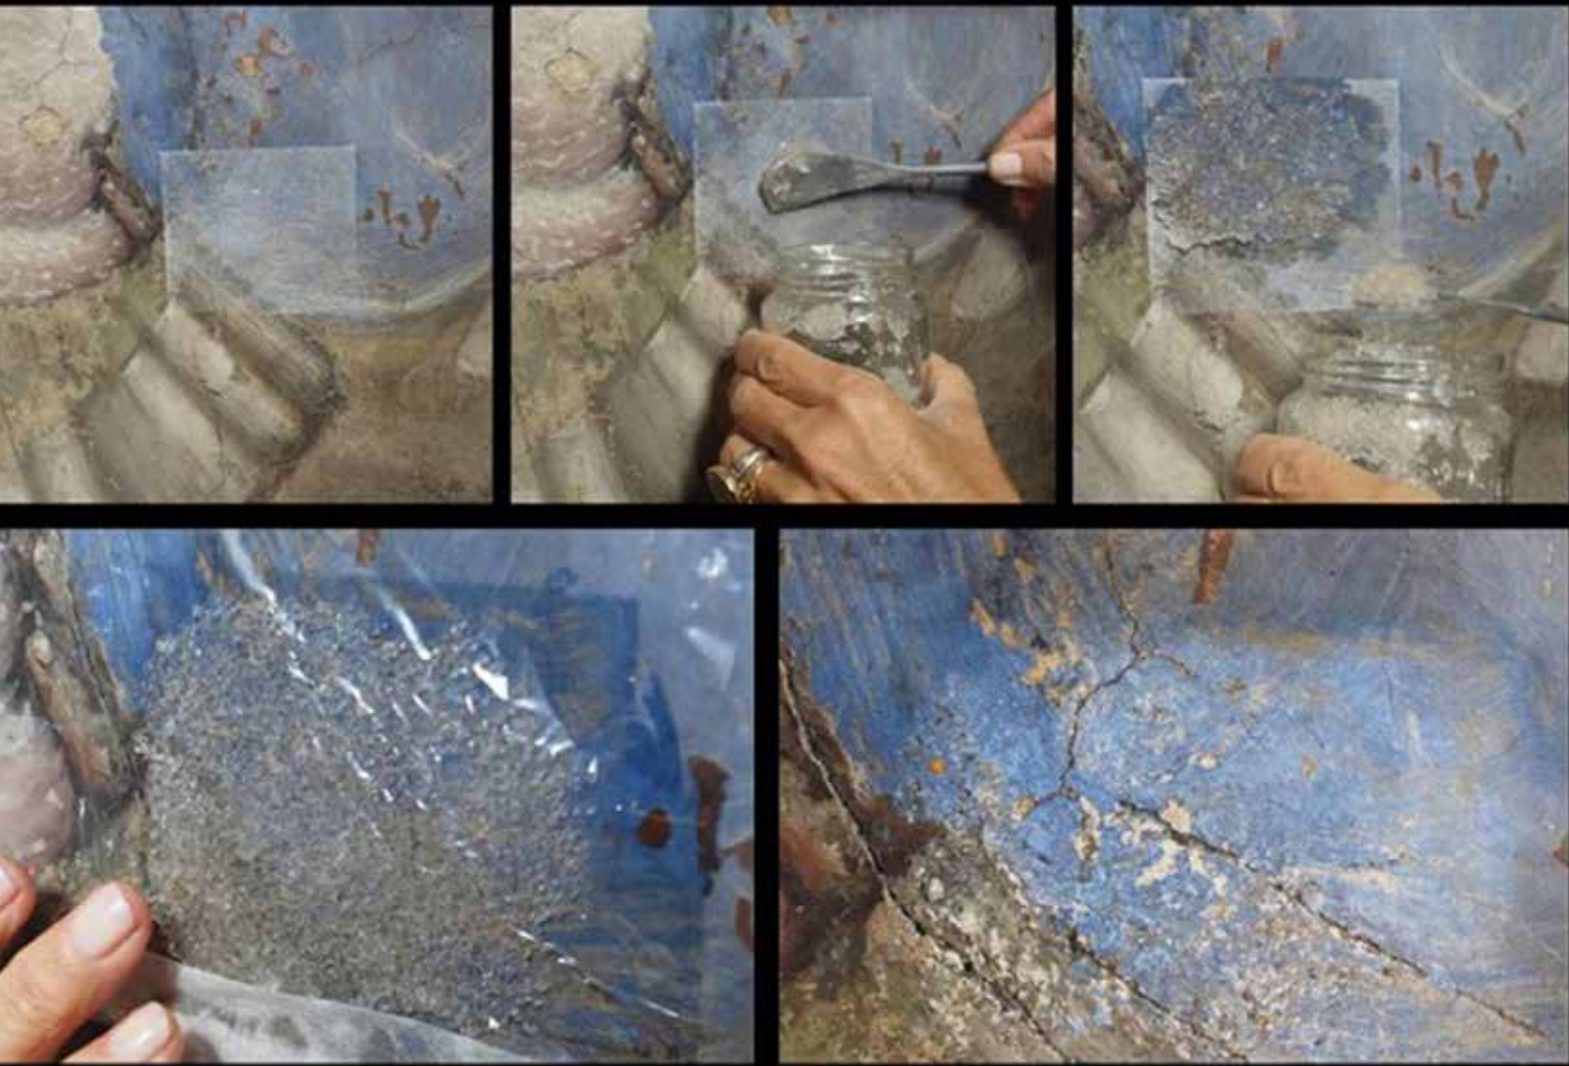
07

Fig 7. Test of bio-cleaning with bacteria by Restorer's Anna Lucchini.

For cleaning of the black crusts sulphate origin, frequently very hard to remove (figure 7), are now being used sulphate-reducing bacteria, present in nature and harmless to humans, able to destroy the incrustations, preserving the integrity of the artwork of which they have overlapped.

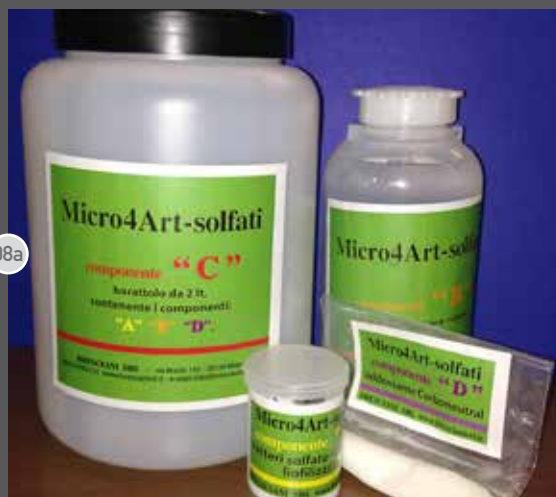
08a

Fig 8a. *Desulfovibrio vulgaris*.

For example, Micro4Art-sulfates is an innovative cleaning technology employing the sulfate-reducing bacteria (SRB) (figure 8a,b).

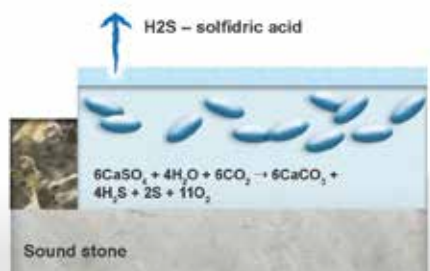
09

Fig 9. Mechanism of action

MECHANISM OF ACTION *Desulfovibrio vulgaris*, thanks to its metabolism (figure 9), is able to dissociate gypsum into Ca^{2+} and SO_4^{2-} ions, and the SO_4^{2-} ions are then reduced by the bacteria, whereas the Ca^{2+} ions react with carbon dioxide to form new calcite⁽⁴⁾ according the following reaction. $6\text{CaSO}_4 + 4\text{H}_2\text{O} + 6\text{CO}_2 \rightarrow 6\text{CaCO}_3 + 4\text{H}_2\text{S} + 2\text{S} + 11\text{O}_2$

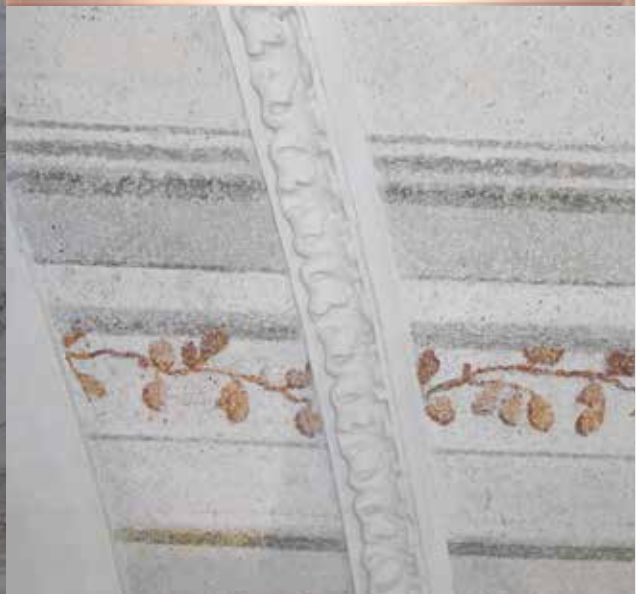
Stuccoes and frescoes during cleaning

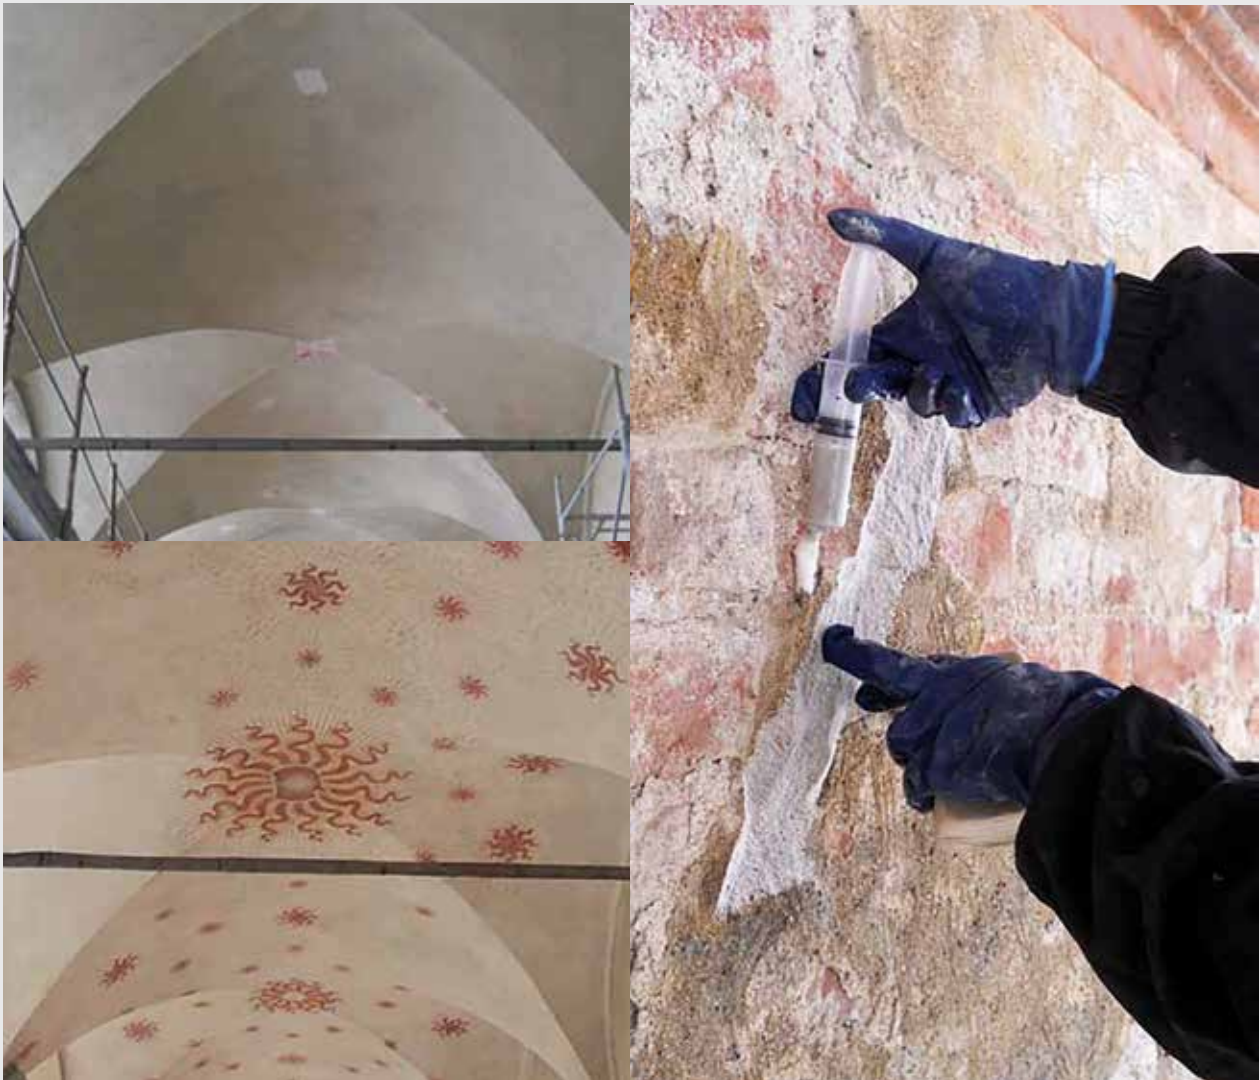
Stuccoes and frescoes after restoration detail

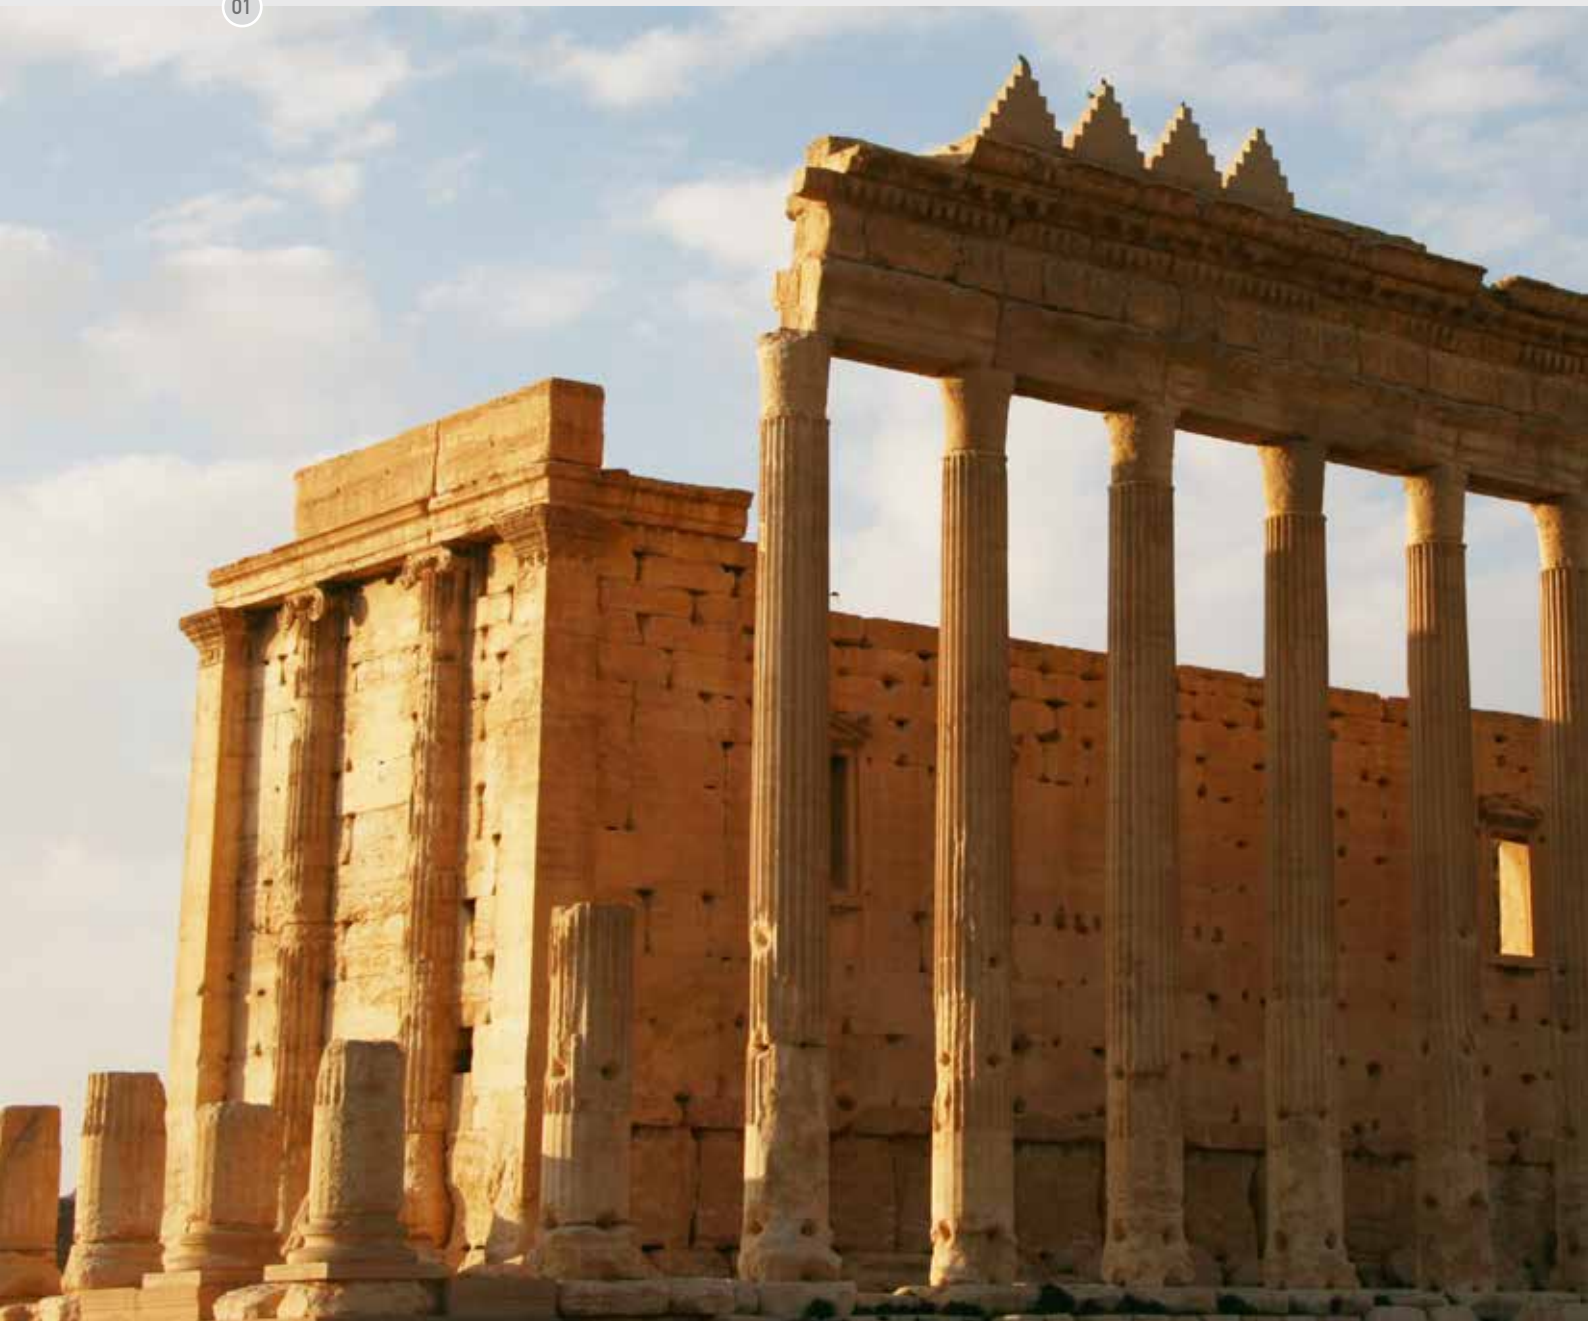
01

The outside of the east wall of Bel's Temple, Palmyra, 2009 (courtesy I. Baraldi)

and relief models from every era, and no less than 10 three-dimensional architectural models created by universities, foundations, or private individuals. Palmyra, which has been a World Heritage Site since 1980, has been known since the 19th century, when archaeological digs also took place, and documentation of it is thus rather obsolete. In particular, there are only a few relief drawings of the Temple of Bel, published in the books “The ruins of Palmyra, otherwise Tedmor, in the desert” by Robert Wood (1753) and “Le temple de Bêl à Palmyre” by Henri Seyrig, Robert Amy and Ernest Will (1975). These are the only two reference works featuring drawings and engravings that describe the temple in detail; in addition there are the historic photographs taken between 1867 and 1876 by the French photographer Félix Bonfils. The digital reconstruction of the ceiling on the northern Thalamos was based on these sources, which document the state of the monument upon its discovery, and on the photographs taken by G. Degeorge in 1999, the only high-resolution photos of the site. (figures 1-2)

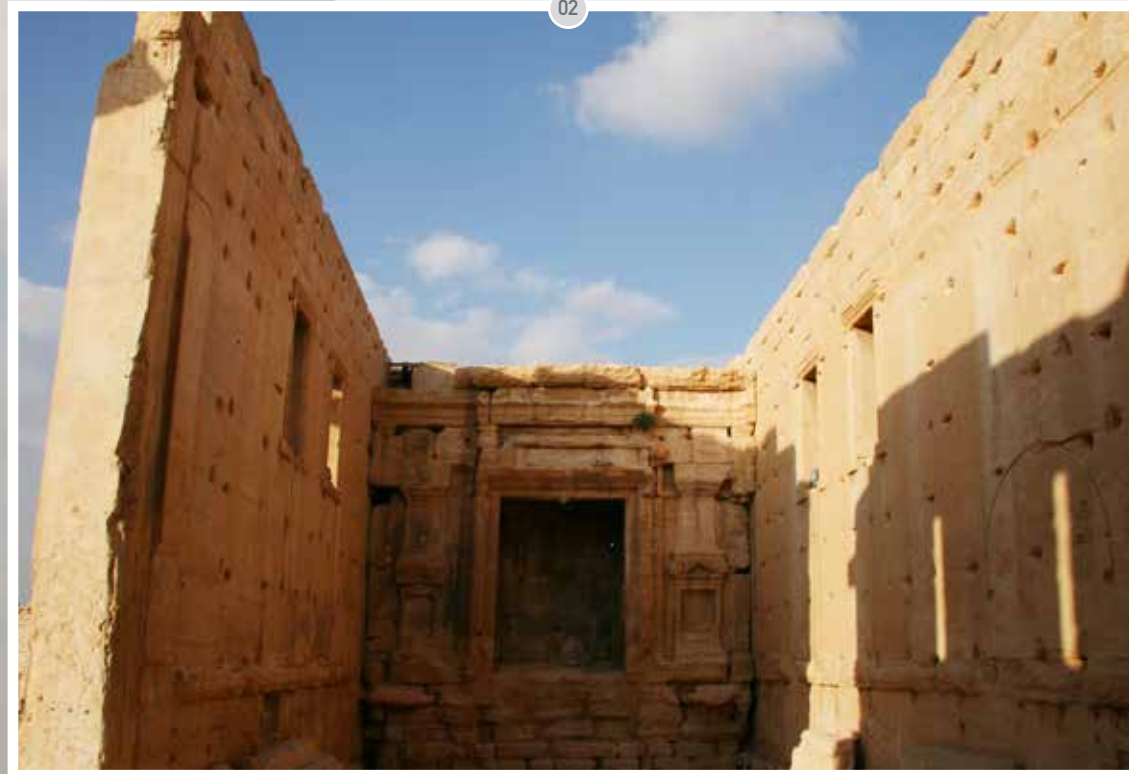
02

The inside of Bel's Temple, looking towards the North Thalamos, 2009 (courtesy I. Baraldi)

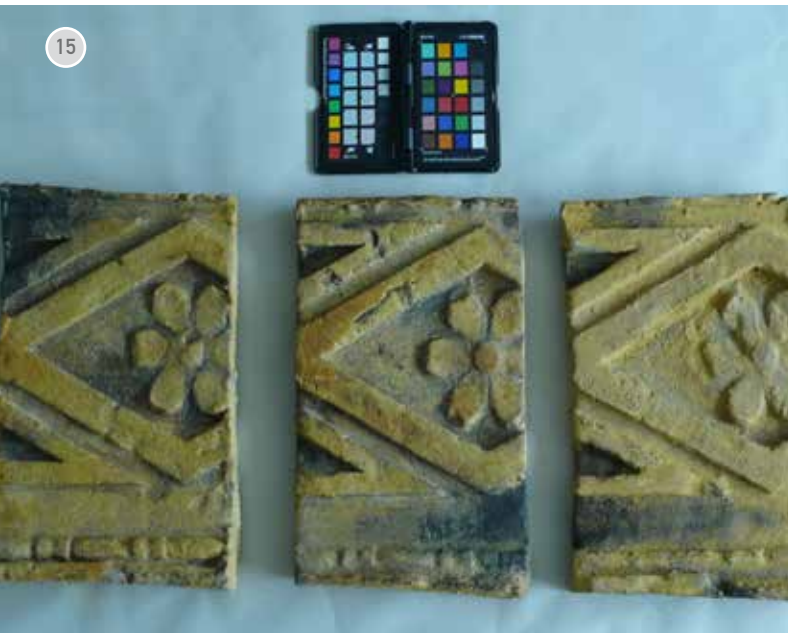
15

Fig 15. Samplings of different kinds of colour finishes, made in real size on a meaningful detail of the model. On the samplings different finishes has been tested to reproduce the effects of time, wind, temperature changes and human activities and then submitted to the scientific committee.

The final tint of each component was picked from a series of samples by the scientific committee in order to best match the effects of wear from time, wind, temperature changes, and human activities, such as the destruction of parts of the ceiling and soot from bivouacs inside the temple. (figure 15)

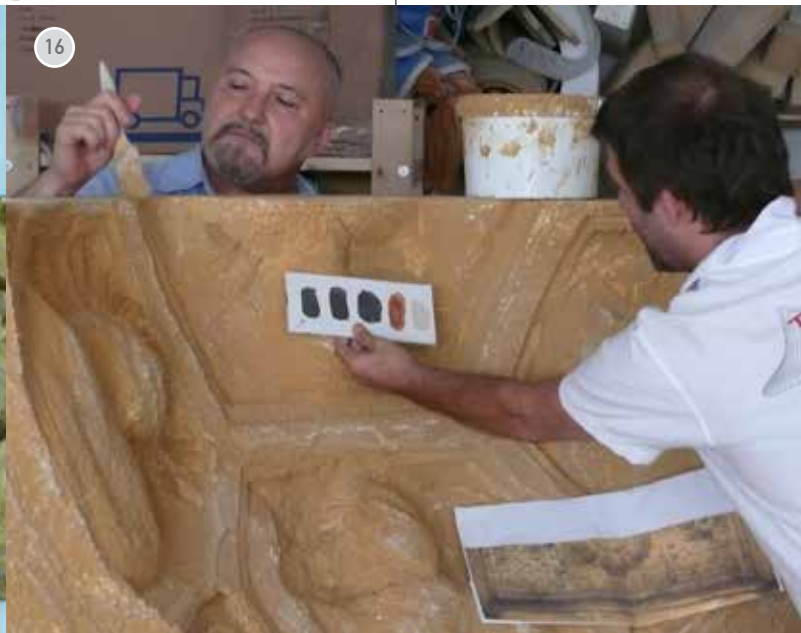
16

Fig 16. Beginning of the final phase of the realization of the life-like model.

After balancing the colours of each component and completing all the various tints using suitable liquid and powdered acrylic and oxide-based pigments, the entire replica was coated with a transparent opaque acrylic protective layer. (figure 16)

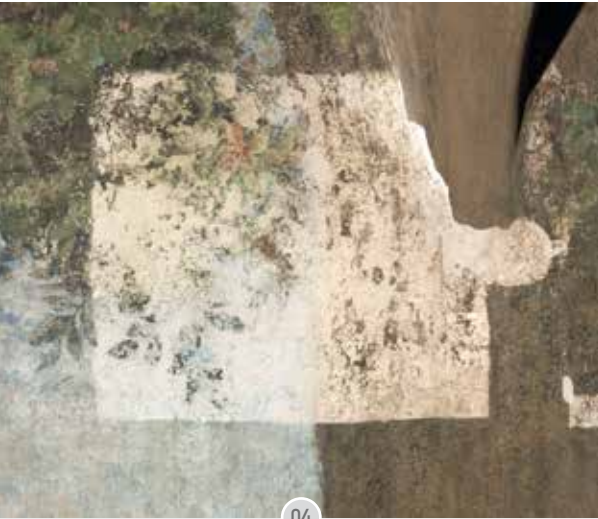
04

Removing layers of whitewash caused serious damage (figure 4) to the original mural painting; so architect Luca Beltrami decided that it had to be repainted over by the painter Ernesto Rusca who concluded this work in 1902 (figures 5 and 6). Between 1955 and 1956 there was a new intervention but Leonardo's picture remained under Rusca's repainting (figure 7).

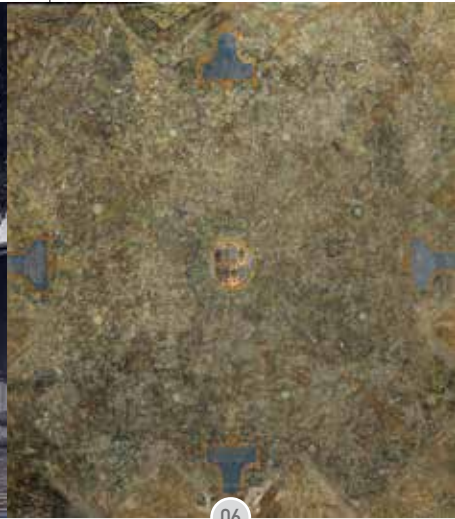
06

Milano, Sforza Castle, Sala delle Asse, Leonardo da Vinci, 1498.
Leonardo's picture traces discovered under Rusca's repainting,
2016, Copyright Milanese Municipality
(all rights reserved). Photo by M. Ranzani

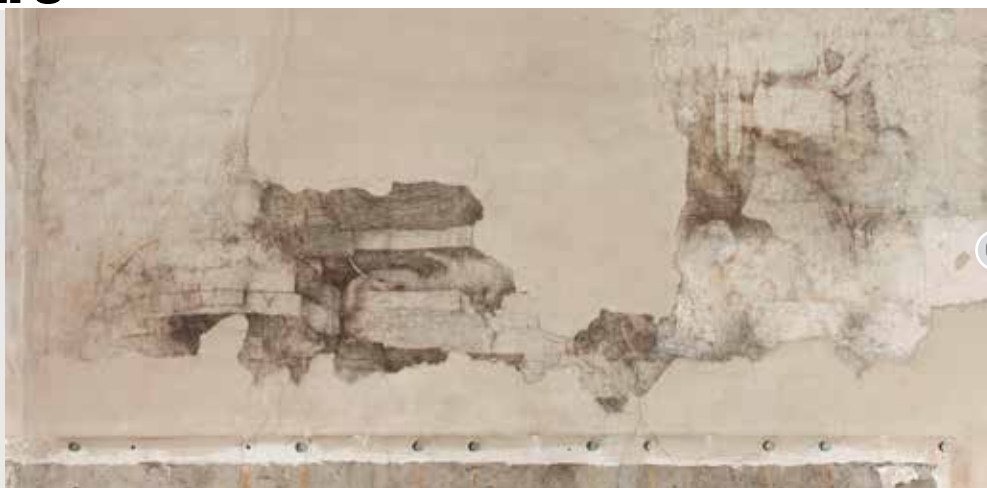
07

Fig 7. Milano, Sforza Castle, Sala delle Asse, Leonardo da Vinci, 1498. The so-called monochrom on the east wall, 2013, Copyright Milanese Municipality (all rights reserved). Photo by M. Ranzani

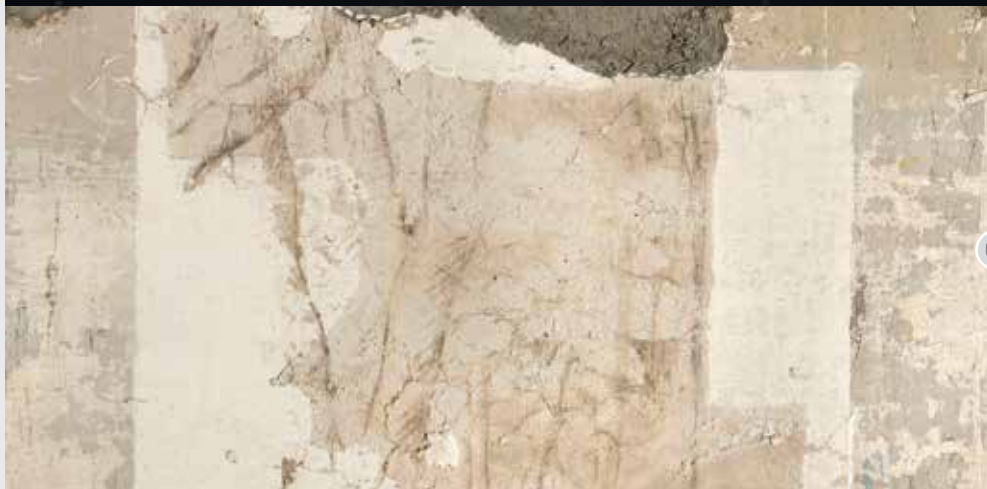
09

Fig 9. Milano, Sforza Castle, Sala delle Asse, Leonardo da Vinci, 1498. Traces of preparatory drawings found under the layers of whitewash, 2016, Copyright Milanese Municipality (all rights reserved). Photo by M. Ranzani

tural Heritage and Activities and Tourism to start the new intervention with three goals: to understand and remove the causes of deterioration (figure 8); to find traces of Leonardo's vault painting (figures 9 and 10); to remove the layers of whitewash to allow the vision of the Leonardo's preparatory drawings on the wall (figure 11).

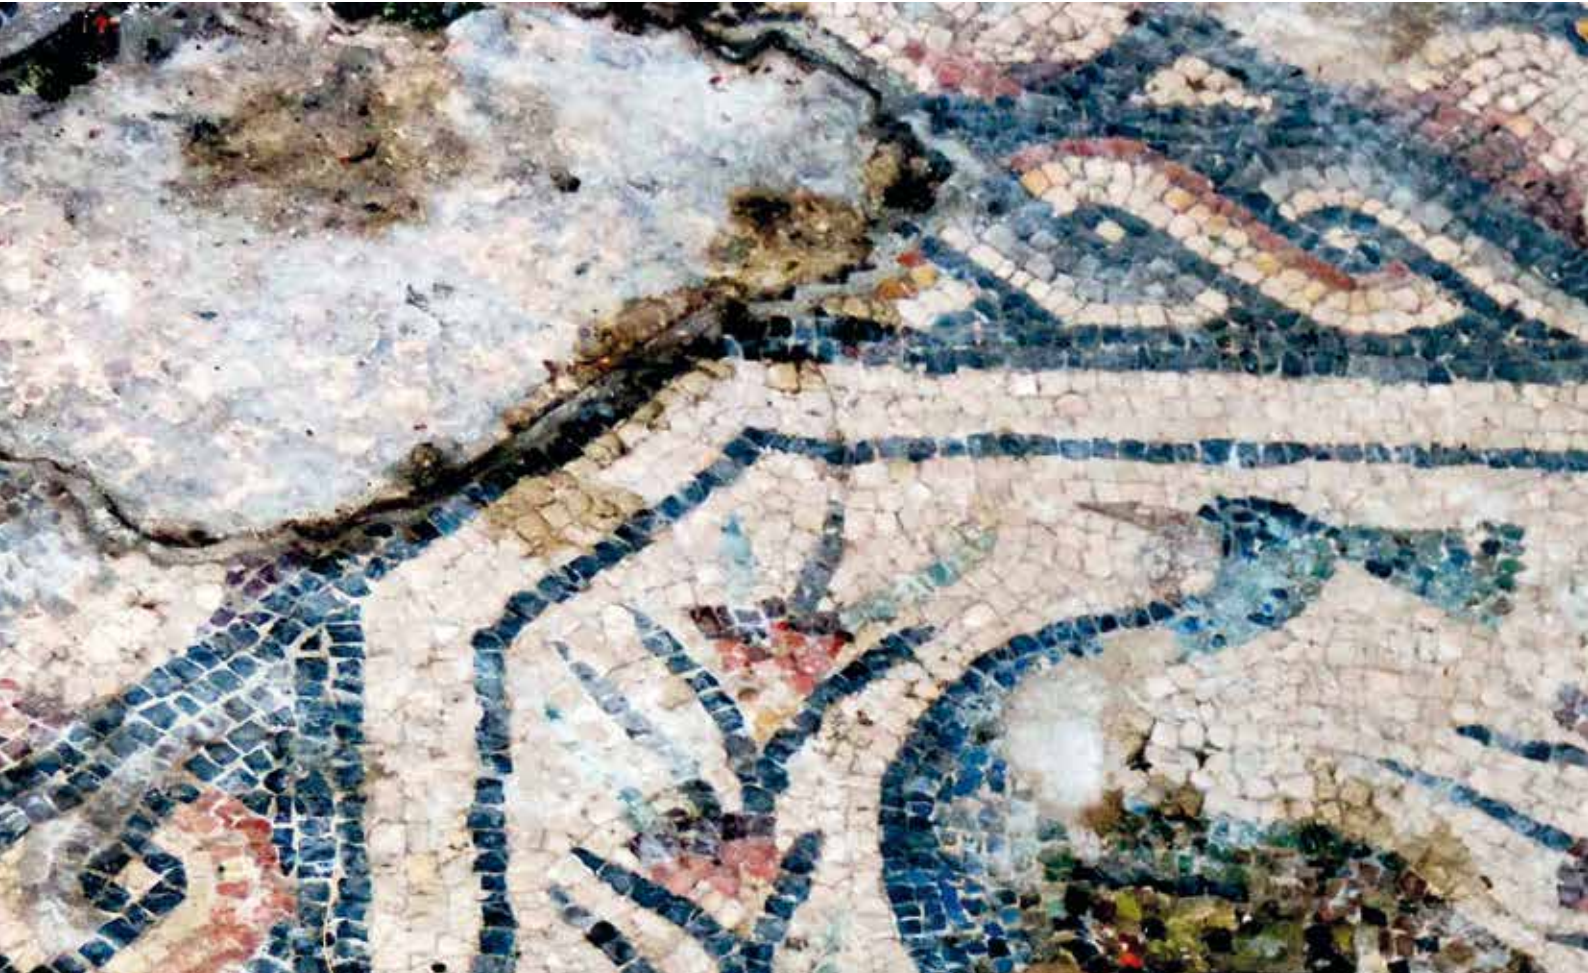
Then, it was decided to apply the cryogenic technique, i.e. the projection of Co₂, dry ice, on the surfaces to be cleaned. For this operation, the IB-ICE equipment, also supplied by IBIX, was used. Unlike traditional cryogenic cleaning, which is mainly used in the industrial sector, IBIX has developed a low pressure (3 bar) intervention parameter that has made cryogenic cleaning much more delicate and economical than the standard interventions. As a

matter of fact an IB 2000 compressor supplied by IBIX was employed. Such compressor is able to supply 2000 litres of air per minute (this power is extremely lower than the one regularly used for interventions with cryogenic technology). Thanks to these adaptations, a generally aggressive technique has been turned into a suitable procedure for a delicate restoration intervention.

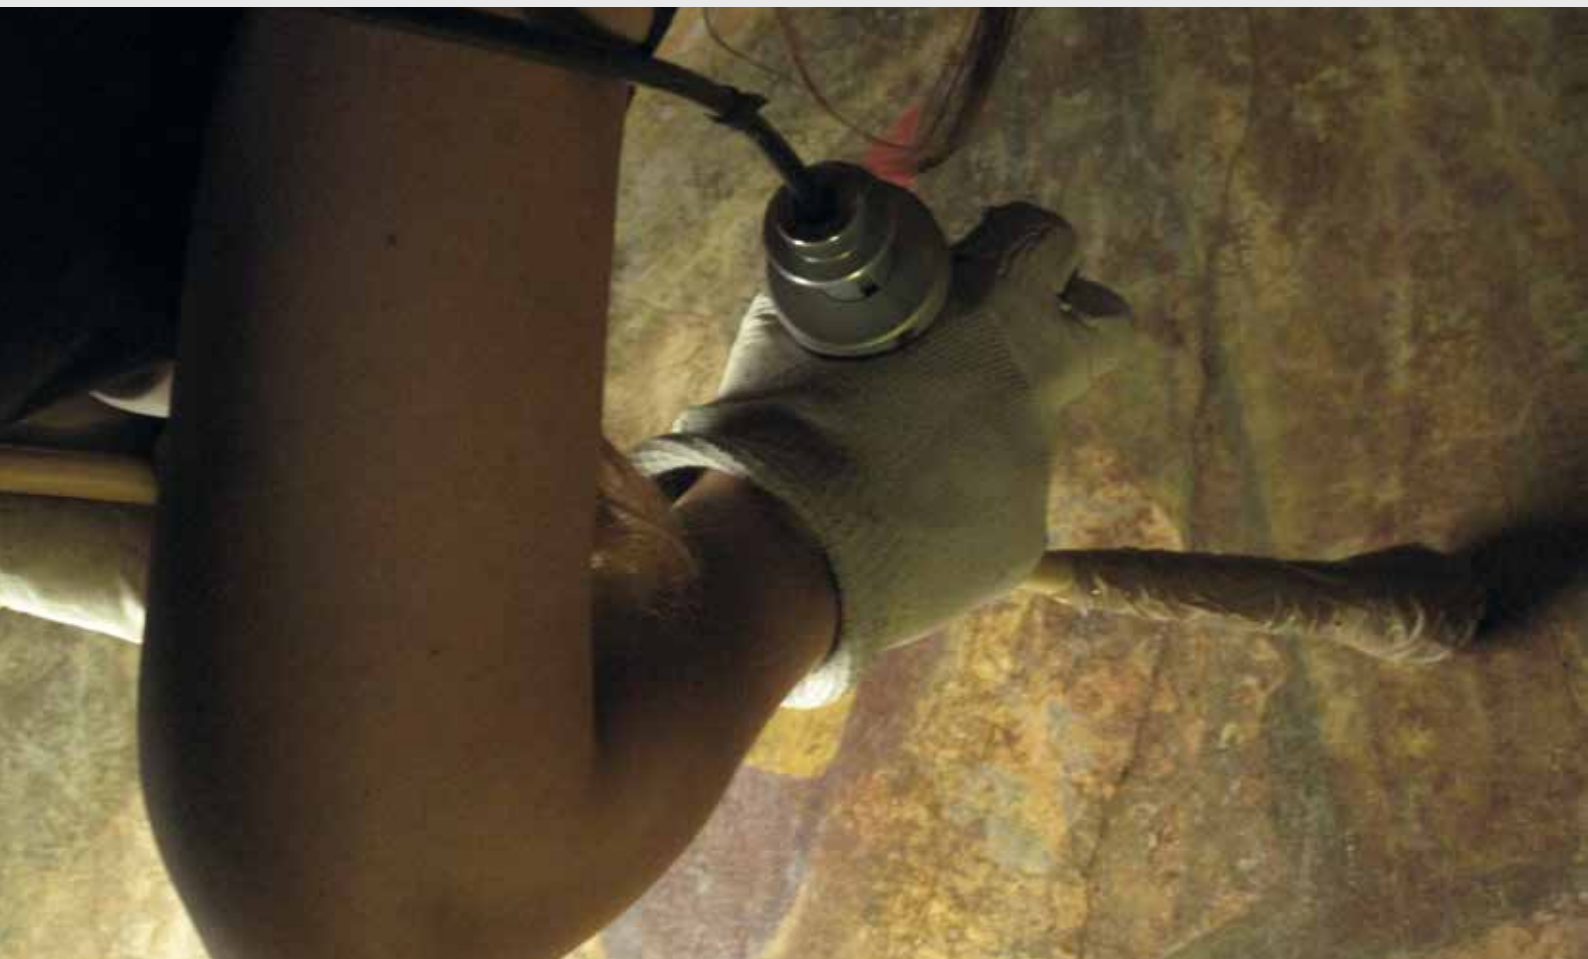
Frescoes cleaning
in the Old Sacristy
in the Santa Maria della
Scala Complex, Siena

vaults of the Old Sacristy were painted by Lorenzo Vecchietta between 1446 and 1449 with scenes from the Old and New Testaments. The paintings were coated with layers of white-washing applied in the past. Used as first-aid room, the Chapel of the Mantle shows three spans divided into groin vaults painted by Cristoforo di Bindoccio and Meo di Piero in 1370. Again, in the past the paintings had been almost completely whitewashed. Traditional chemical and manual techniques proved unsuccessful in the removal of the whitewash because it was strongly attached to the pigments underneath. For this reason, restorers thought about the groundbreaking use of lasers. Preliminary tests were carried out using two intermediate-pulse systems: used together or one by one, they resulted in the successful removal of the whitewashing, revealing the frescoes underneath.
