quaderni di assorestauro

YEAR05NR05
DECEMBER 2016

SEMINAR
ICE-ASSORESTAURO
IN COOPERATION
WITH ISFAHAN
UNIVERSITY OF ART

**RESTORATION
& CONSERVATION
OF DECORATIVE
SURFACES
(ORNAMENTS)**

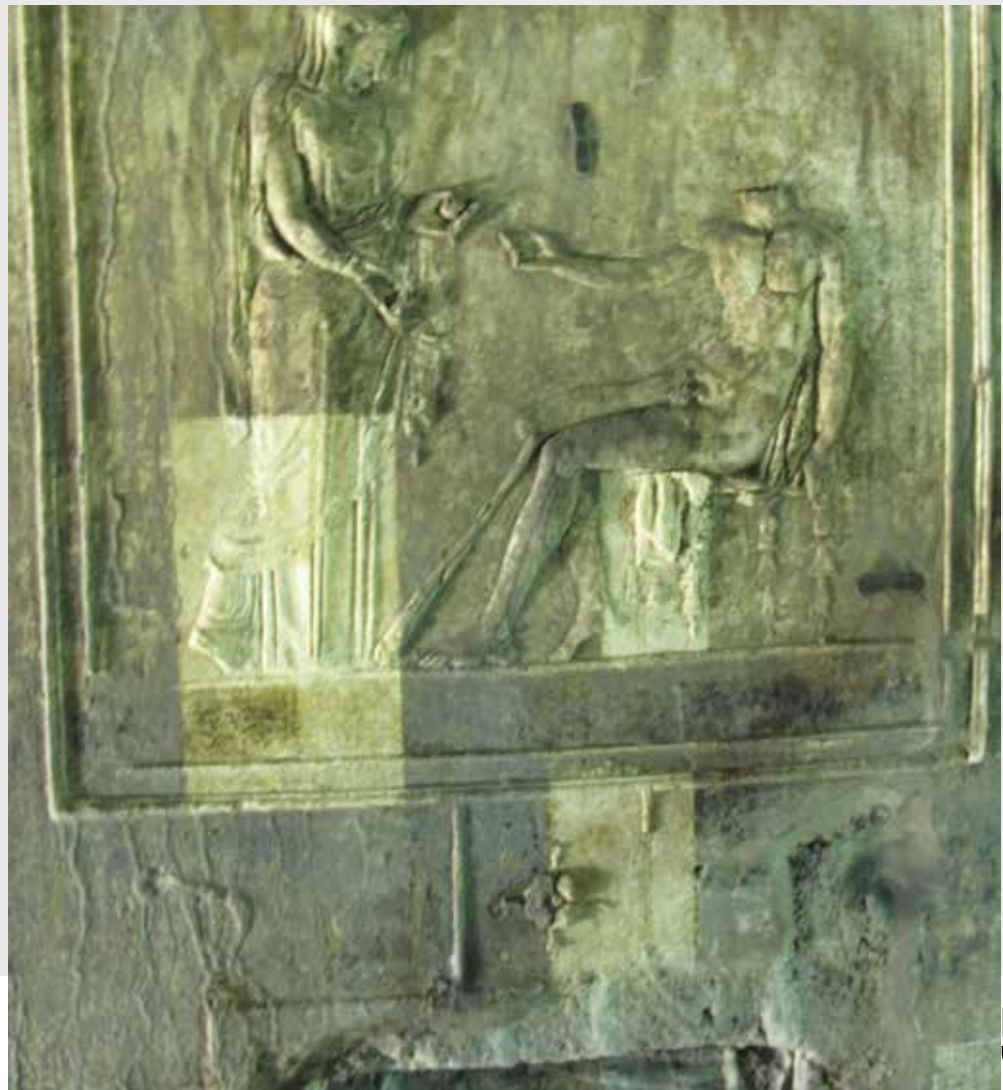
Cleaning trials
on the stuccos of the
hypogean Basilica of
Porta Maggiore in Rome

A similar conservation problem was faced in the first century A.D. Roman complex of the Underground Basilica of St. Maria Maggiore in Rome. This is a beautiful and fascinating hypogean temple decorated with fine stuccos and a fresco, a three-nave hall destroyed and buried few decades after its completion. Here, too, the laser had to intervene for removing thick layers of mineralized carbonation that obscured and covered the precious depictions. Thanks to the experience gained in the first laser cleaning interventions on wall paintings the technique has been lately applied on many other important wall paintings such as in the Villa of the Mysteries in Pompeii, in the Main Chapel of the Santa Croce Basilica in Florence, in the Santa Tecla's Catacombs in Rome.

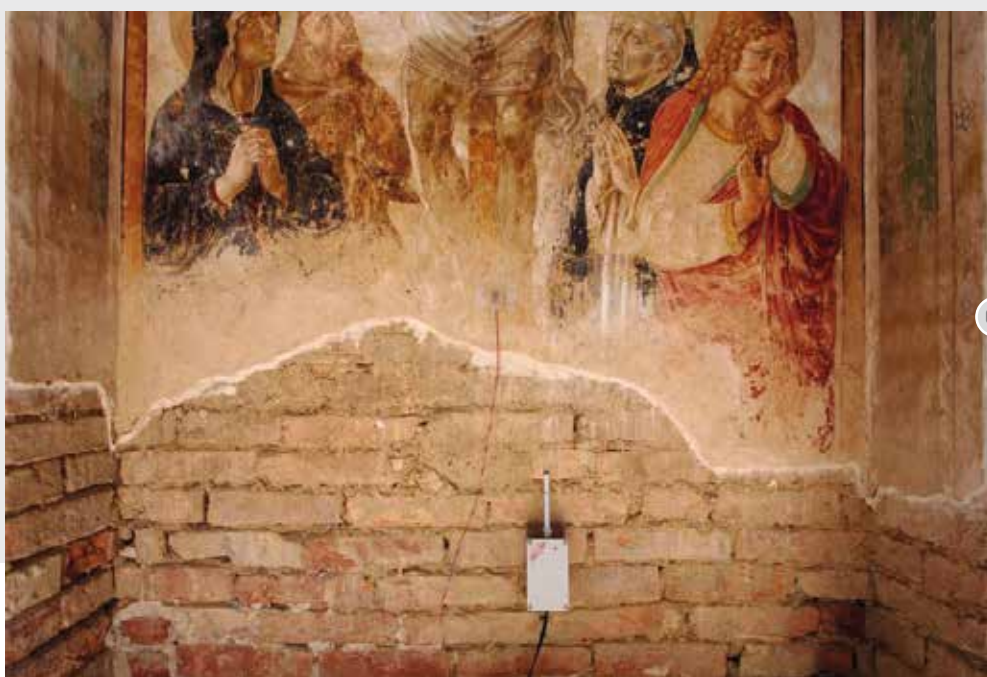
01

Installation of sensors
 to detect ambient
 temperature, the
 superficial temperature
 of masonry and relative
 humidity

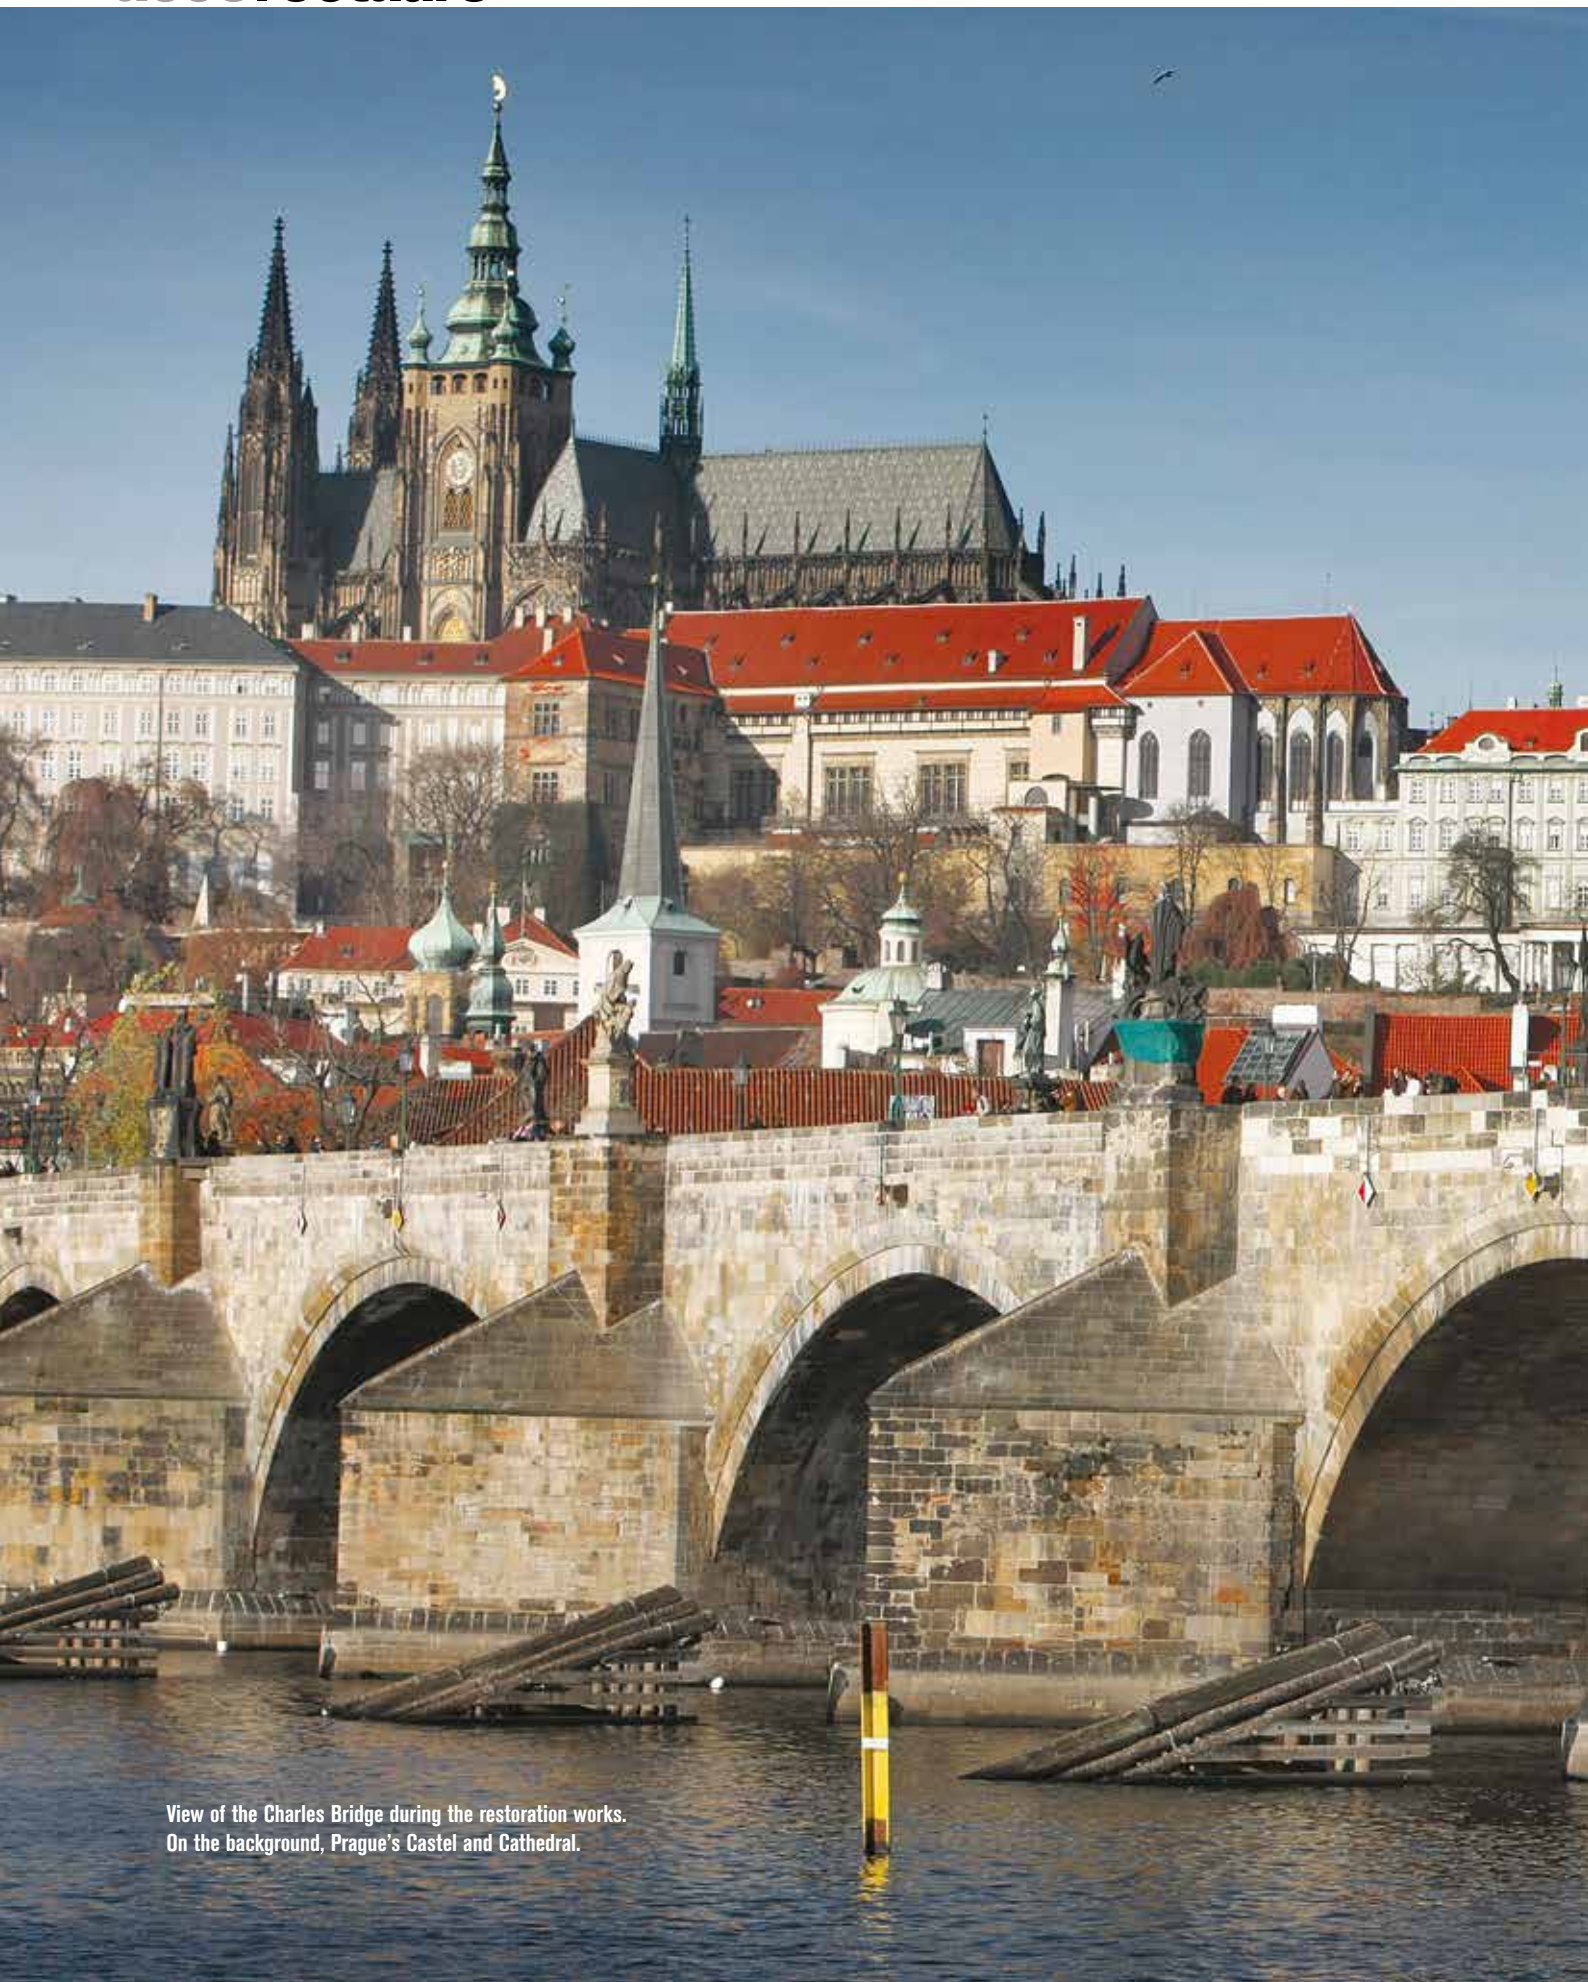
View of the Charles Bridge during the restoration works.
On the background, Prague's Castel and Cathedral.

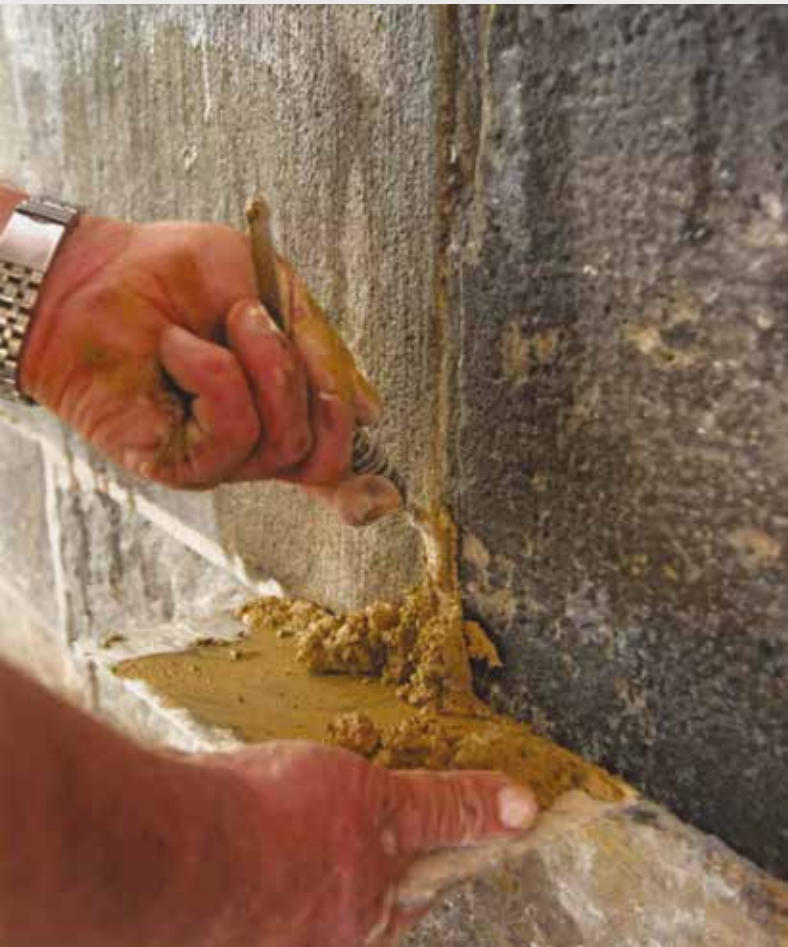
After careful analysis MAPE-ANTIQUE LC, cement-free, hydraulic binder based on lime and Eco-Pozzolan was used to repair the sandstone blocks

MAPE-ANTIQUE LC was used in this case, salt resistant, hydraulic binder based on lime and Eco-Pozzolan, cement-free, mixed with local aggregates in various grain sizes to reproduce the original mortar. MAPE-ANTIQUE I, super-fluid, salt-resistant, fillerized hydraulic binder, based on lime and Eco-Pozzolan was used for consolidating masonry by injection of some sections in the bridge pillars.

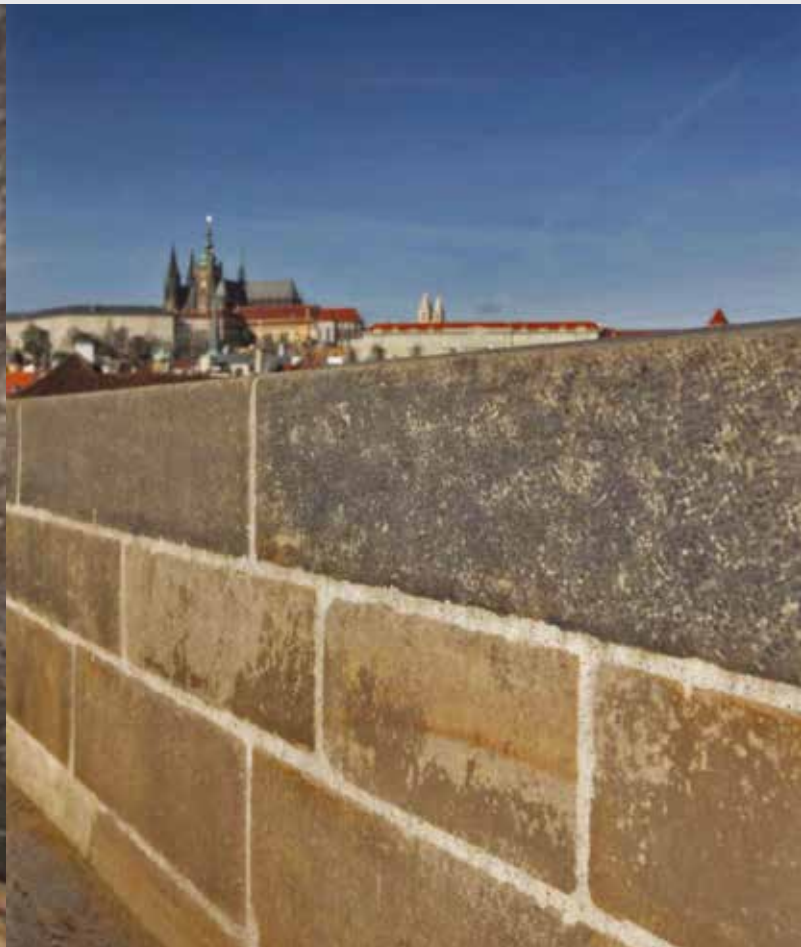
A detail view of the bridge after completion of the repairs

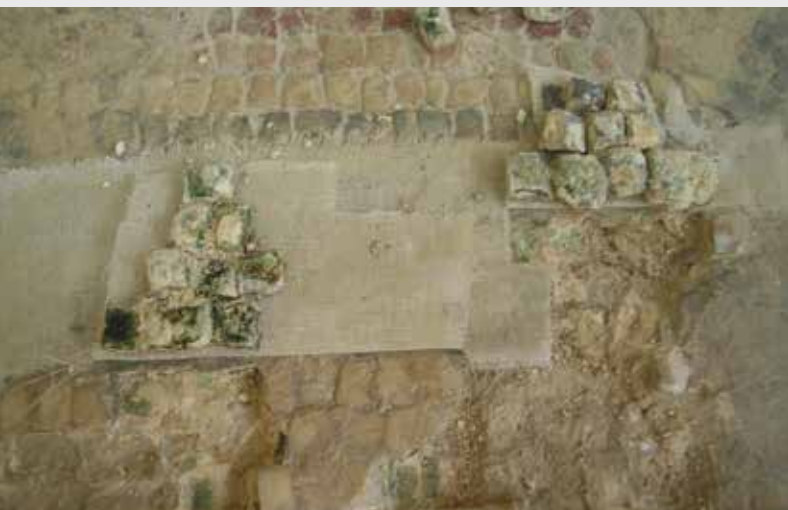
Biological attack

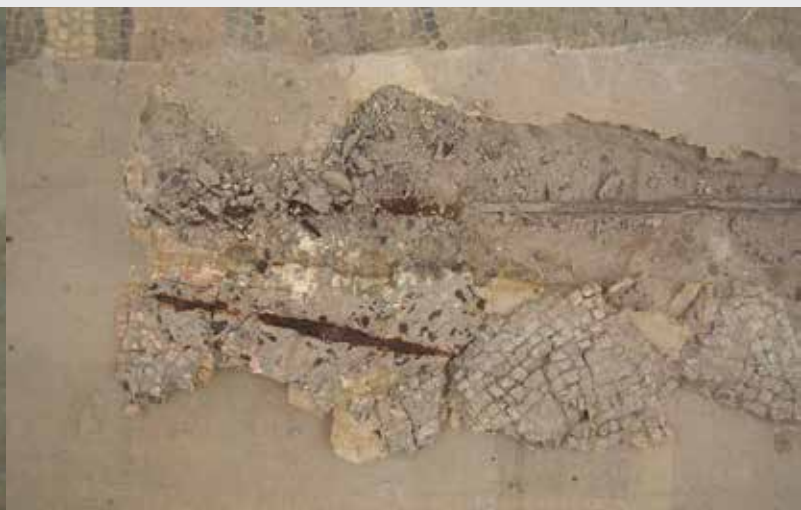
Reinforced iron bars removal

es, encrustations, resins); detached small mosaic portions to intervene on the reinforced iron bars of cement screeds, now rusty; leveled the gaps and infiltrated into the substrate consolidating products, as barium hydroxide that has been injected with needles inserted between the tesserae, using hundreds of drip bottles. It allowed the removal of some salts and the cohesion of the support.

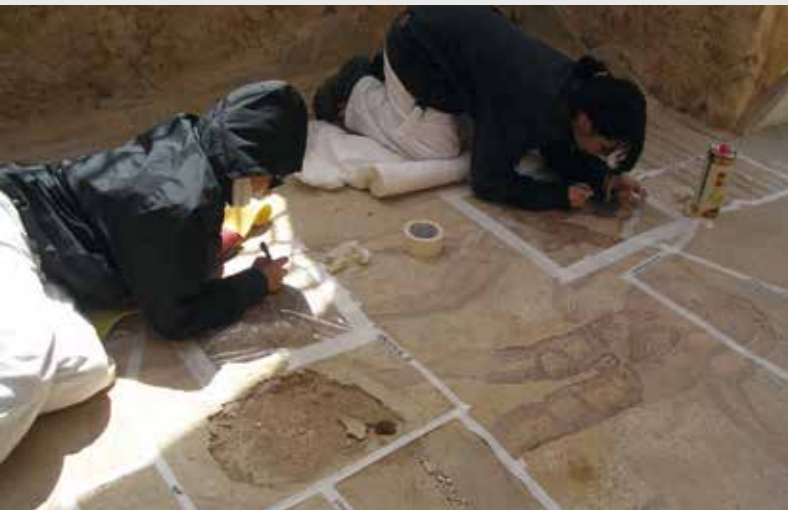
Execution of the grids

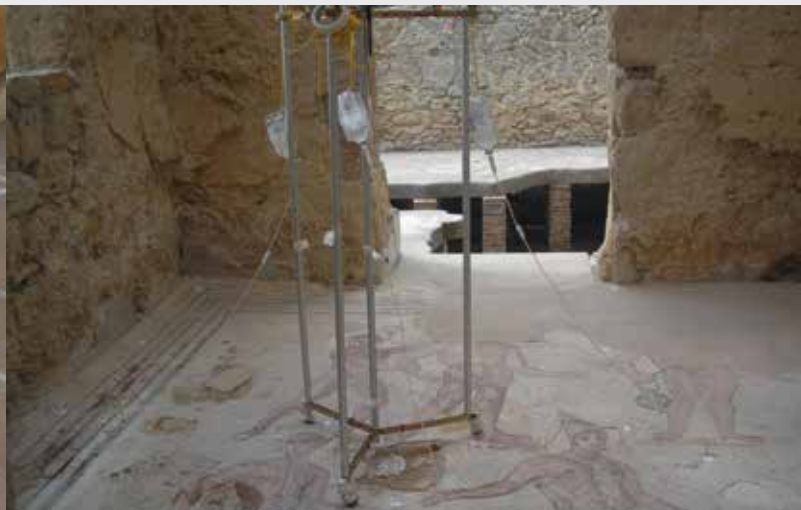
Support's consolidation

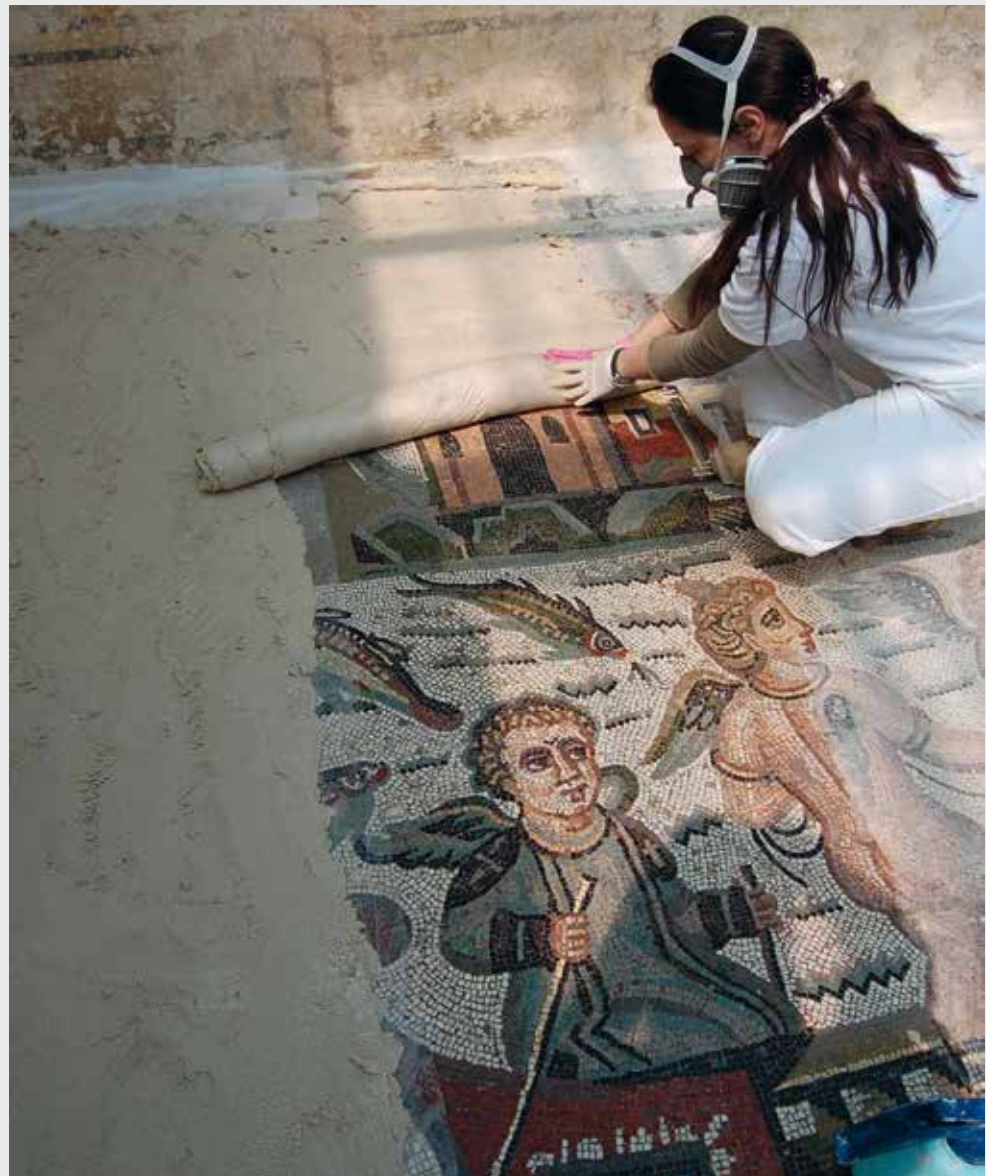
Cleaning phase

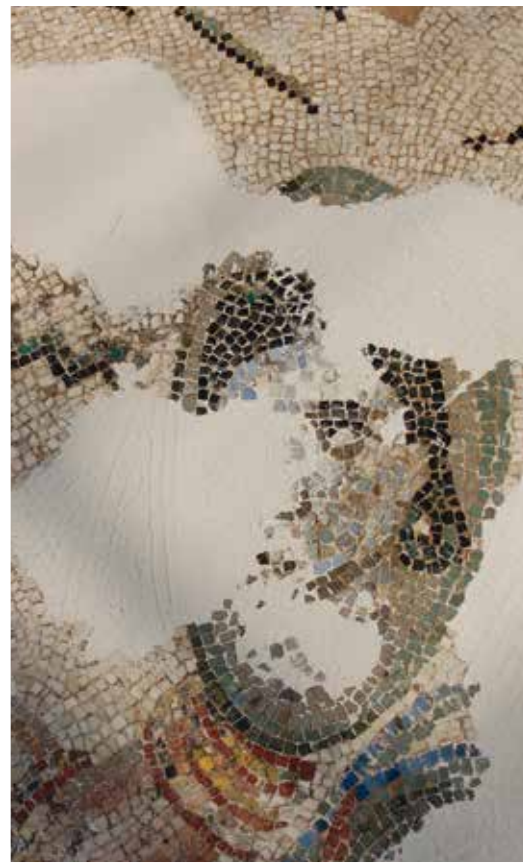
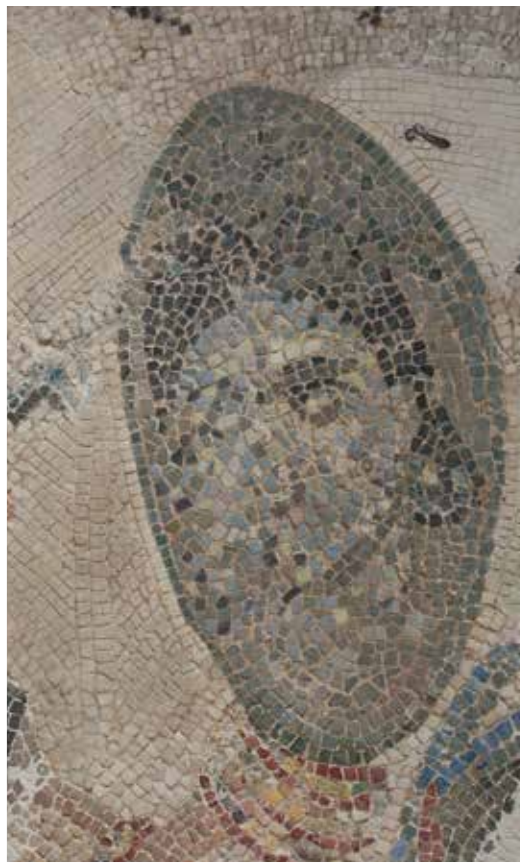
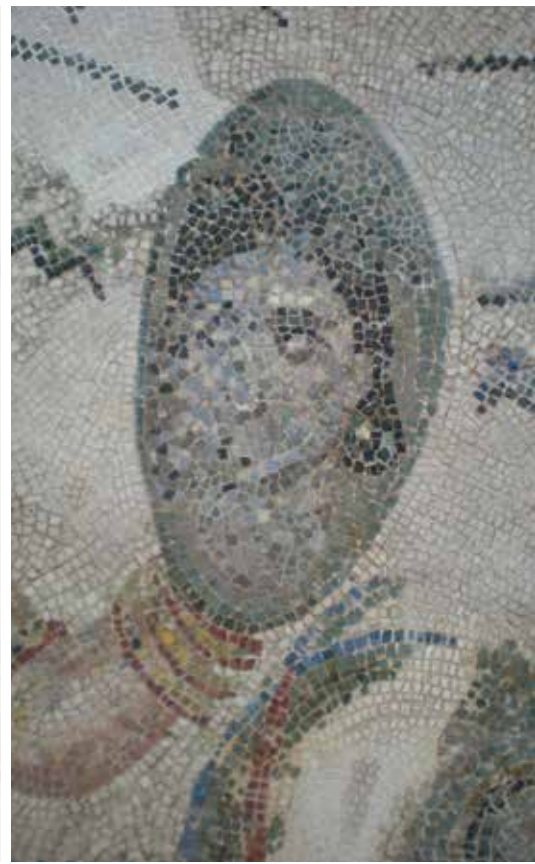
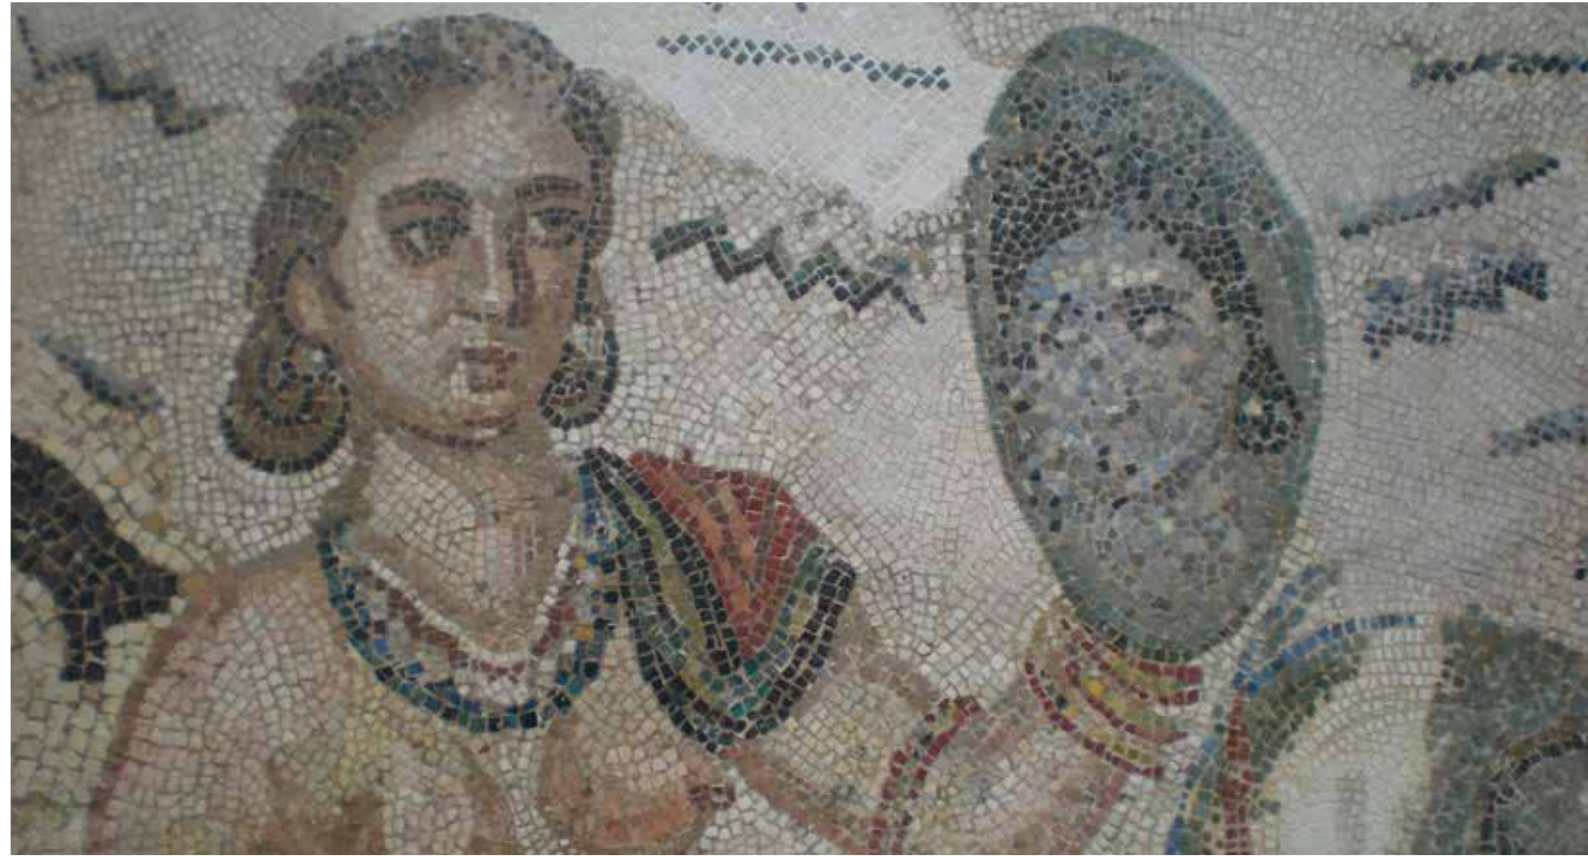
Reconstructive technique of the gaps - Chromatic dispersion

In the Villa, for the first time, a precious reconstructive technique of the gaps was implemented, carried out in some details of small dimensions figures, using chromatic dispersion carved mortar, according to the primary colors on the edges, borrowing this technique from the pictorial reintegration of paintings and frescoes.

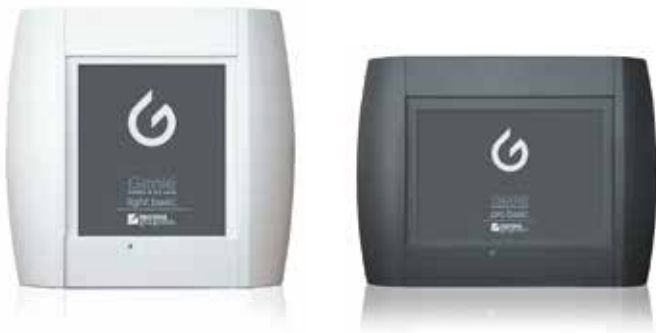
Fig 2. Genié is available in 10 models with a different range, and in two versions, Light and Pro. Genié is based on the innovative electrophysical dehumidification technology using “multiple frequency impulses”.

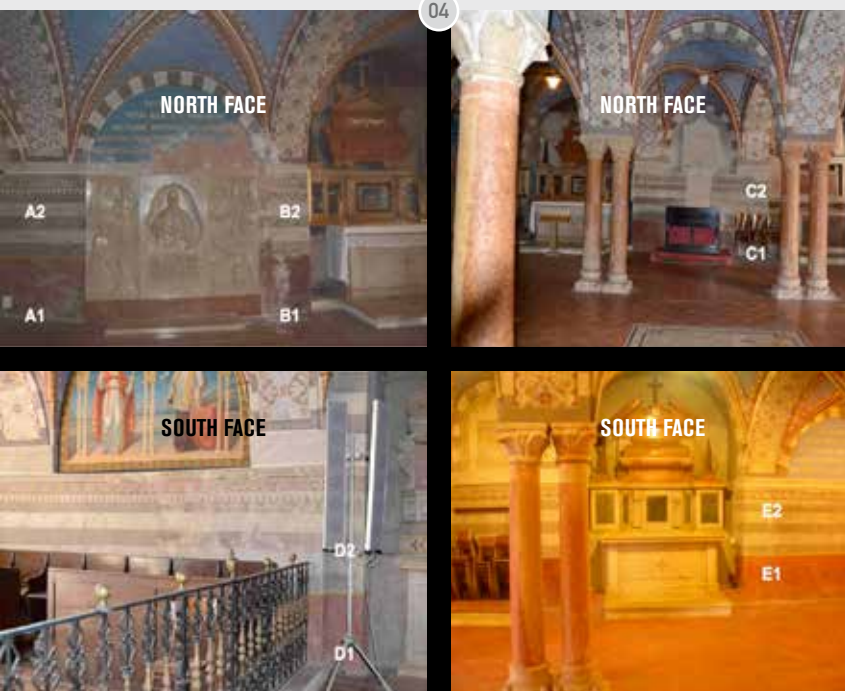
04

Fig 4. The 5 areas of the crypt that were tested for humidity.

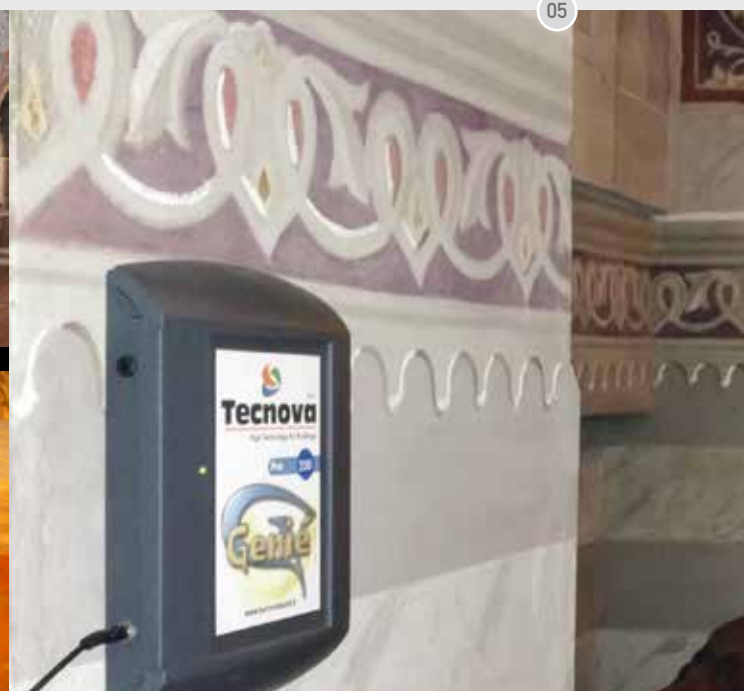
05

Fig 5. The picture shows one of 4 Genié devices mounted on the wall of the crypt of the Cathedral of Cremona.

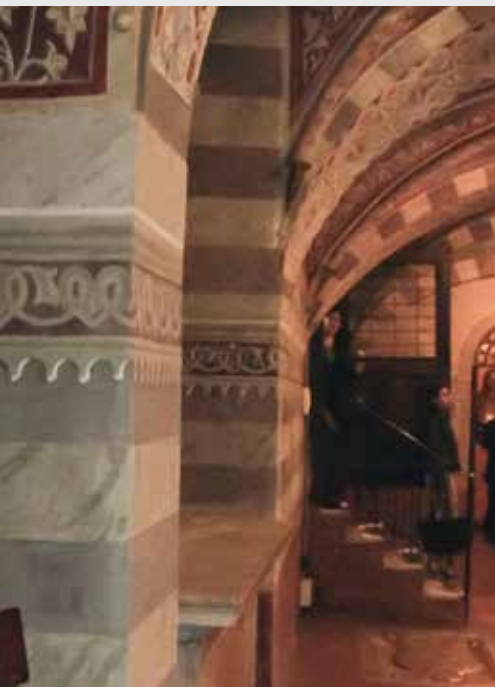
07

Fig 7. Overview of humidity rates over time.

02 Feb 13	04 Sep 13	31 Jan 14	18 Jun 14	06 May 16	
	% damp	% damp	% damp	% damp	% damp	
North wall, to the left of the headstone						
A1A	20 cm from the floor	11,2	7,7	2,9	8,1	3,7
A1B	20 cm from the floor	15,9	9,8	16,1	12,5	3,9
A2A	150 cm from the floor	5,2	1,7	1,5	6,8	3,4
A2B	150 cm from the floor	4,3	3,2	1,7	8,9	2,7
North wall, to the right of the headstone						
B1A	20 cm from the floor	4,1	3,5	1,7	5,3	2,5
B1B	20 cm from the floor	10,5	6,4	10,4	4,5	4,2
B2A	150 cm from the floor	4,4	3,3	1,2	2,1	2,5
B2B	150 cm from the floor	0,8	4,9	3,5	3,2	1,0
North wall, to the left of the second altar						
C1A	20 cm from the floor	4,5	4,8	2,0	2,0	2,6
C1B	20 cm from the floor	9,2	10,5	2,8	5,8	3,5
C2A	150 cm from the floor	3,4	4,5	1,1	1,0	2,7
C2B	150 cm from the floor	14,3	6,5	4,3	4,3	3,9
South wall, to the left of the second altar						
D1A	20 cm from the floor	6,0	2,2	2,5	3,0	1,6
D1B	20 cm from the floor	9,0	3,3	3,5	3,3	3,0

D2A	150 cm from the floor	6,7	8,4	1,3	1,9	1,4
D2B	150 cm from the floor	8,2	1,8	6,4	3,3	1,2
South wall, to the right of the first altar						
E1A	20 cm from the floor	3,7	1,6	1,8	2,4	2,1
E1B	20 cm from the floor	5,3	2,9	2,7	2,6	0,6
E2A	150 cm from the floor	4,1	1,5	0,9	1,4	1,9
E2B	150 cm from the floor	8,3	6,7	4,7	3,8	2,2
